Evergreen Home Inspections

PROPERTY INSPECTION REPORT

Property Address: **2222 Sample Dr., Southfield, MI 48076**

Inspection Date: **November 5, 2016**

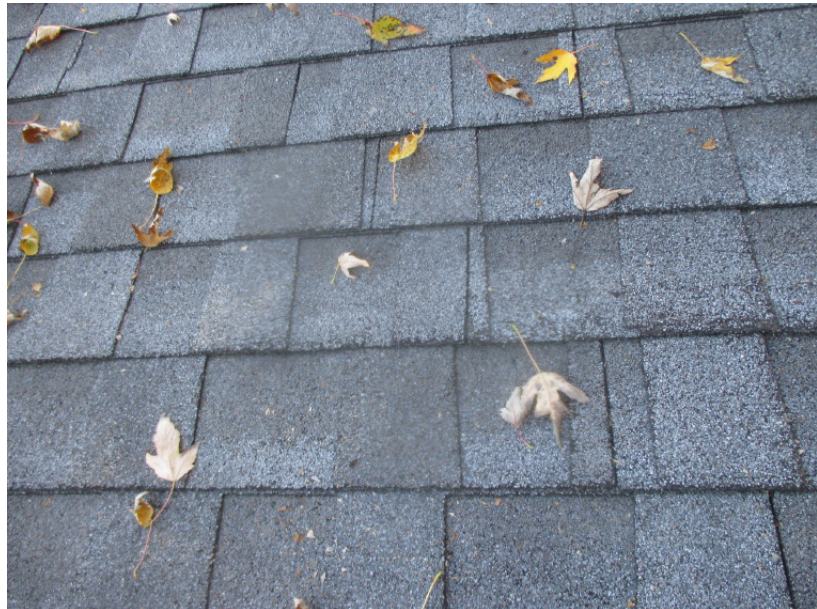
Note some shingle wear, but shingles intact and generally sound

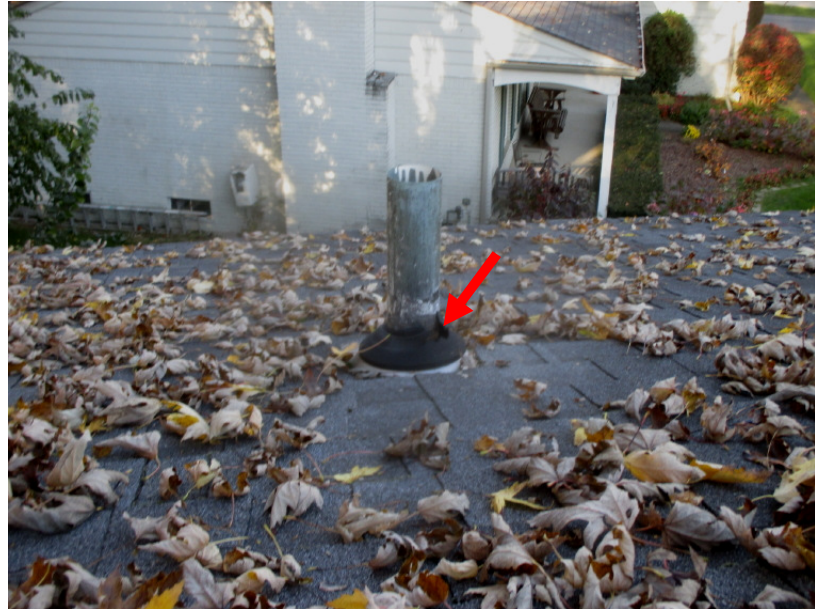
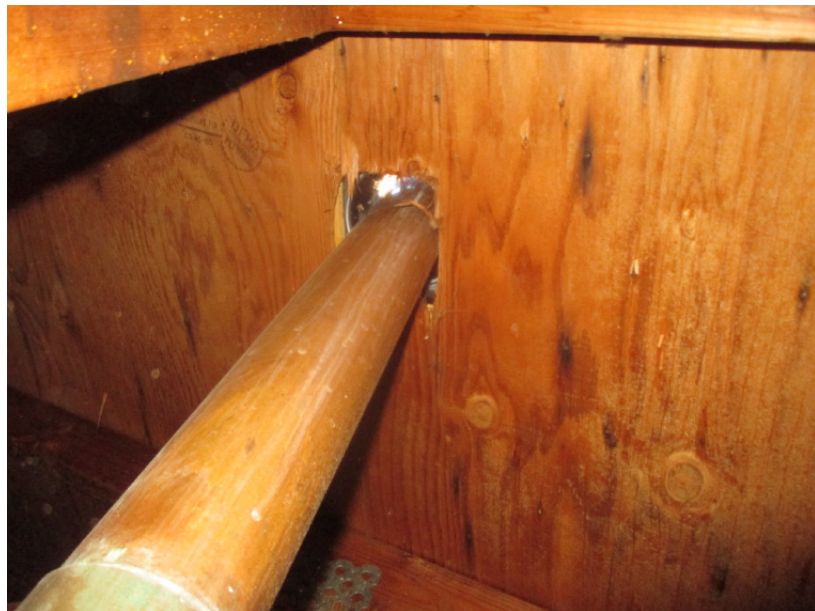
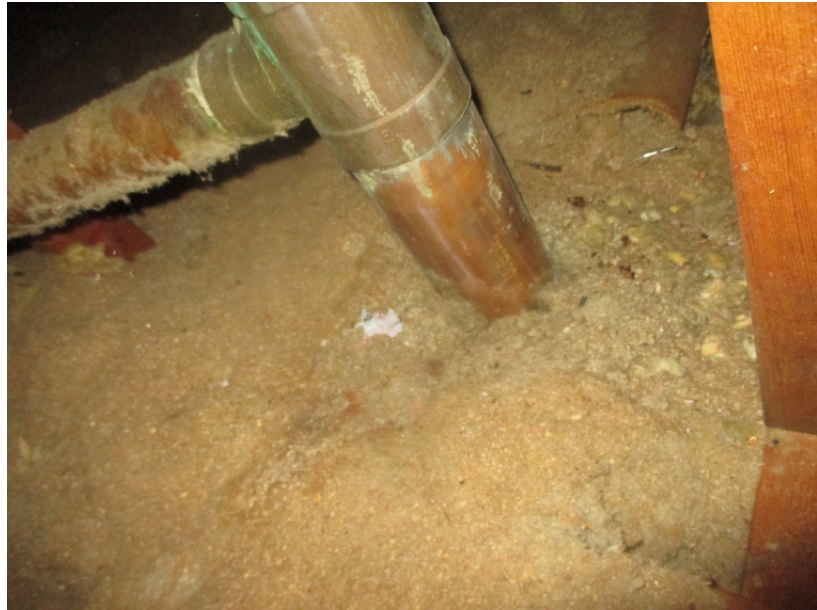
- Rubber sleeve (gasket) was badly torn, evidently causing leakage, as stains and consistent with such leakage were observed on insulation in the attic below. Adapter sleeves that can be slid right over the stack pipe are available for roofs of various slopes (itches), this one being about 4/12.

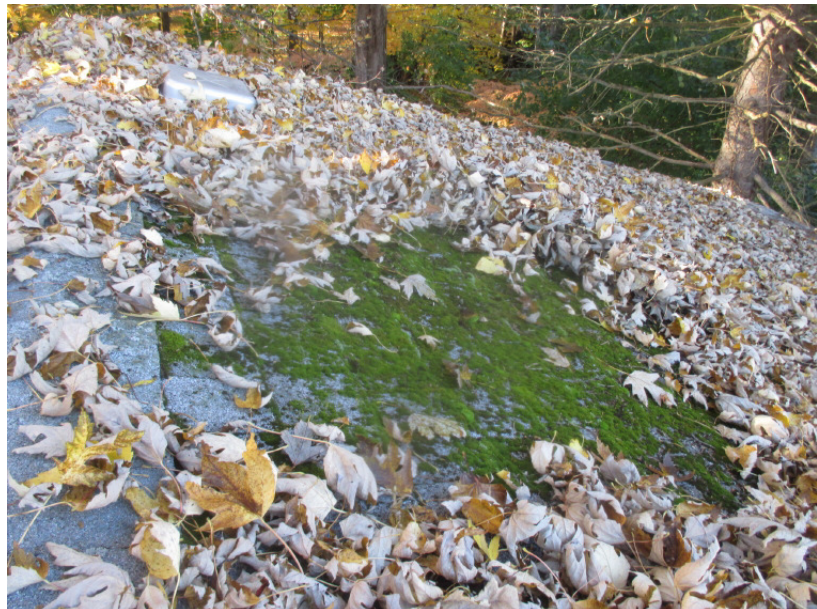
- A considerable amount of moss was observed on the roof under trees, especially on the rear portion of the NE face. Moss can break down shingles, as can fungi and algae, to a lesser extent. Power washing is not recommended, as it can be too damaging to the shingles. There are chemicals available that can remove moss, and zinc strips that can inhibit its growth.

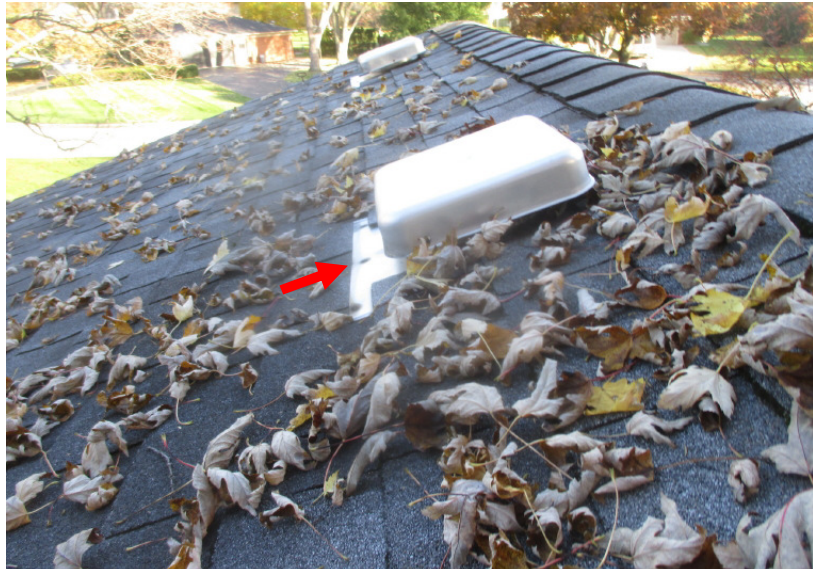
- Exposed nail heads were observed on some flanges of vents and stack pipes. Sealing these with roofing caulk is recommended to reduce the possibility of leakage through such unsealed roof penetrations.

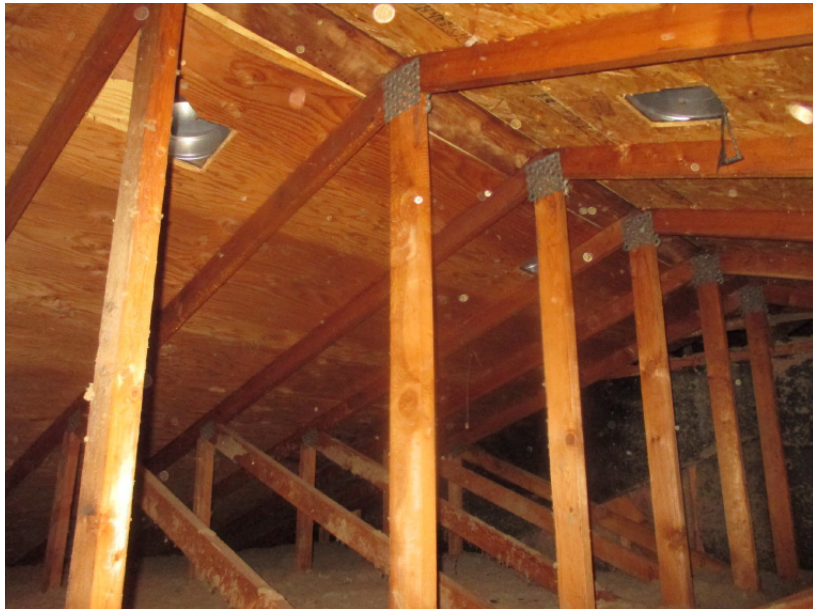
- Limitations: Attic space above the main level ceiling was not readily accessible for safe entry due to shelving. Inspector viewed the attic and pictures were taken from the opening.

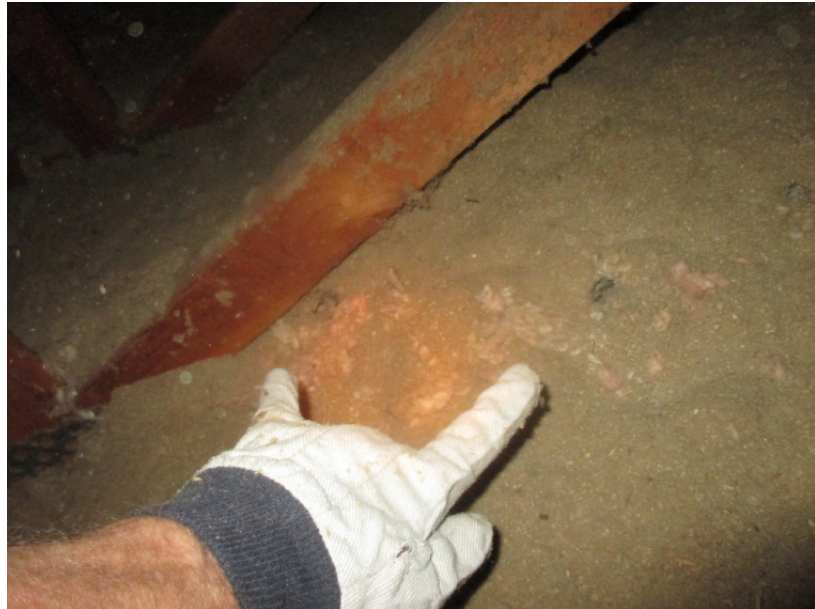
- Slight matting of insulation was observed below the torn E plumbing vent sleeve, evidently due to slight leakage, as noted above.

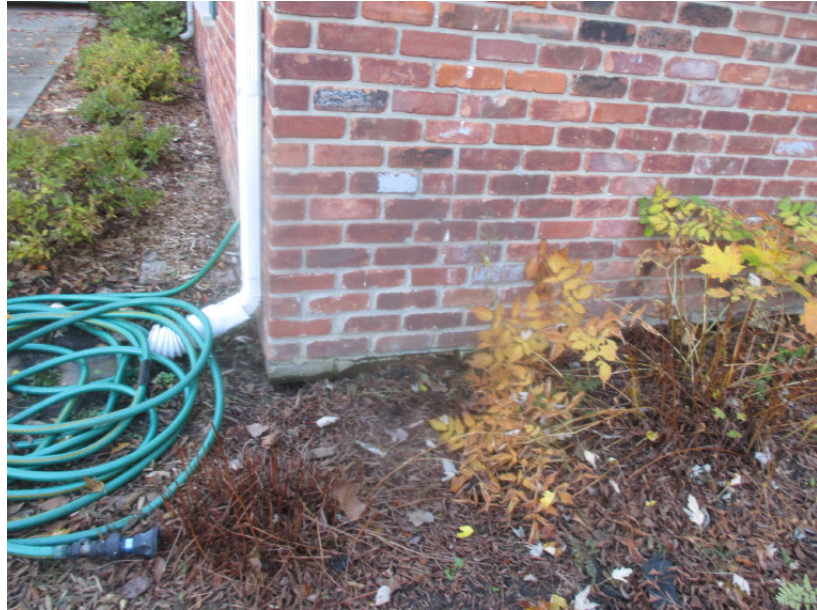
- Isolated loose masonry was observed on the lower corner of the garage. Patching (“tuck-pointing”) is recommended to keep water out of the wall, as water penetration can lead to more serious issues, and expansion of water as it freezes can cause more rapid deterioration.

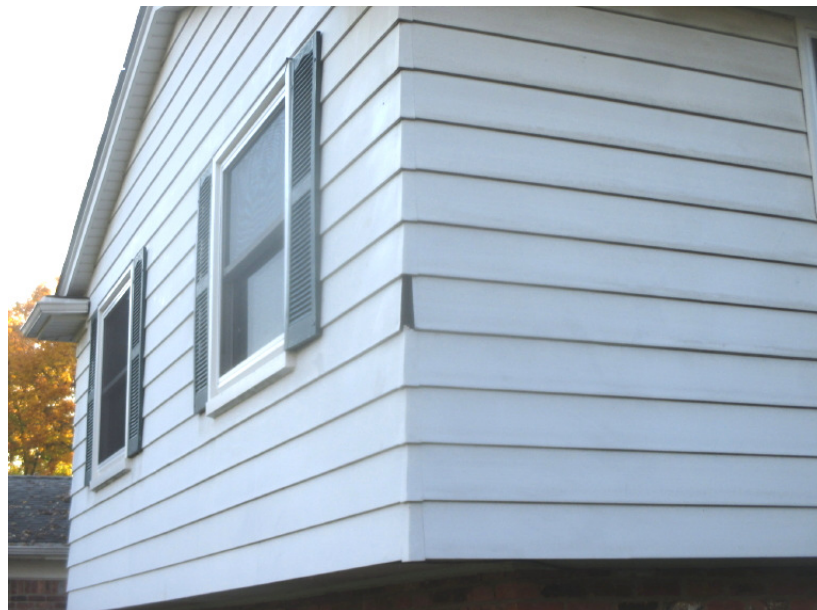
- A corner piece was missing from the siding on the SE corner, which could enable water entry. Replacement pieces should be available.

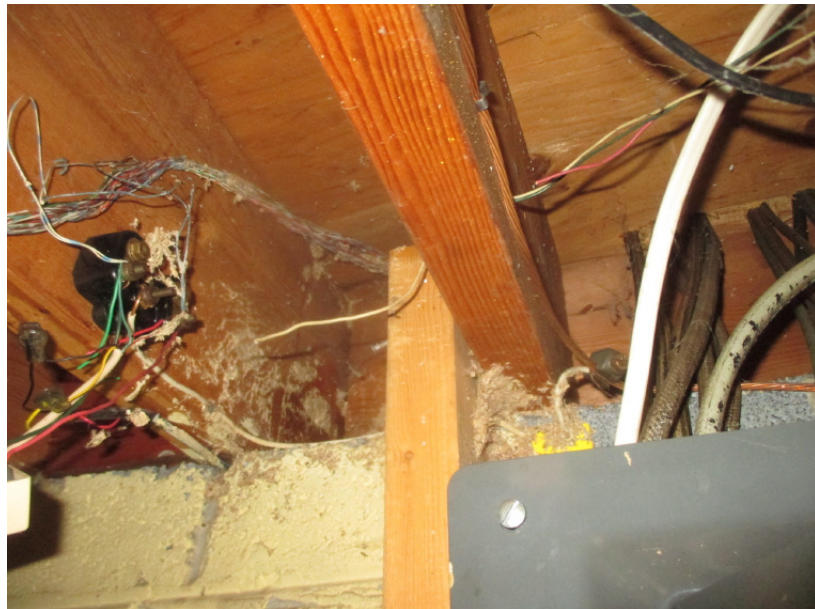
- Ceilings and floors were observed to be generally in good condition, except as otherwise noted, with no indications of structural issues observed.
- Wood shavings were observed between ceiling joists in the basement above left of the main electrical panel. Such deposits sometimes result from infestation by wood-destroying insects, but in this case appeared to be sawdust from drilling of the hole for the telephone wiring that passed through the ceiling above, given the absence of obvious indications of significant moisture.

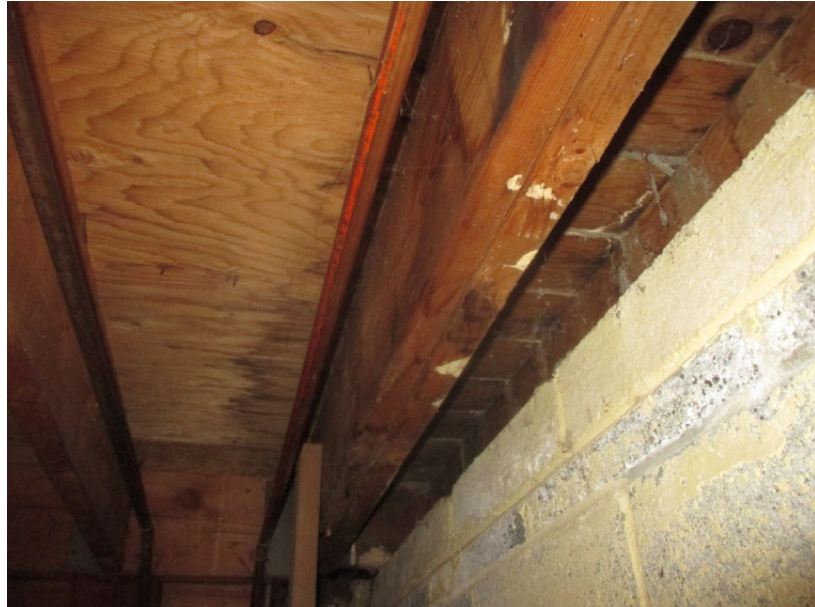
- Slight staining consistent with water entry was observed on the basement ceiling below the front door. Damage did not appear serious, but the condition of underlying materials could not be determined.

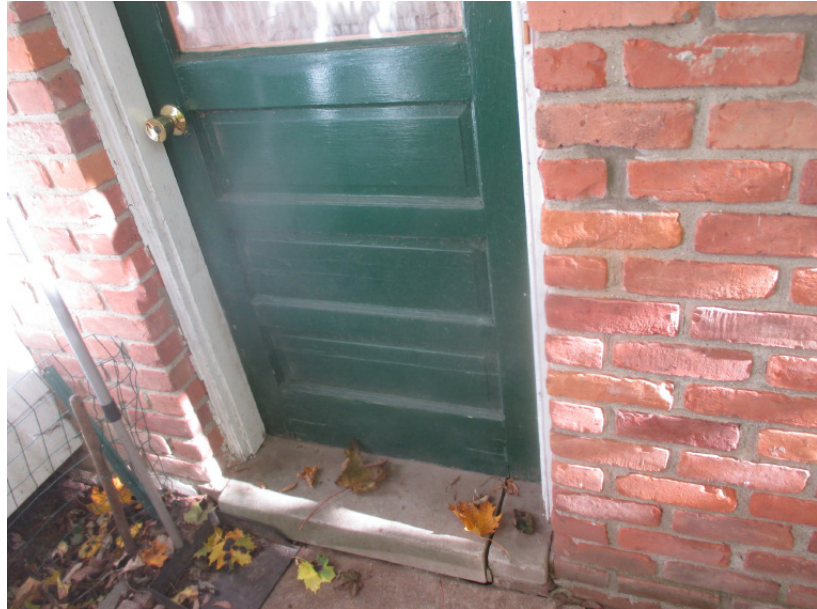
- *Security Concern:* Wooden exterior garage passage door had thin decorative panels that could easily be kicked in, and a single-pane window near the locks that could be easily broken. Sturdy security screens to provide additional protection against such window breakage.

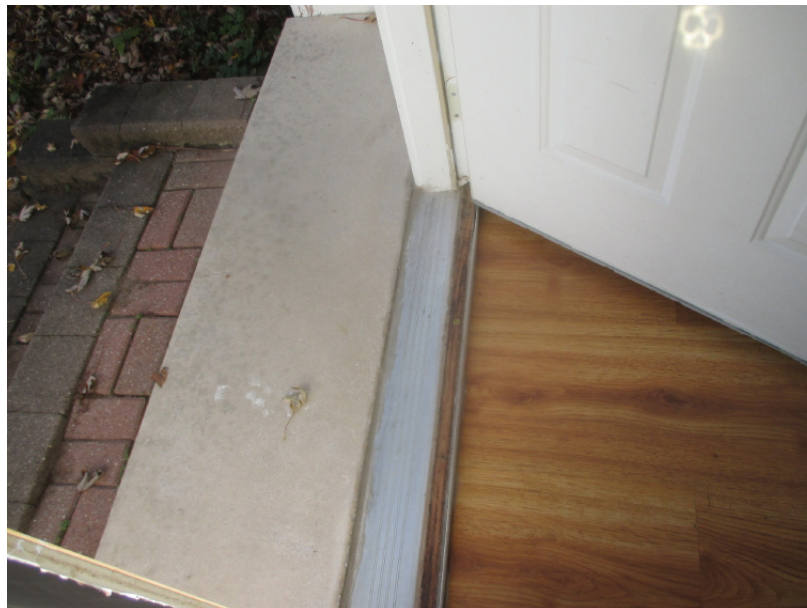
- Front door threshold was below the elevation of the sill in front of it. This could enable water entry if not kept fully sealed around the threshold, including the sides.

Indications of such water entry were observed on the basement ceiling below, but the area was not noticeably wet at the time of the inspection, and the threshold was mostly caulked around its edge.

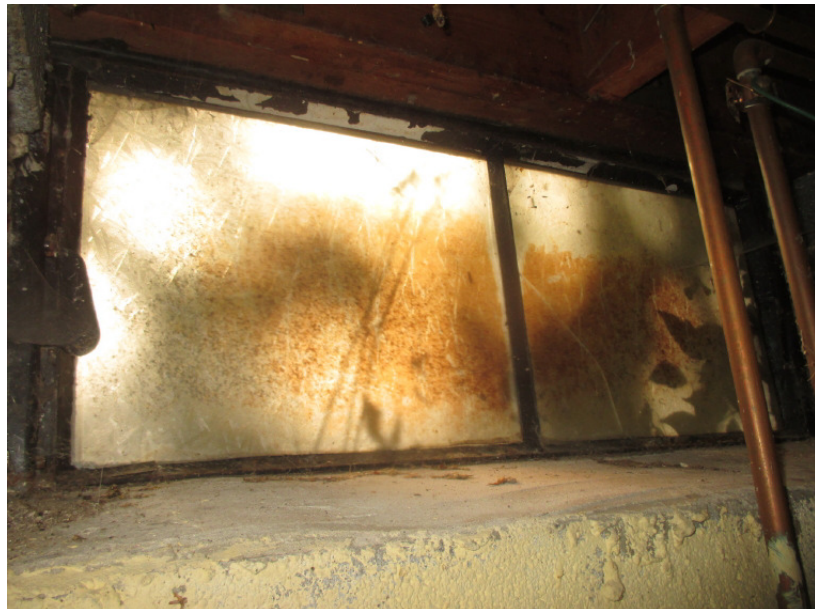
- 2 of the basement window panes were cracked.

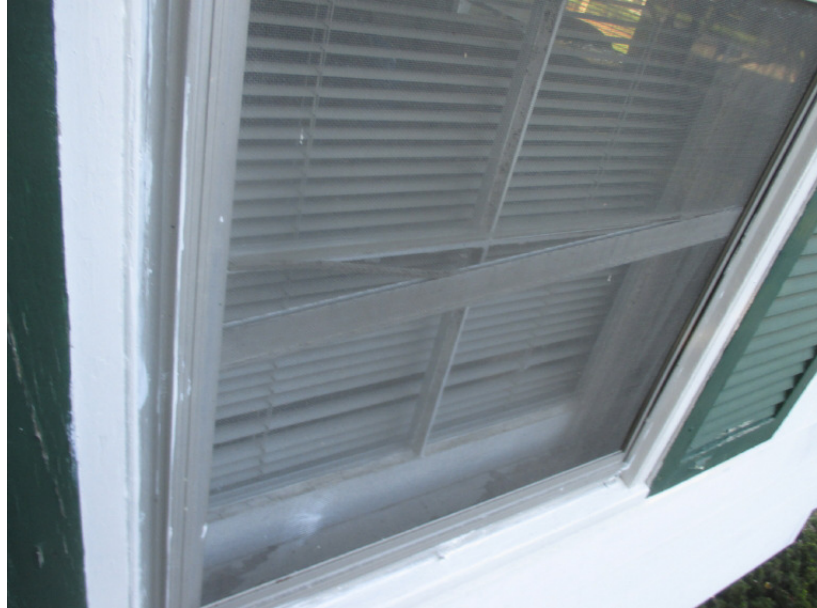
- Storm window piece on the 2nd floor SW bedroom W window was broken.

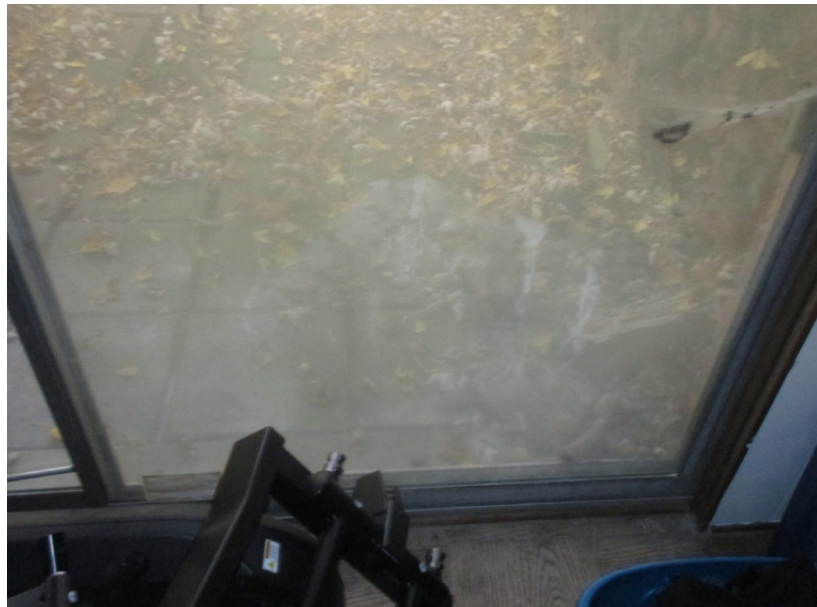
- Condensation was observed between the panes of the old, possibly original lower level sliding glass door, evidently due to a poor sash seal. The effect is essentially cosmetic. Some companies advertise “de-fogging” of windows, the effectiveness of which Inspector has not confirmed.

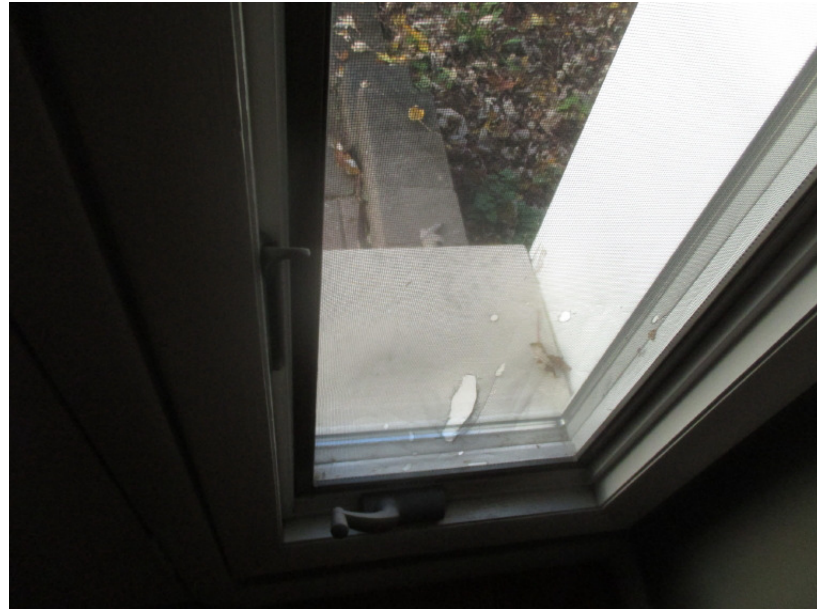
- 2 of the old wooden windows in the lower level and 2nd floor SW bedroom did not open, evidently having been over-painted. Over-painted windows may be able to be opened by carefully using a putty knife or similar object and hammer to break the paint.
- Some isolated screen damage was observed. Patching or re-screening recommended to keep out insects and other vermin. Screen kits and patches for small holes are available, and some hardware dealers repair screens.

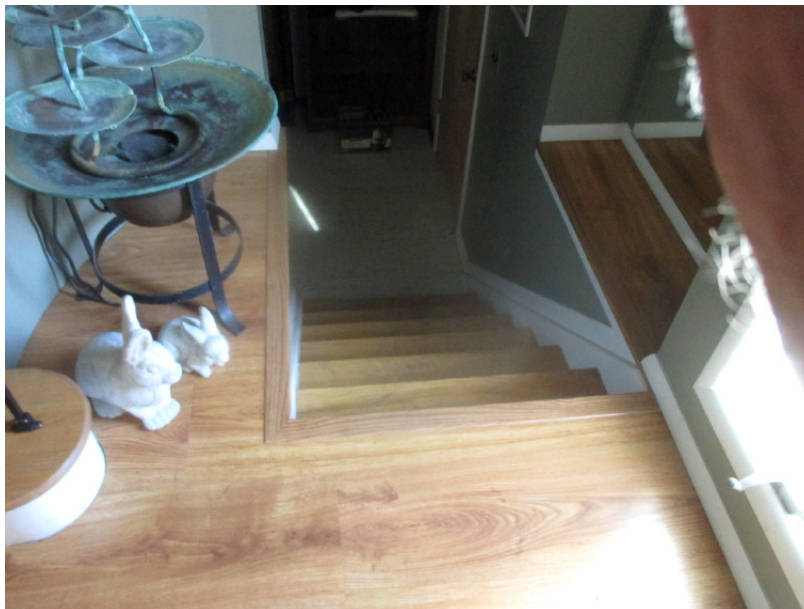
- Opening for the stairway to the lower level had no guard rails. Guard rails with no openings exceeding 4" in width into which small children could fall or get stuck are recommended on open sides of all stairway elevations exceeding 2 steps or 30 inches.

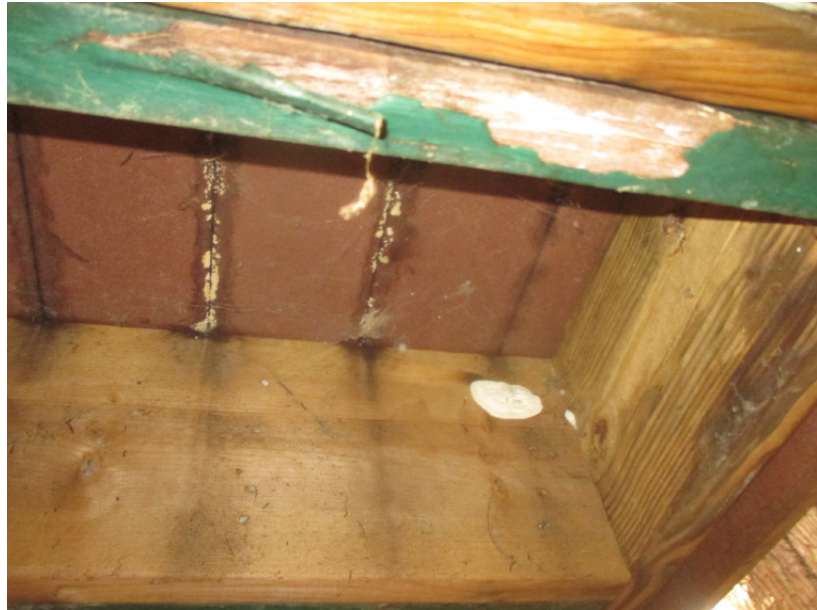
- Noticeable spotty whitish formations were observed on the underside of the balcony consistent with mold or other fungal growth. This should be cleanable, the joists being of treated wood and the floor boards being moisture-resistant composite.

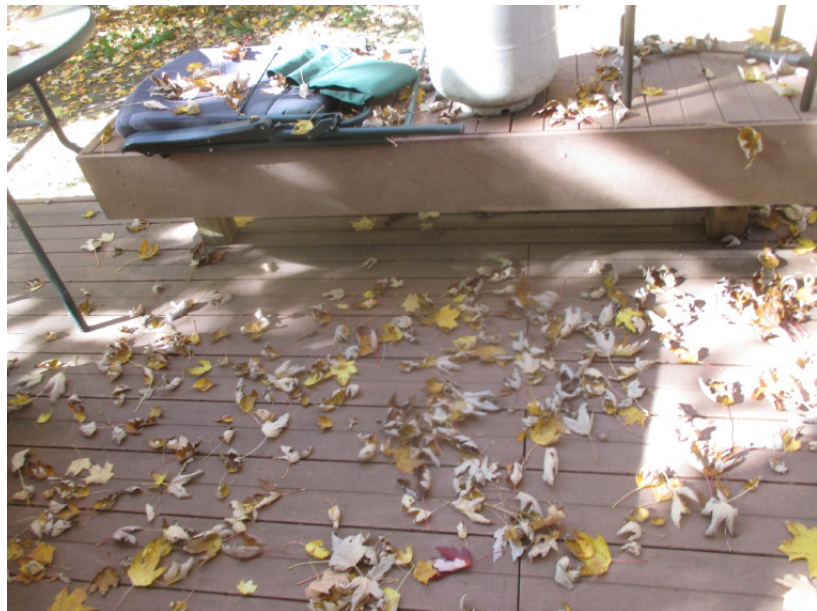
- Deck boards were installed rather tightly against each other, so the surface had poor drainage. Separation of deck boards is typically recommended. This could result in a slippery surface due to wet debris, upon which algae, fungi, and moss could grow.

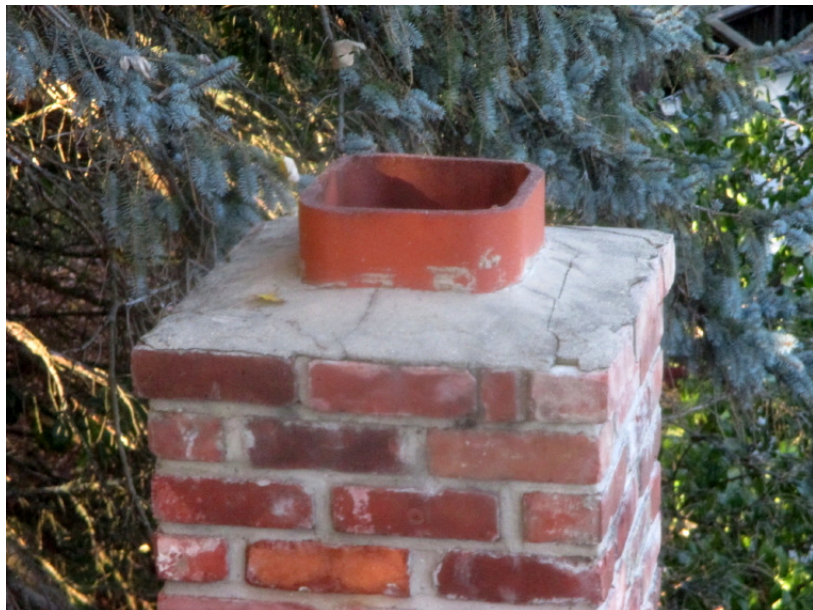
- Chimney cap had no cover, and slight cracking of its crown was observed. Absence of a cover could enable vermin such as birds to enter the chimney, or even or raccoons, if tree branches grow near enough to the roof. A very sturdy cover is recommended, as raccoons can tear apart flimsy covers very easily.

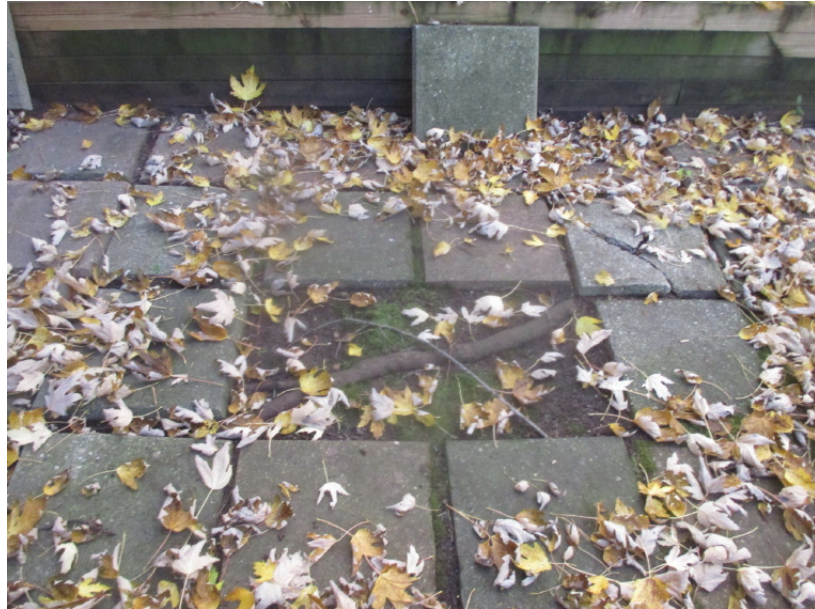
- 2 patio pavers were missing and others were uneven due to tree roots, and adjacent concrete sections were observed on the far W side of the driveway, which could pose tripping hazards. Tree roots would have to be cut or the pavers reinstalled after leveling the patio to correct the patio pavers, taking care to ensure a good slope away from the house for drainage. Concrete on the driveway could be patched.

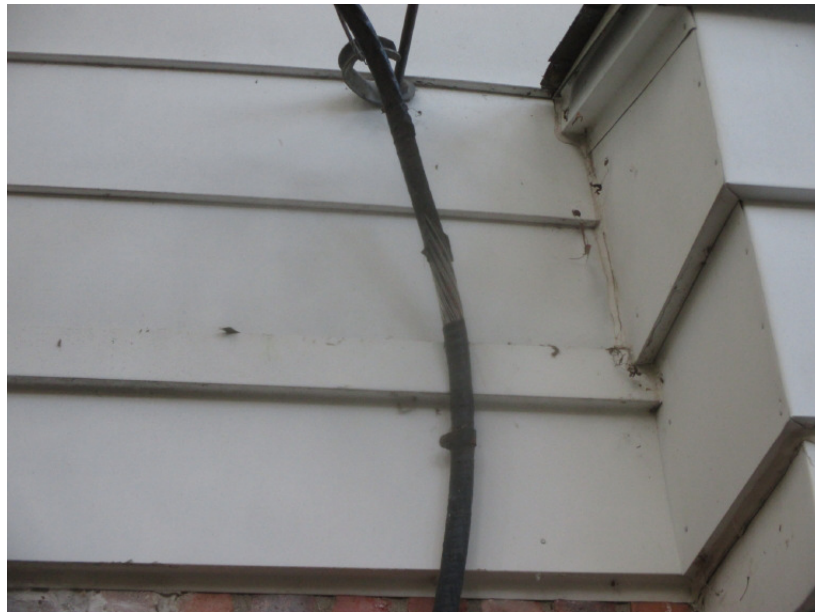
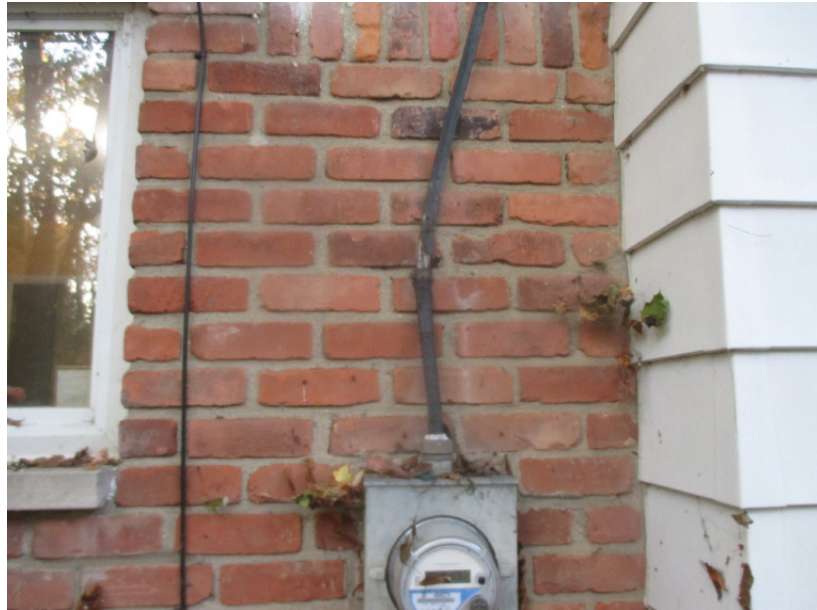
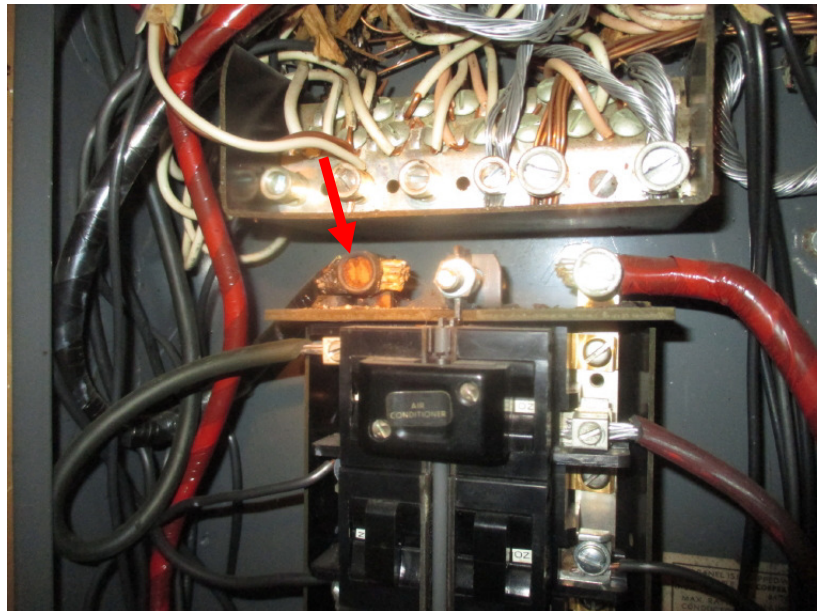
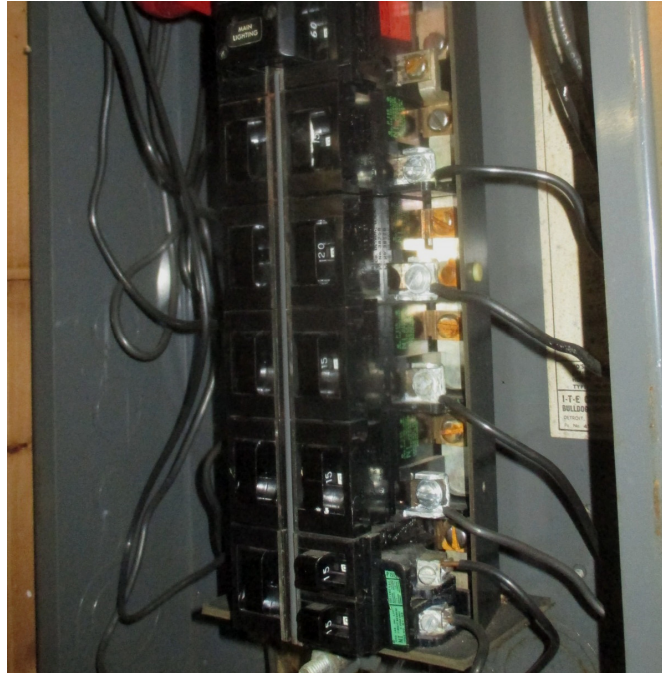
- Exterior service cable was severely worn, with much of its outer insulation worn through completely, enabling water to enter the wiring.
- Corrosion was observed in the main panel, mainly on the L main terminal and some terminals of circuit breakers on the R side of the panel and their wires, especially in the 12 and 14 positions, evidently due water entry into the equipment via the deteriorated cable.
- Replacement of the cable and all corroded parts and cleaning of corrosion off affected wires are at a minimum recommended ASAP.

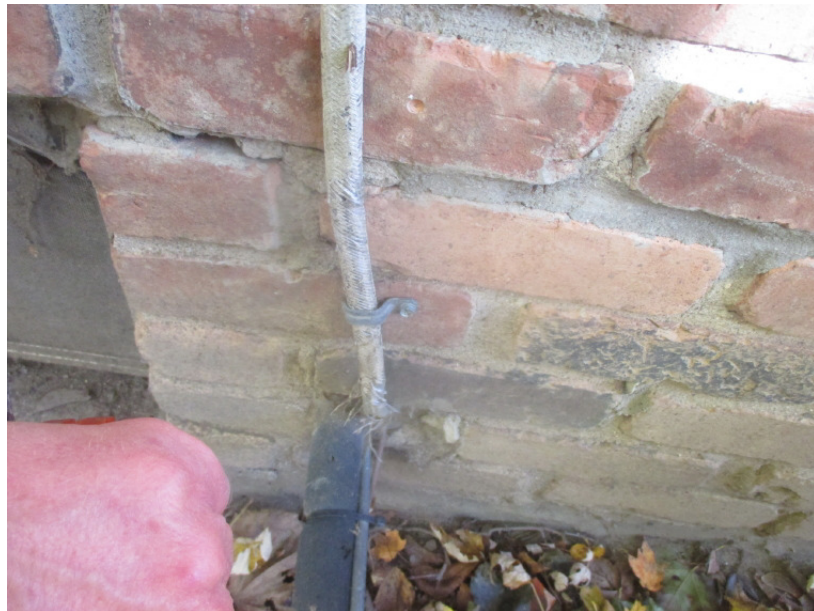
- Exterior AC cable was also worn to a lesser degree, but would also be advisable to replace.

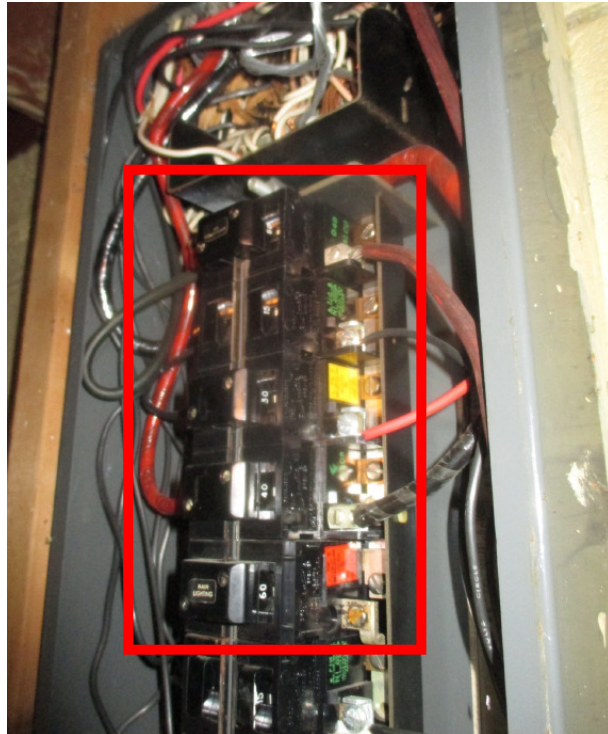
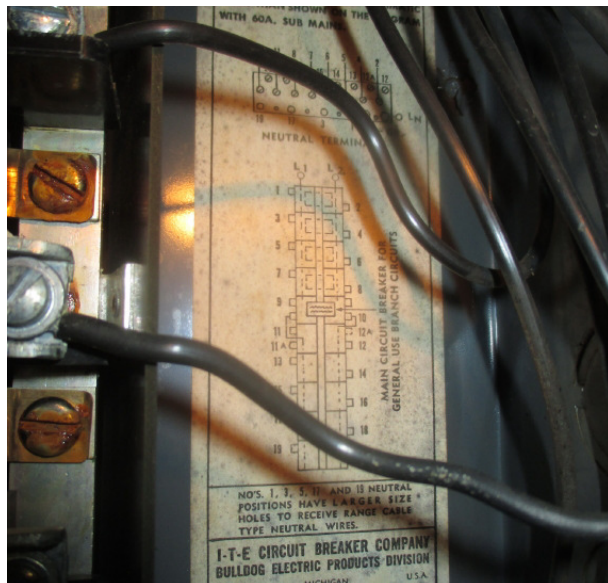
- The main panel was of an outdated design, in which the maximum possible current allowable through the main service cable through the circuit breakers in the main section that branch off the main terminals ($60A + 40A + 30A + 15A + 50A = 185A$) could exceed the 100A rated capacity of the service cable, which could cause the main cable to overheat, creating a potential fire hazard.

This was a customary panel configuration at the time of installation, and it is improbable for all circuits to be carrying such a high percentage of their current capacity at the same time for such a main cable overload to occur. Nonetheless, reconfiguration or replacement of the panel, main cable, and/or main section circuit breakers would be advisable to ensure safety, even though the panel may be "grandfathered."

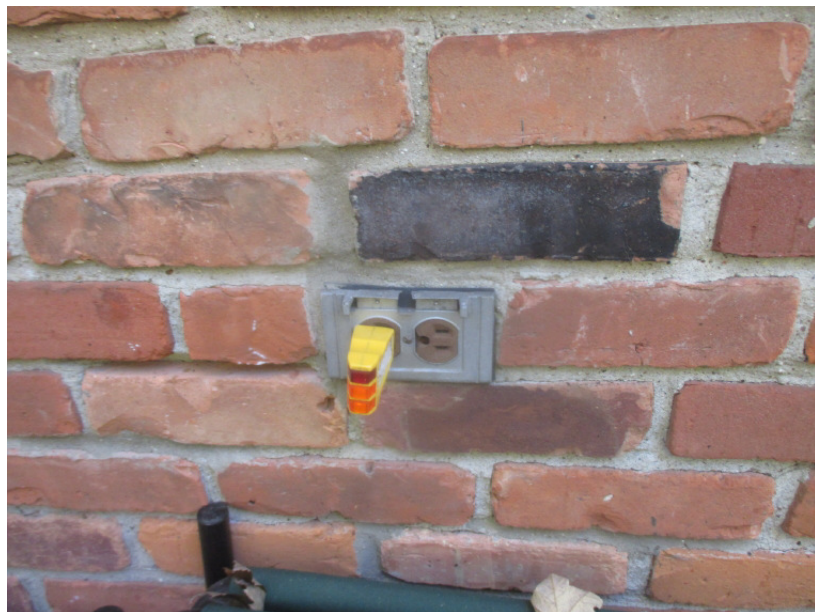
- No weatherproof cover was observed on the exterior outlet in the rear above the deck. The outlet was also evidently not GFCI protected (see below).

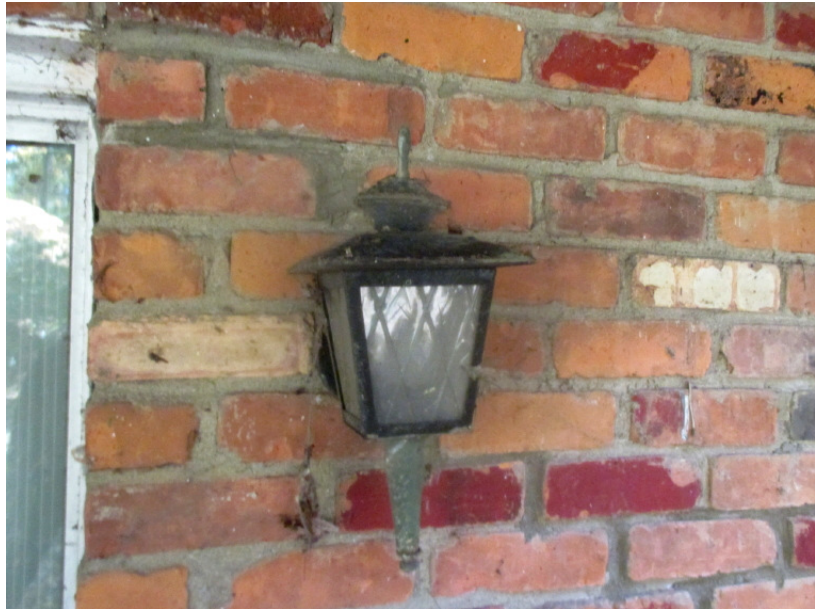
- Light fixture in the rear off the lower level sliding glass door was not securely mounted, and did not turn on. The bulb may have been dead.

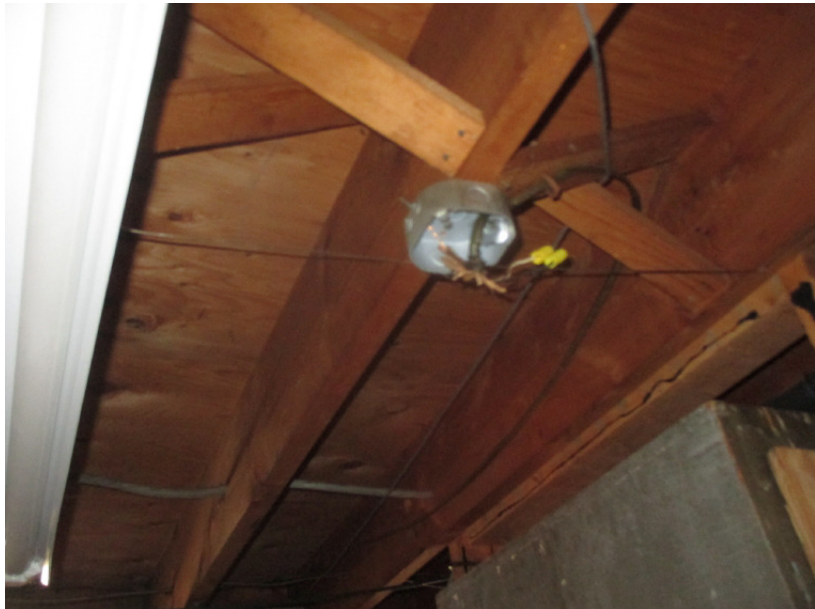
- Disconnected wires were observed in a junction under the basement ceiling, evidently intended for a light fixture, which had since been disconnected.

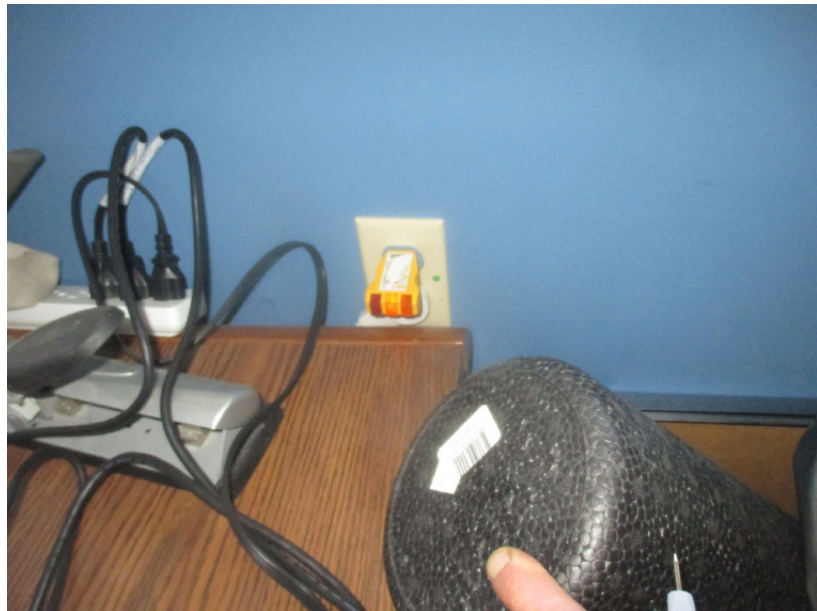
- Non-grounded regular 3-hole outlets were observed in the lower level bedroom (marked with green dots). Non-grounded 3-hole outlets are not inherently hazardous, but falsely indicate grounding that is not present, and provide less protection against electric shock than grounded outlets. These most likely had a disconnected grounding wire at an “upstream” connection where there were several nearby ungrounded outlets, as grounded wiring was present throughout the house.

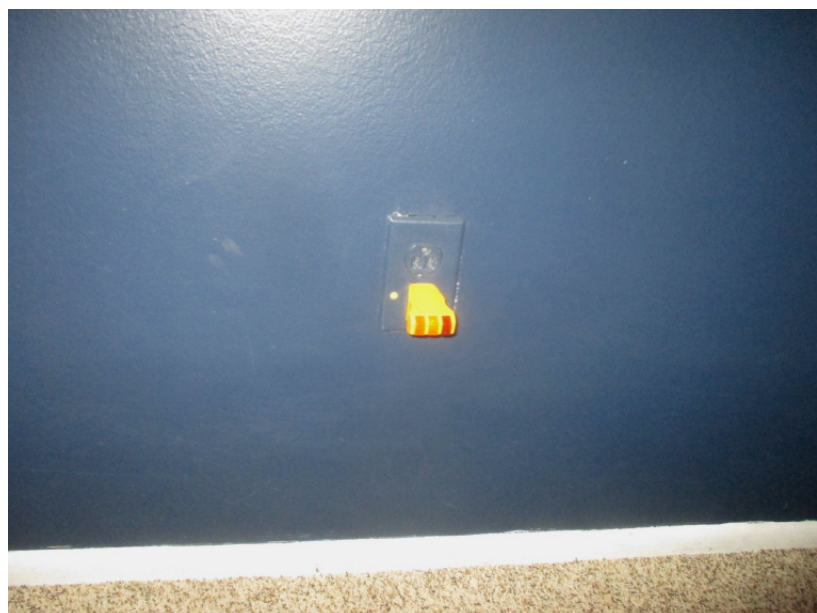
- Some outlets were difficult to use or had poor grounding contact (marked with yellow dots) due to over-painting. Painting of outlets is strongly discouraged for its effect on operation.

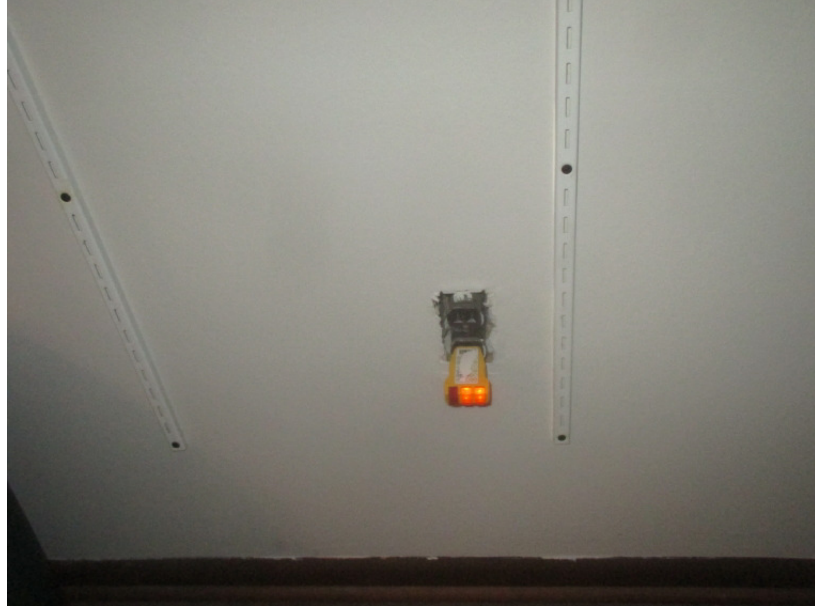
- An outlet in the lower level den had no cover.

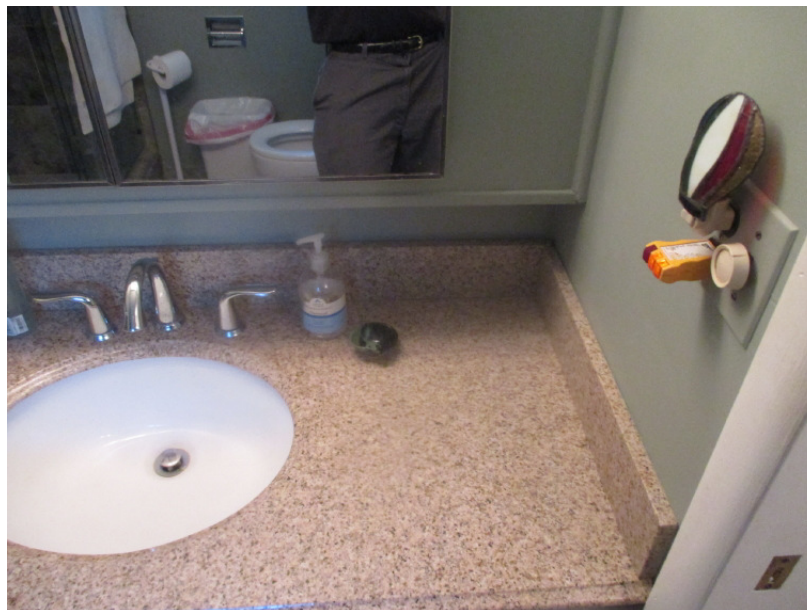
- Outlets were not ground fault circuit interrupter (GFCI) protected in most recommended locations.
It is recommended that outlets in potentially wet locations (e.g., near sinks, exterior, garage, unfinished basement areas) be GFCI protected to minimize the possibility of accidental electric shock, except where used for refrigerators, freezers, or other such equipment for which undesirable consequences could result in the event of an accidental trip of the GFCI.
When outlets are run from one another the first in the chain should be GFCI protected, which will also protect the others, if properly wired, and those identified with stickers provided with the GFCI outlet.

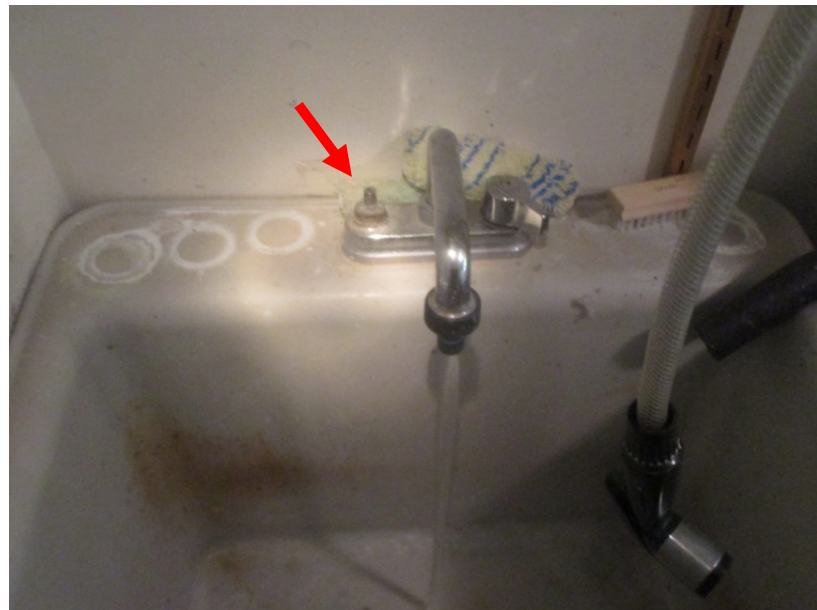
- Laundry sink hot water faucet was missing its handle and stuck, unable to be operated with a wrench with ordinary force. Faucet may need to be replaced unless it can be operated with a wrench after the stem is lubricated with hot water. Valves for the faucet were in the basement behind the laundry sink, and were not stuck.

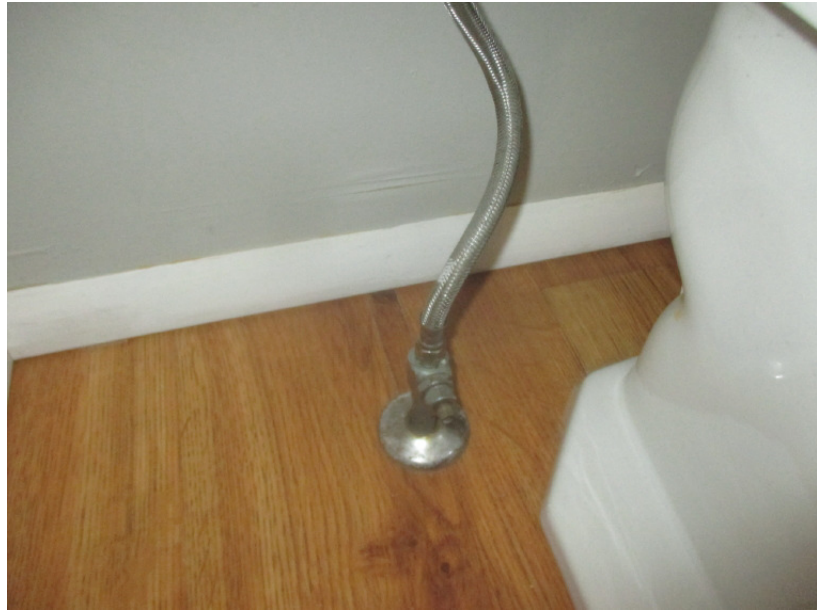
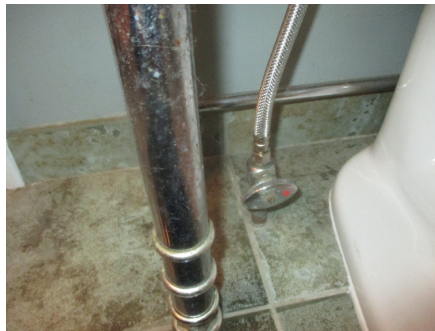
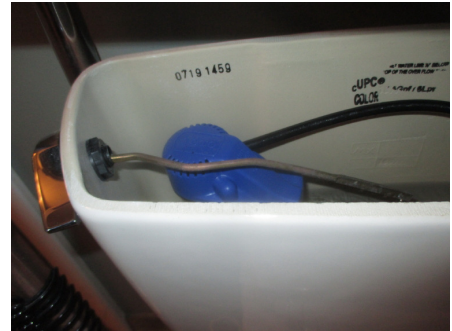
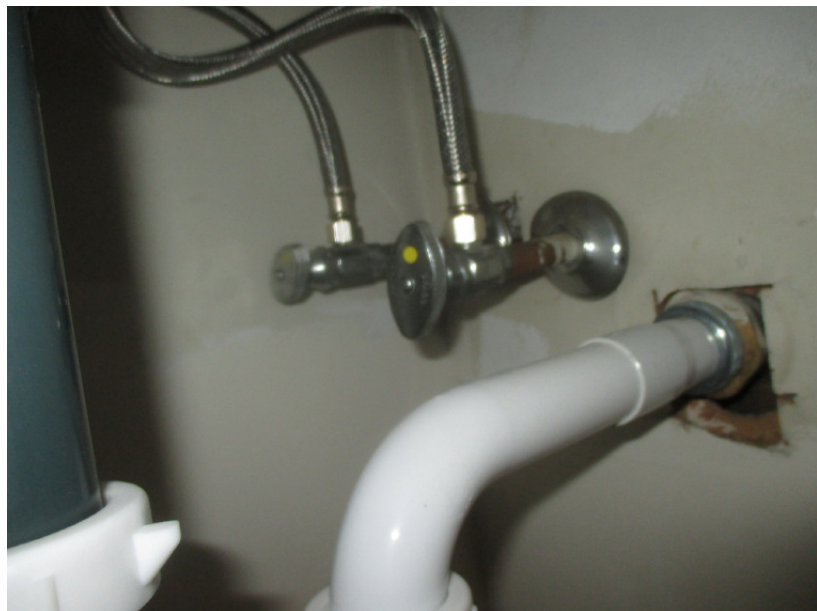
- Many issues were observed with shut-off valves ("stops"). Valve for the 2nd floor bedroom bathroom was ineffective (marked with a red dot). Valve for the 2nd floor common bathroom and main floor lavatory toilets had no handles, and valves for the lower level bathroom toilet and several under sinks were stuck open (marked with yellow dots).
A stuck valve may be able to be operated by turning it very carefully with pliers or a wrench or unstuck by loosening its stem nut, if so designed (which could cause stem leakage if loosened too much). If it still does not operate properly, replacement is recommended.
Repair or replacement of any inoperative shutoff valves is advisable so it will be possible to work on fixtures individually without shutting off water elsewhere. It is important to use replacement valves that are compatible with the supply lines and conform to current codes.
It is important to have a shutoff valve near any toilet in case the toilet overflows due to a tank valve malfunction, preferably a ball valve that quickly and easily turns off with a quarter turn movement.
