Evergreen Home Inspections

PROPERTY INSPECTION REPORT

Property Address: **2222 Sample Dr., Southfield, MI 48076**

Inspection Date: **November 5, 2016**

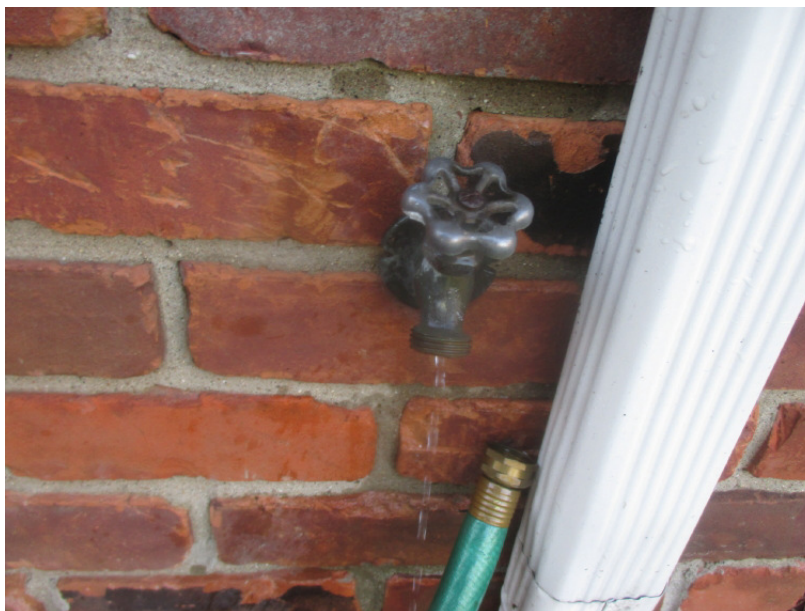
- Dripping was observed from the front exterior faucet when it was turned fully off. The faucet may be repairable with a new stem washer after turning off water to it.

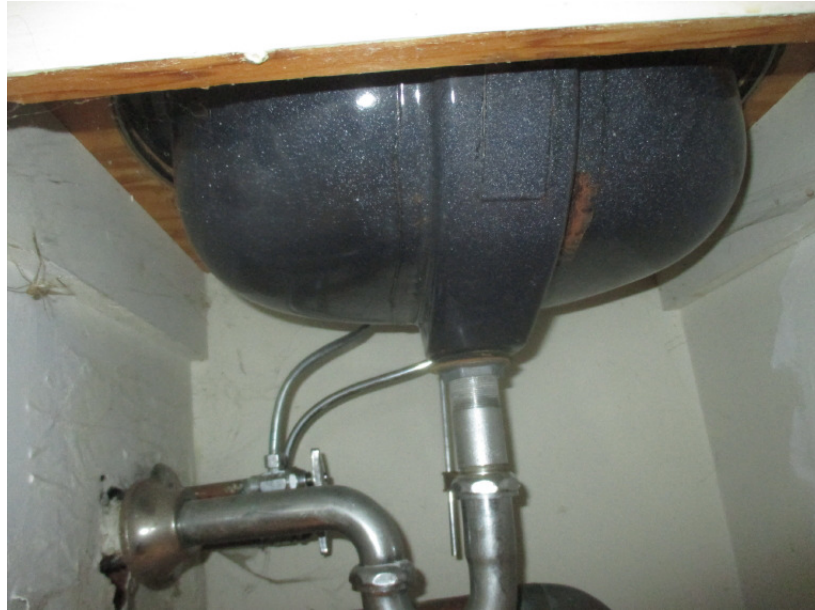
- Corrosion was observed on the seams of the overflow channel for the lower level bathroom sink. Such seams tend to eventually rust through and leak. No active leakage was observed when water was filled so it flowed into the channel.

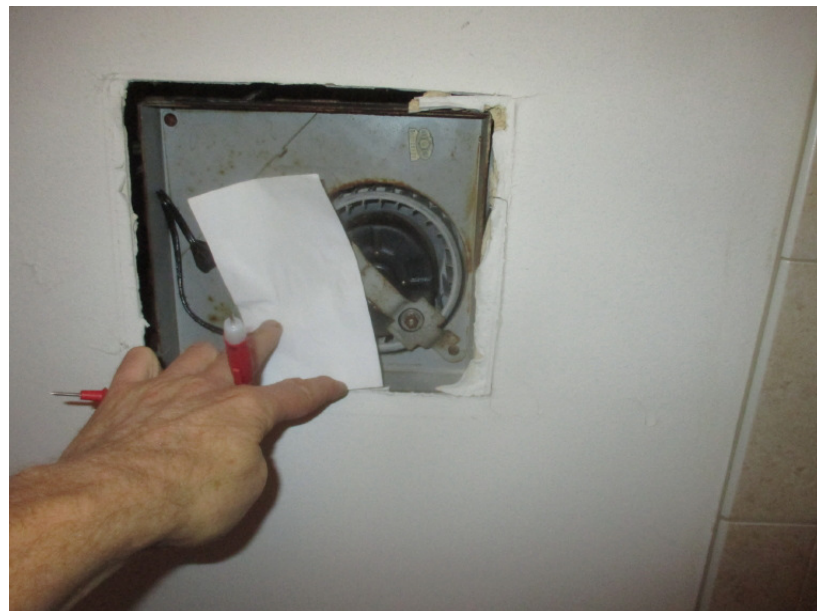
- Lower level bathroom exhaust fan did not function, and had no cover. It was evidently a plug-in unit, and made a humming sound, so there was evidently power. Most likely the fan was stuck or its motor seized. Replacement units should be available.

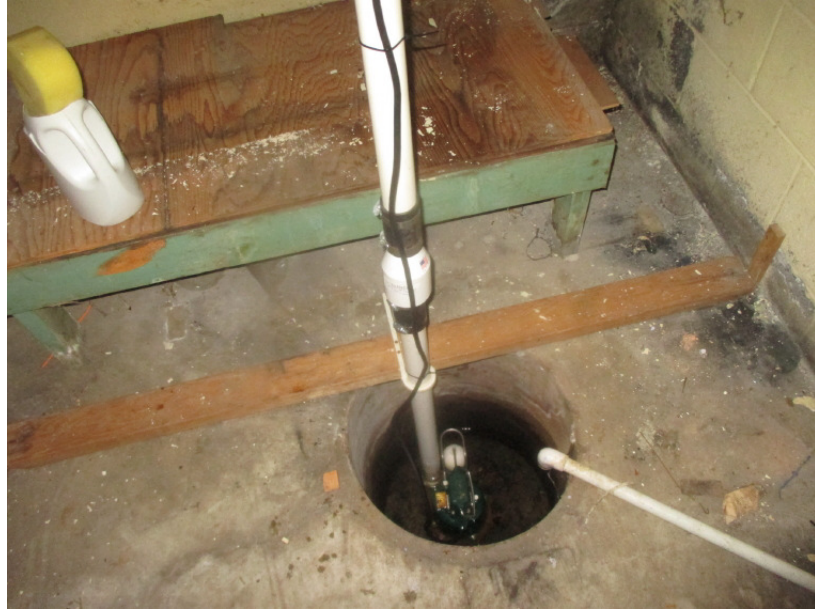
- Sump had no cover. A cover is recommended to keep debris out of the sump, and for the safety of small children and pets.
