## **Evergreen Home Inspections**

# **PROPERTY INSPECTION REPORT**

Concerning: **45717 Sample Lane, Novi, MI 48088**

Inspection Date: **April 1, 2014**

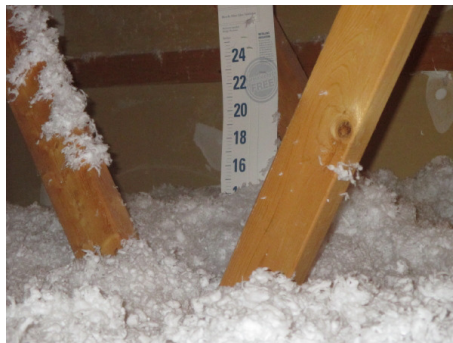
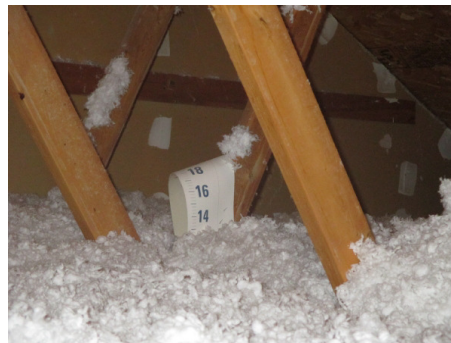
*Possible Security Concern:*

- Attic spaces between units may only be separated by drywall on top of framing, which could be easily cut to allow passage between the attic spaces of the units.

Locking latches on the access panel would be desirable as a precautionary measure.

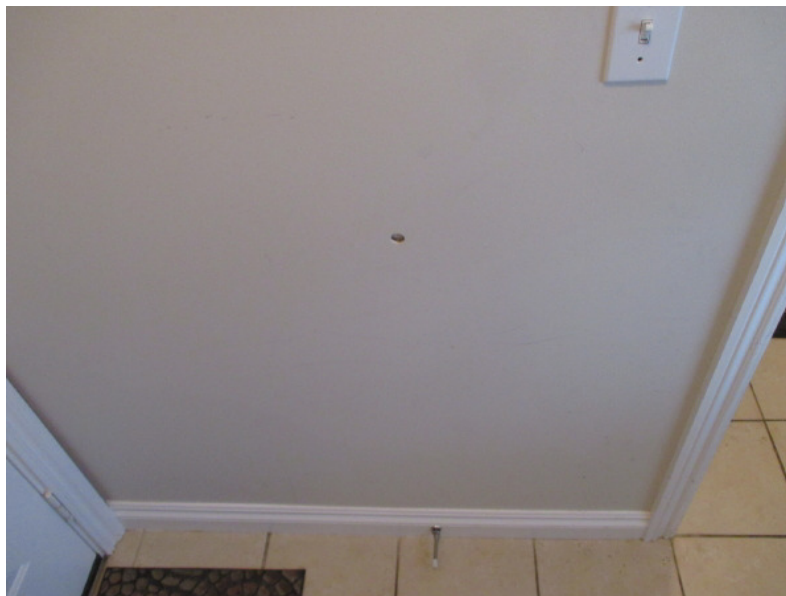
- A dent was observed in the wall in the laundry room from the garage passage door knob. Plastic stick-on door bumpers are available to repair and prevent such dents.

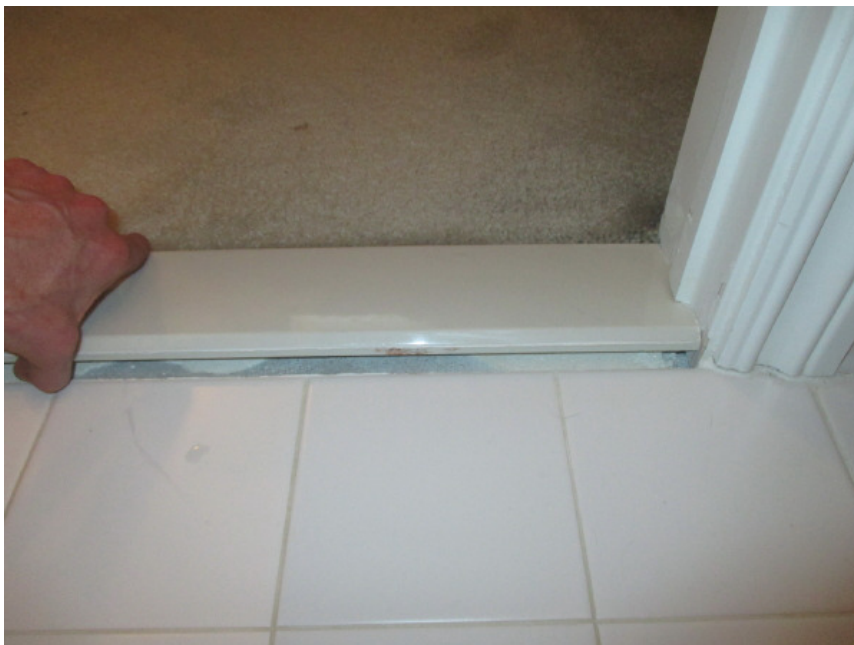
- Threshold for the S 2<sup>nd</sup> floor bathroom door was not secured. Probably the grout or adhesive just came undone.

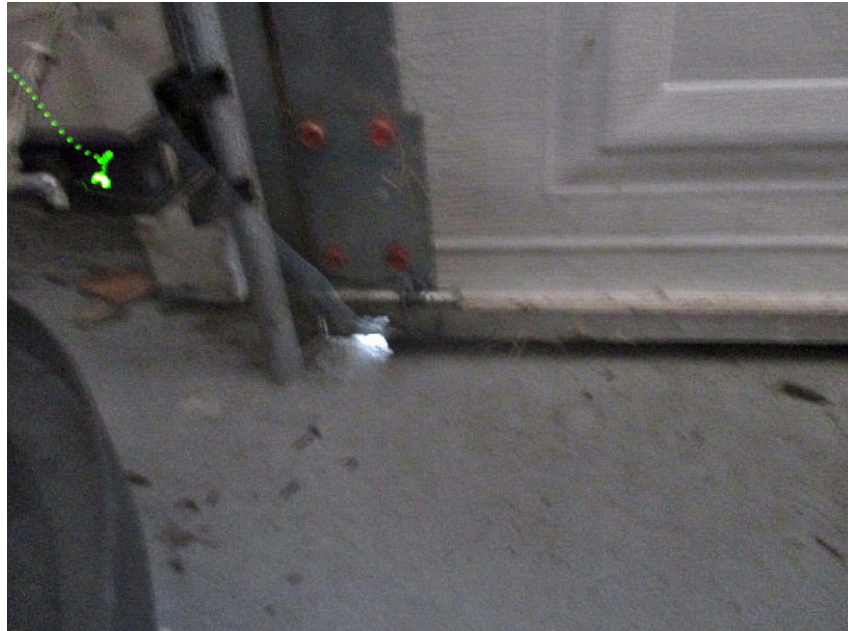
- A gap was observed in the weatherstripping below the corner of the overhead garage door. This could allow mice or other small vermin to enter. Adjustment or replacement of the weatherstripping to close the gap is recommended.

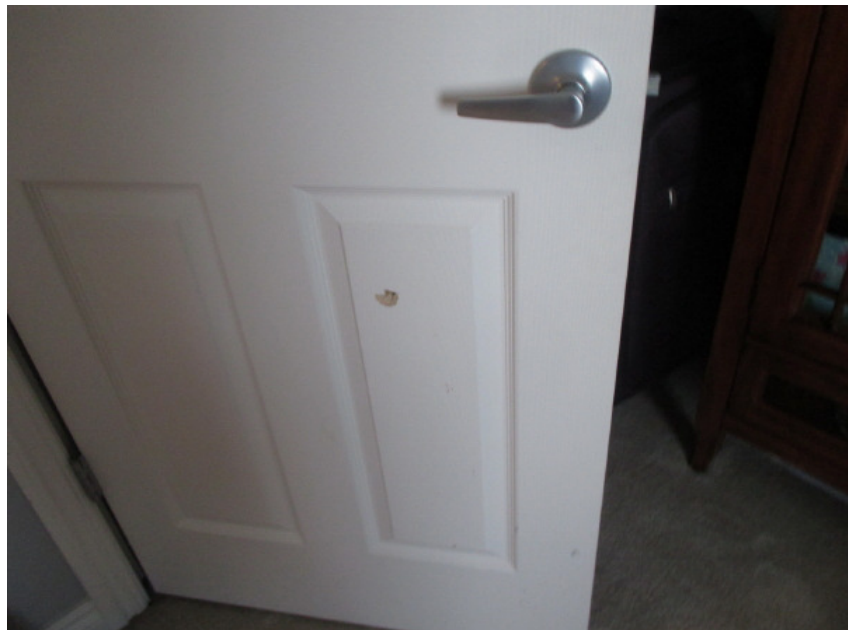
- N bedroom closet door had a small dent that should be easily patchable with spackling or wood filler.

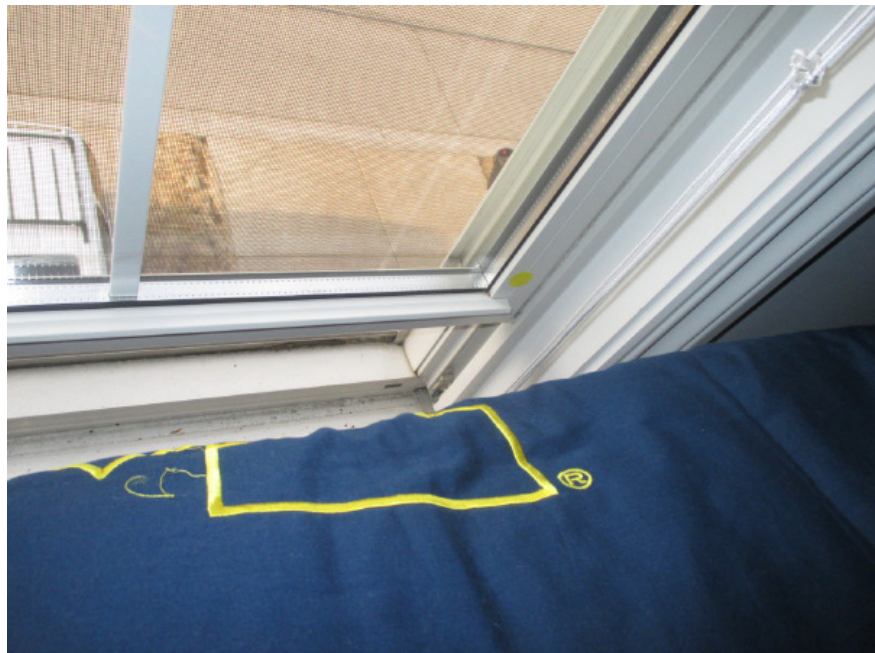
- Lower sash of the N bedroom window did not stay up when opened about 6 inches or less (marked with a yellow dot). This was evidently due to loose, faulty, or disconnected sash springs, and is likely to worsen with time such that the sash could pose a chopping hazard if not corrected.

**Sash being held in place by Inspector**

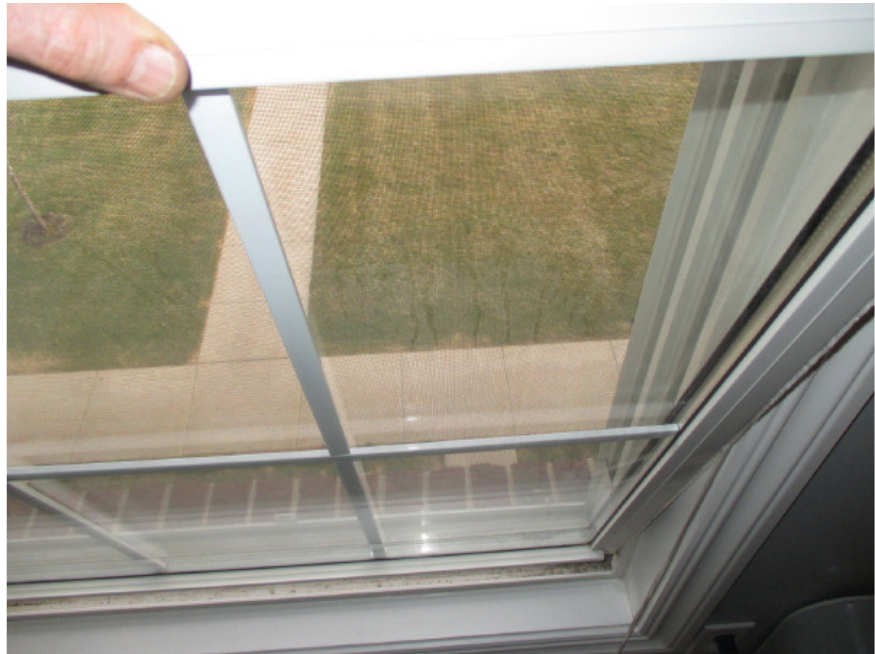
- A small amount of streaky debris, evidently from evaporated condensation was observed between the panes of the L window in the s bedroom, evidently due to a poor seal. The effect is mainly cosmetic. Reportedly there is a method by which such condensation can be removed and the sash re-sealed, typically advertised as "de-fogging" of windows.

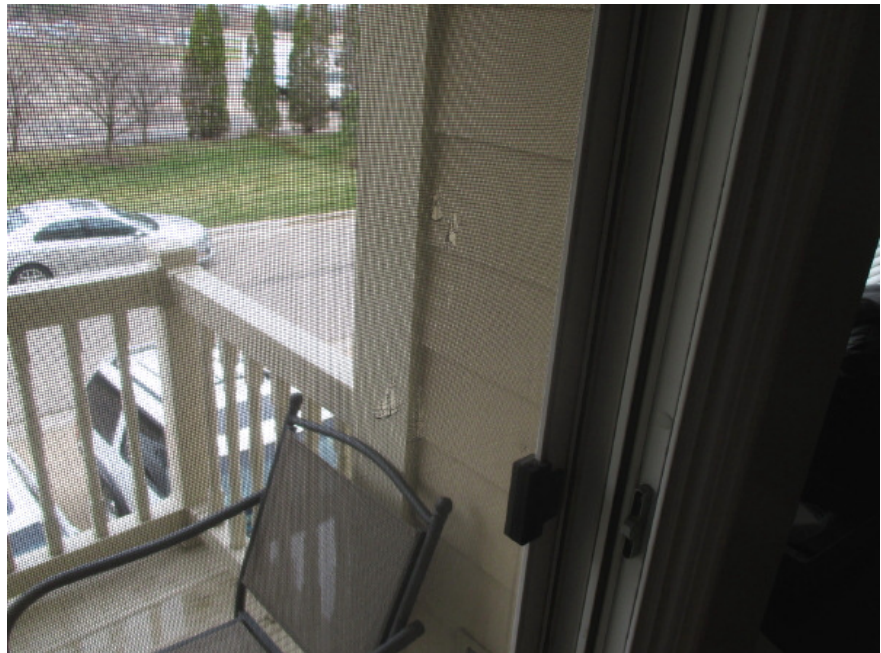
- Small holes were observed in the screen for the sliding glass door to the balcony. Patches for small holes and re-screening kits are available, and some hardware dealers repair screens.

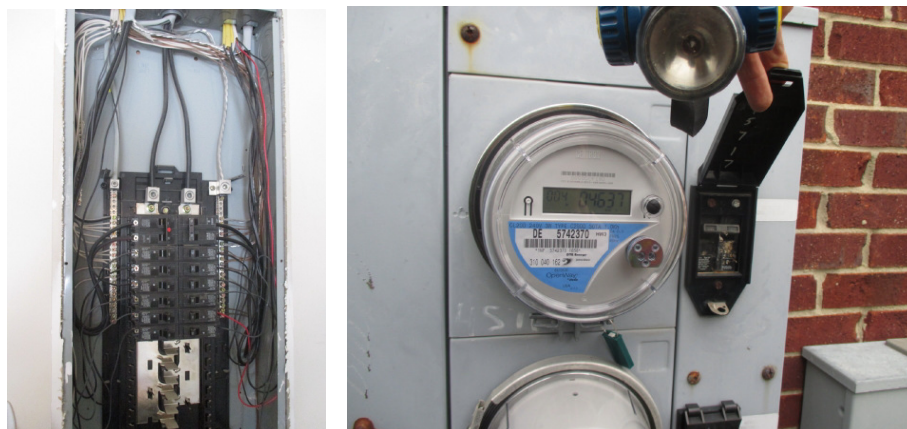
- No main breaker or fuse block were observed in or near the distribution panel inside the unit. Main disconnect was located near the meter on the exterior of the building.

This is not inherently hazardous, and is very commonplace for such complexes built in this era, but could enable a prankster to shut off the power, and makes it more difficult to shut off all of the power to the unit in an emergency than if a main disconnect were present in the distribution panel.

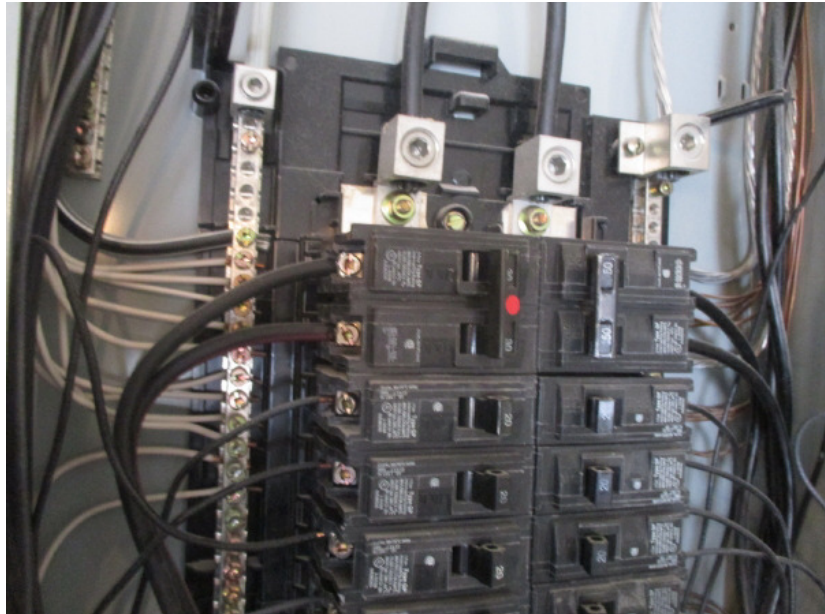
- Dual circuit breaker for the AC circuit was improperly rated, according to its specifications, which called for a circuit breaker or fuses rated no higher than 20A (marked with a red dot).

This provides inadequate protection against current overload. Replacement with a properly rated breaker is recommended.

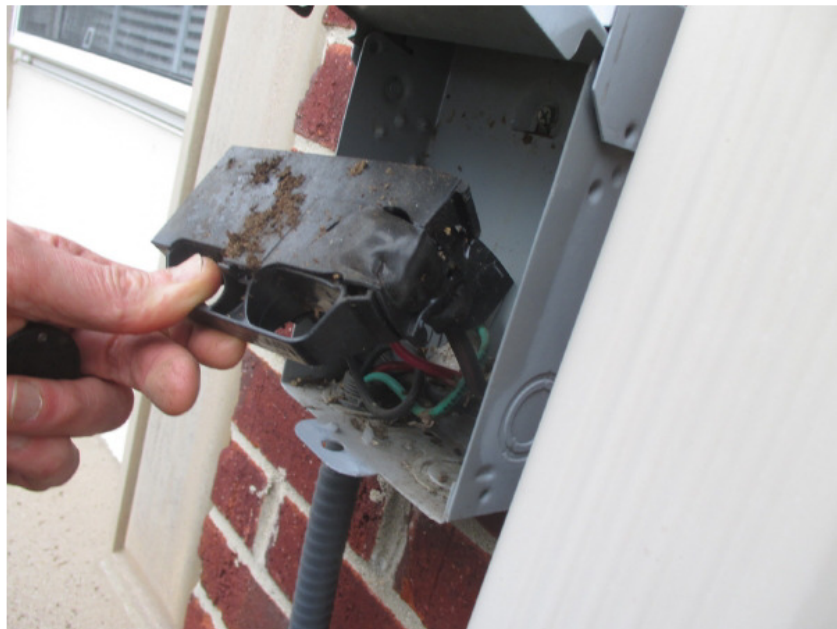
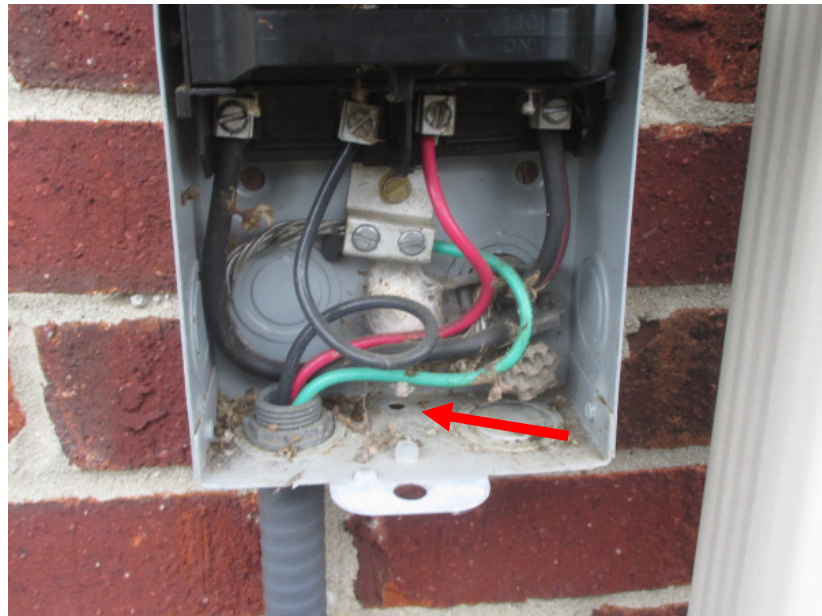
- AC unit exterior disconnect was melted, and its seat not secured, such that it could not be used. This may have been due to overheating of the equipment or wiring, to which the noted improperly rated circuit breaker may have contributed.

Wasp's nests were observed in the panel, which may have been due to the cover having been difficult to close on account of the equipment pressing out against it, or they may have entered through the drain hole on the bottom (indicated).

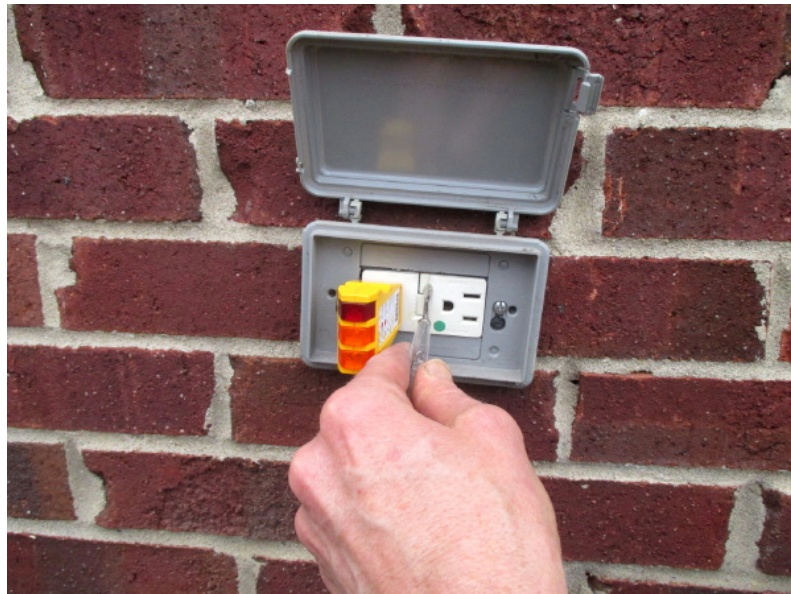
- Front exterior GFCI outlet did not trip when its "test" button was pressed, the button having been jammed (marked with a green dot). This probably lacks GFCI function, operating as a regular outlet. Replacement with a working GFCI outlet is recommended to ensure maximum protection against accidental electric shock.

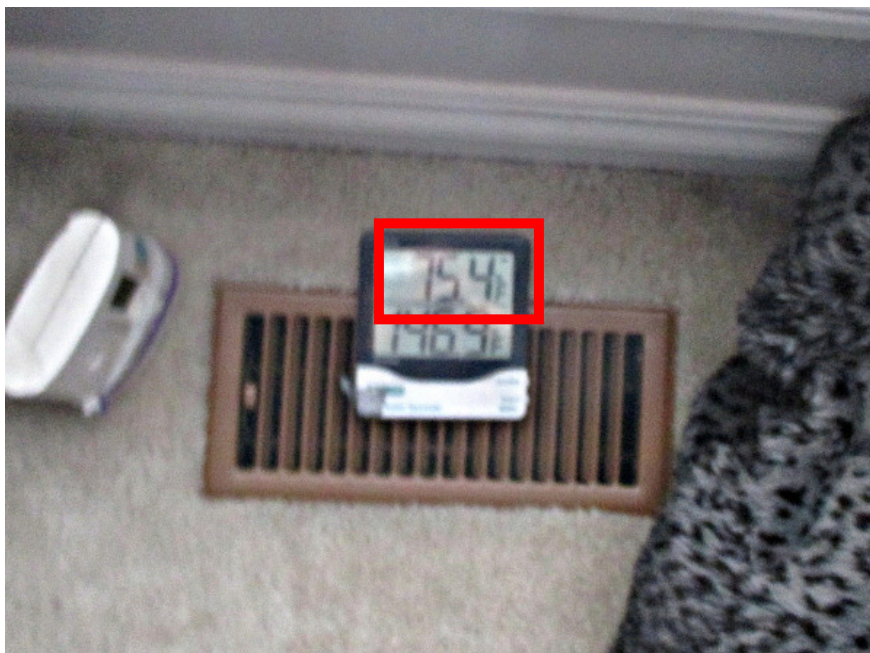
**5:47pm reading (bottom figure an artifact of a broken off probe)**

- AC system was observed to function and cool the air adequately, but not exceptionally well, with an observed temperature decrease in the supply air from 75.4 degrees F to and 64.8 degrees F after having been run for 23 minutes, and 63.2 degrees F after having been run for 46 minutes. Such a supply air temperature cooled the house adequately during the inspection conditions, but may not be adequate during hotter conditions. If cooling performance seems inadequate and/or electric bills appear to be very high during hot weather, a servicing checkup by a qualified, licensed cooling specialist would be advisable, and a coolant recharge may be needed to improve performance. A unit of this age (evidently the original unit) is more-or-less in the middle portion of the typical life expectancy of a central AC condenser, and typically somewhat less efficient than a more modern unit. Annual servicing checkups are recommended.

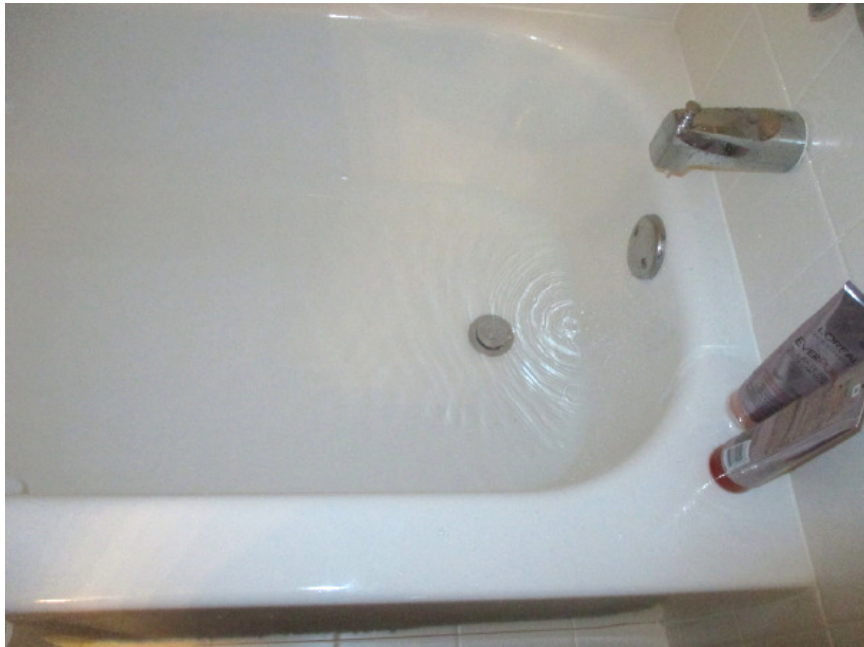
- Bath tub drained slowly. The drain may be clogged with hair and soap deposits, in need of drain opener. Acidic drain opener should not be used in ceramic fixtures, as it can eat the finish.

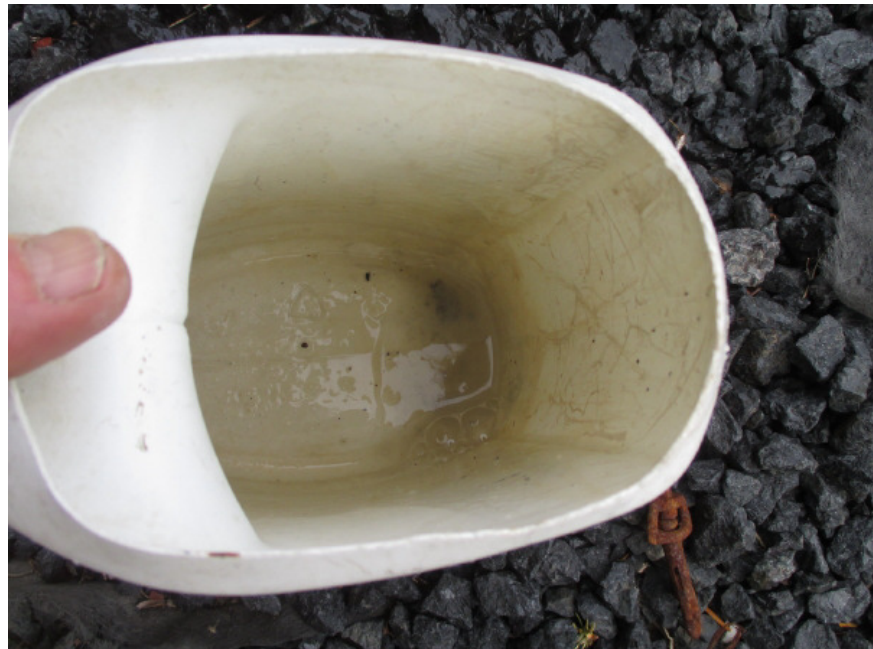
- Water drained from the tank was noticeably cloudy in appearance, with considerable sediment. Buildup of mineral deposits in the tank can affect performance of the unit. Draining of the tank is recommended to clear as much sediment as possible. Draining a few gallons from the bottom of the tank every month or two and/or complete draining/flushing of the tank once a year can help keep the tank relatively clean. It is very important to follow proper procedures in doing so. Instructions should be readily available online.

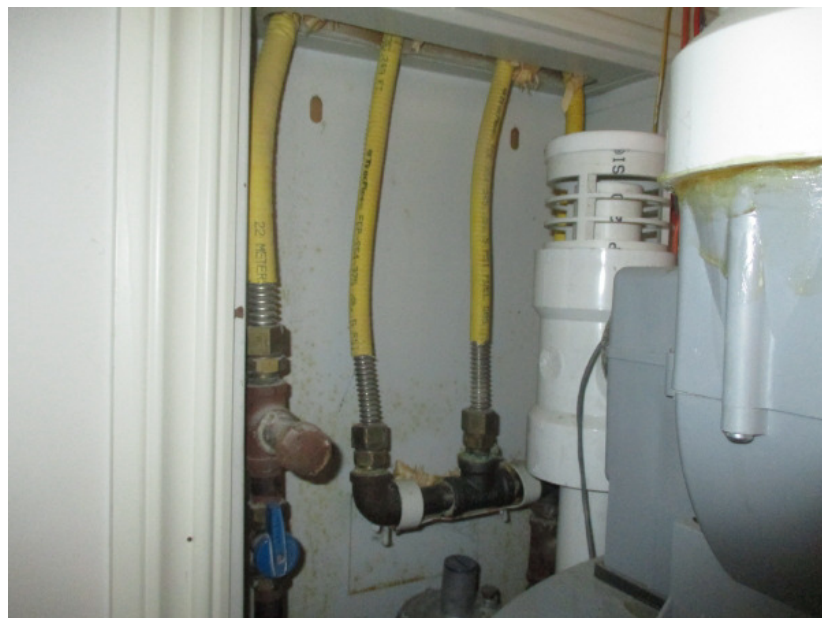
- Corrugated stainless steel tubing ("CSST") flexible gas piping was observed, without confirmation of proper grounding ("bonding").
- There have been reports of fires caused by lightning strikes near homes with CSST, evidently due to lack of or inadequate electrical bonding of the CSST resulting in arcing.
- Proper electrical bonding of all CSST gas piping is very strongly recommended. This may be able to be easily done by grounding any of the gas piping, provided all such piping is conductive metal, with unbroken conductivity to all CSST piping.
