Evergreen Home Inspections

PROPERTY INSPECTION REPORT

Concerning: **888 Sample St., Detroit, MI 48222**

Date: **February 7, 2011**

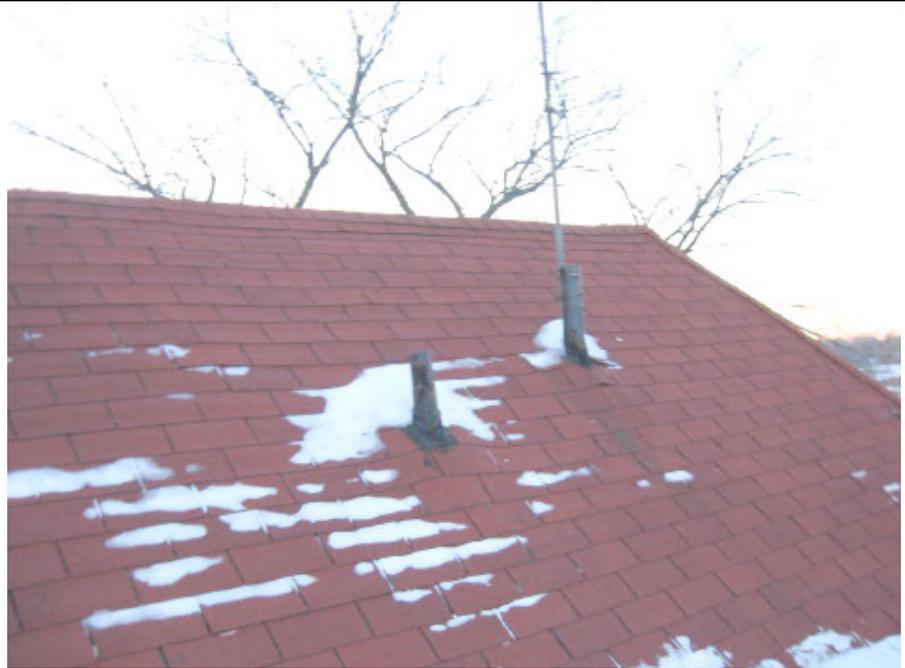
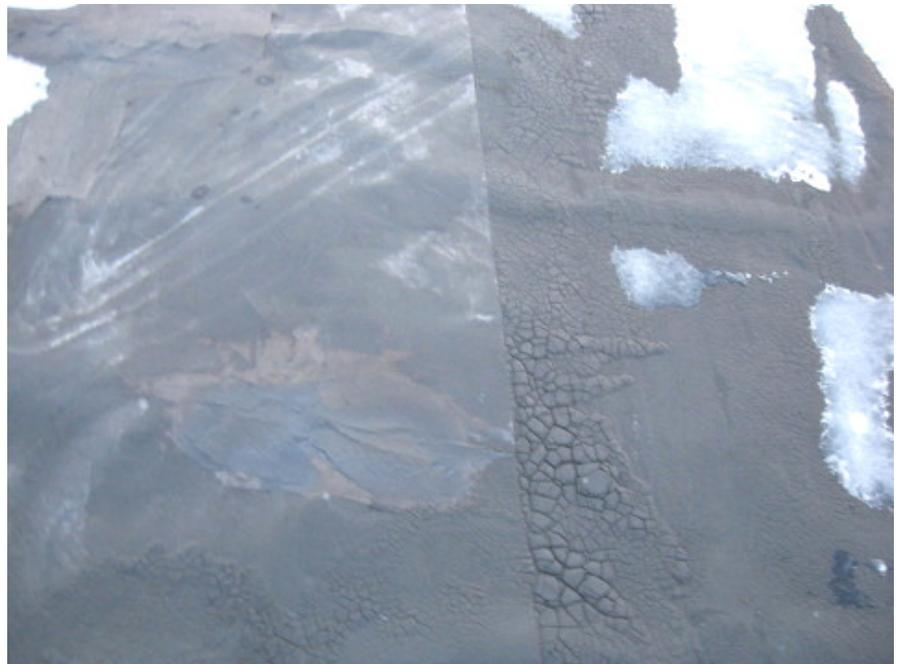
- Roof: The low-pitched portions of the roof had noticeable cracking (“alligatoring”) of the surface observed. Some patchwork repairs were also evident, suggesting that small leaks had been repaired. As cracking worsens, leaks may form. Periodic top-coating of such surfaces is recommended to prevent leakage, but eventually, complete re-roofing will be necessary.

- Roof: When the low-pitched portion of the roof is next resurfaced, it may be advisable to use modern membrane roofing material, which is more easily replaced than a built-up roof.
 - Exterior: Leakage observed from gutter and downspout seams. Noticeable corrosion was observed on some lengths of the gutters.
- Considerable ice glazing was observed along much of the perimeter of the building, some of which may just have been a consequence of melting snow and ice, but some of which was evidently due to gutter/downspout leakage. All in all, the gutters and downspouts appeared mostly functional, but in need of updating.

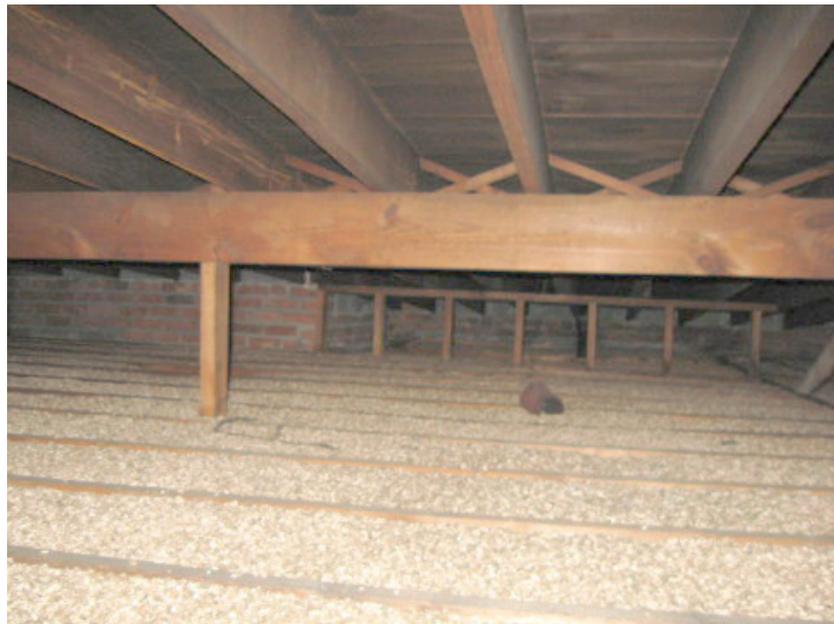
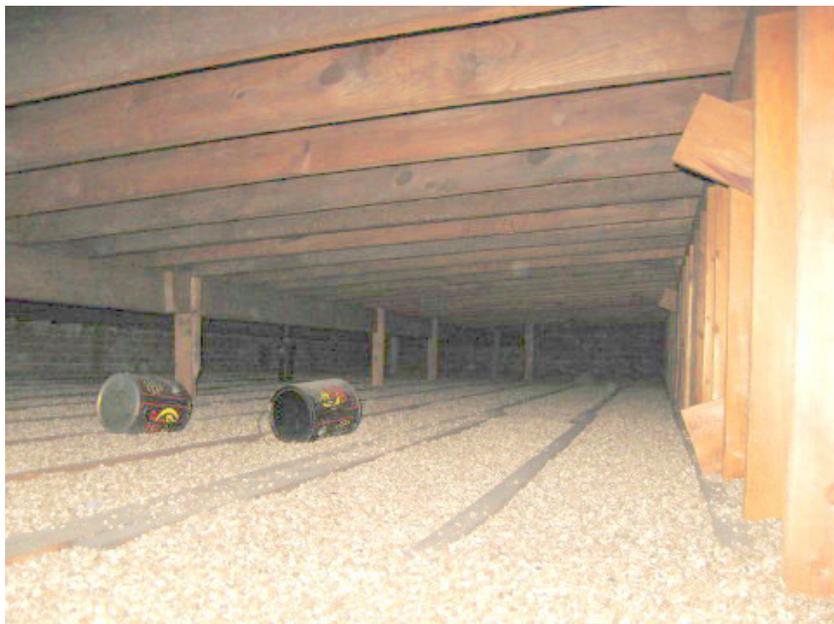
- Attic: Attic appeared to have a moderate amount of insulation, roughly to the top of the attic floor / 3d floor ceiling joists.
- Attic: Roof structure was evidently functioning as intended, with no significant issues observed.

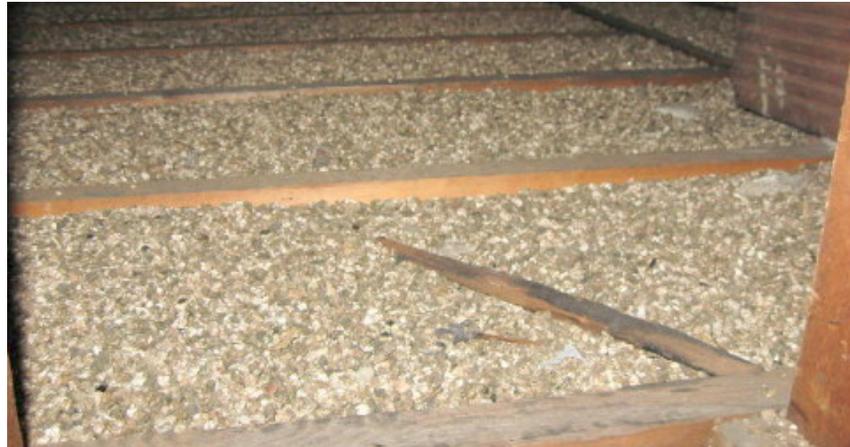
- Attic: Some vermiculite insulation (loose insulation with a metallic, crystalline appearance) was found in the attic. Some vermiculite has been found to contain asbestos, which can get into the air if disturbed, and create a potential hazard. As the attic space is only entered for service, this should not have a significant effect on the air in living spaces, as long as the attic entry scuttle remains closed.

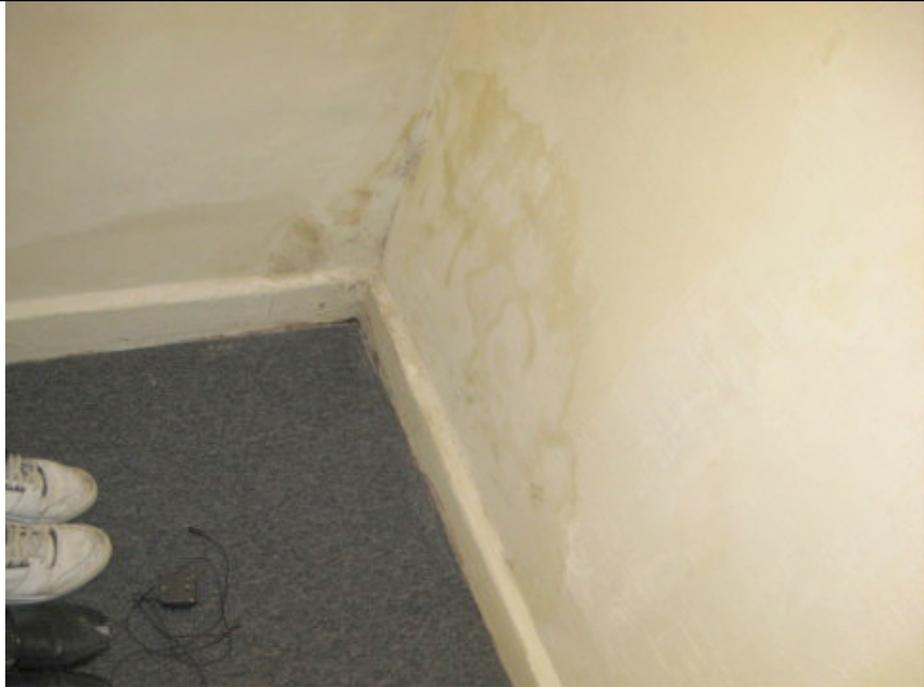
- Living Rooms: Indications of moisture damage were observed in the corner of the living room. This was probably due to seepage through the brick foundation wall, to which leakage from the nearby gutter/downspout in the front, (R of entrance) and/or inadequate grading/drainage may have contributed.

This probably only occurs during heavy rains. Repair/replacement of leaky gutters and downspouts and (if necessary) re-grading are recommended, and may fully correct this. If not, waterproofing and/or replacement of finished walls using moisture-resistant materials may be necessary. Painting of brick foundations is generally not recommended. When tuck-pointing old masonry it is important to use proper mortar. Urethane injection may be best suited to achieve a long-lasting repair of leakage through small cracks in a brick foundation.

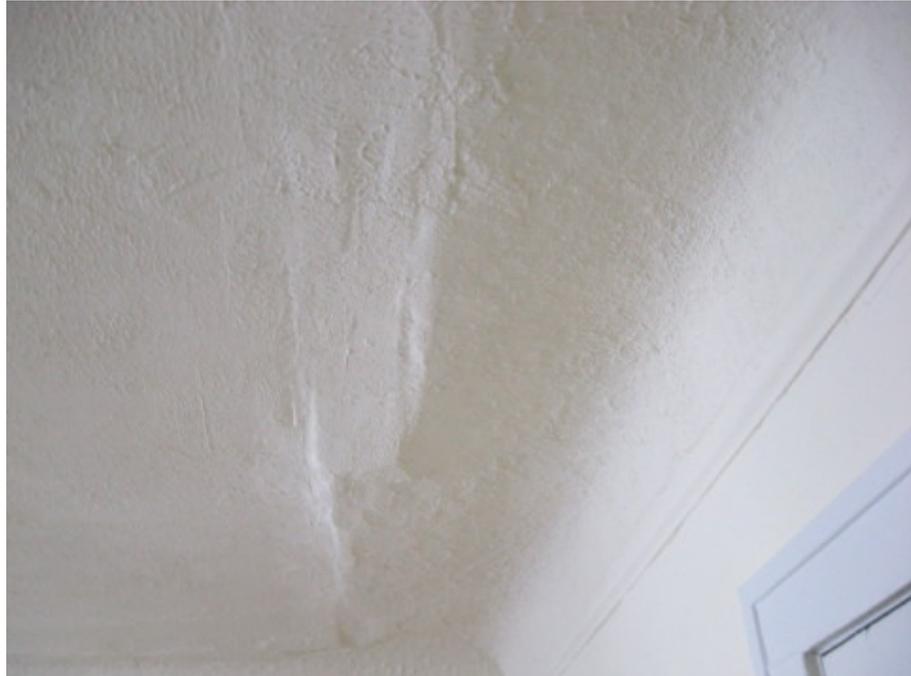
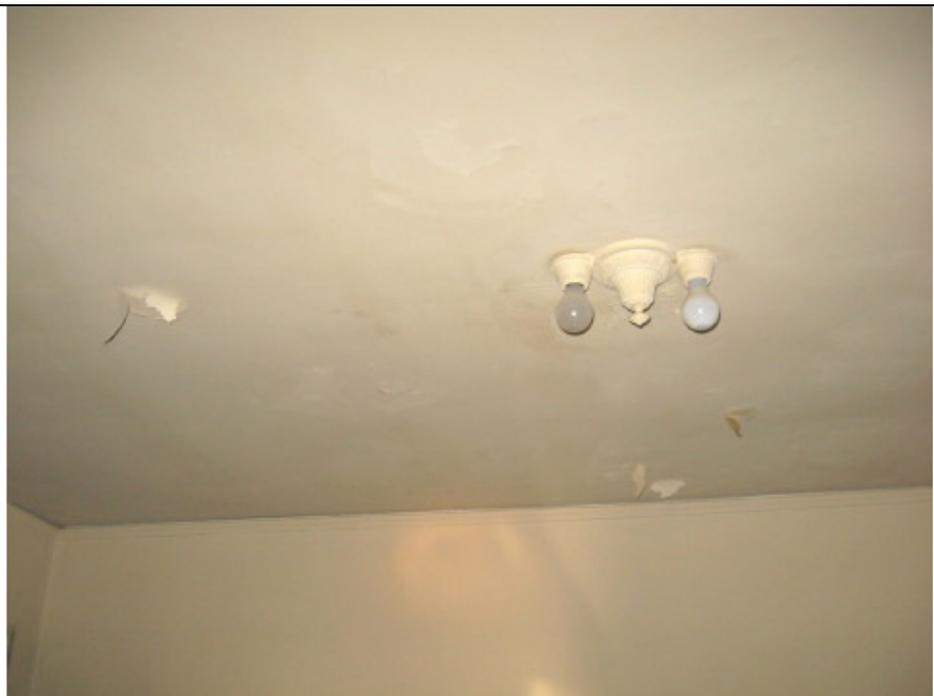
- Interior: Indications of water damage, such as staining, bulging, cracking, and blistering paint were observed on many of the ceilings, particularly in bathrooms, kitchens, and living room areas near bathrooms. These were probably the result of plumbing leaks, mainly in bathrooms.

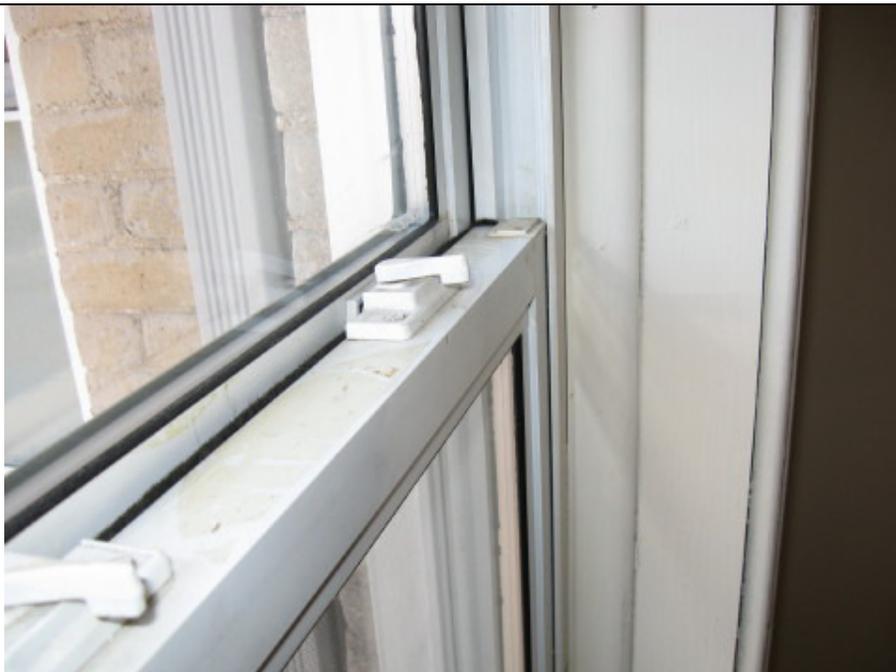
- Many windows had broken spring mechanisms in their lower sashes, and therefore the sashes did not stay up. This could be a chopping hazard, and caused some windows to fit poorly in their openings, resulting in draftiness. It was possible to open such windows with the upper sashes. In most cases this was evidently due to careless use by tenants. The resident manager said these springs can be obtained from the manufacturer at no charge and claims to frequently replace them.
- Some windows (roughly 10-20% of those observed) had difficulty fully locking, as the latch parts did not align. Some of the sashes may have fit the window openings poorly. If so, the manufacturer may correct these issues under warranty.

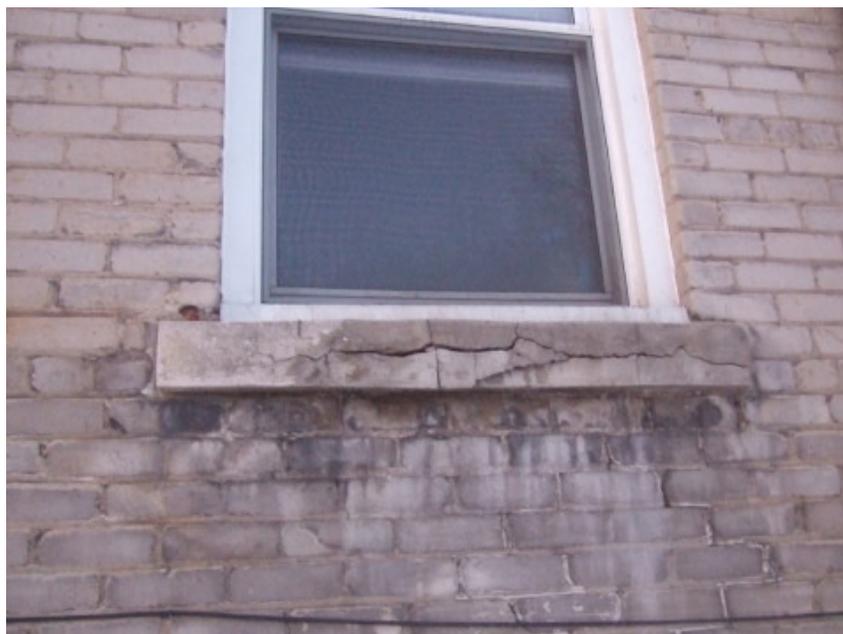
- Exterior: Noticeable cracking deterioration of a few limestone window sills was observed, particularly on one sill on the S side. Patching of cracks is recommended. The most deteriorated sill may need to be replaced, as falling debris could be a hazard and the sill might not keep water out of the structure.

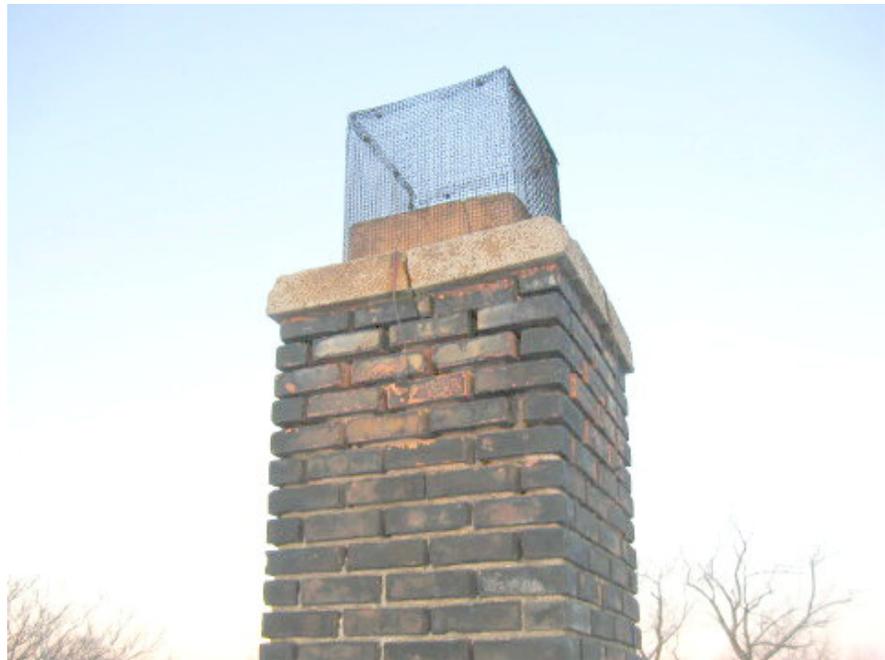
- Roof: Very old chimney masonry was also noticeably deteriorated, especially near the cap, badly in need of tuck-pointing.

Masonry repair and installation of a chimney liner to protect the chimney from acidic condensation of exhaust are strongly recommended. It is advisable to hire a mason who is familiar with old masonry to do the masonry work, as old masonry may require specific types of mortar to achieve an effective repair.

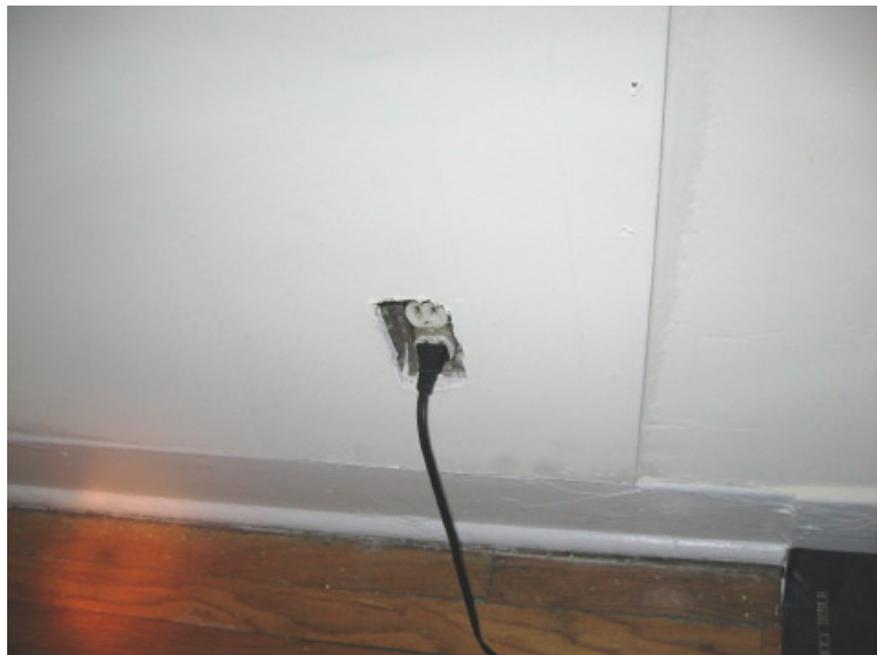
- Some outlets and fixtures in apartments were improperly wired and/or mounted, with poor backsets, missing covers. etc., mainly in basement work areas, though a few such instances were observed in apartments and common areas accessible to tenants

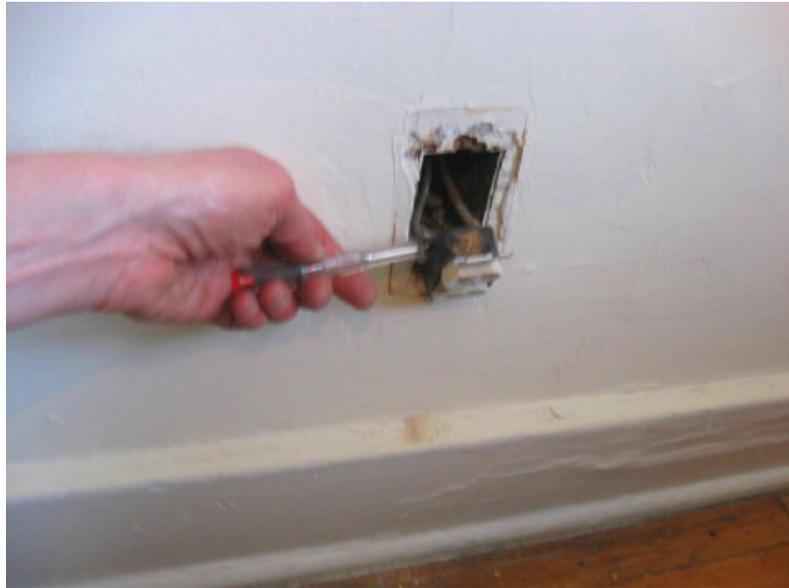
- Improper wiring was observed, which included one of more of such potentially hazardous features as: exposed inner wires and splices, taped splices, taped "wire nut" connectors, open junction boxes, and/or wires run to enclosures without proper clamps. Such instances were mainly observed in basement work areas.

- Correction of all improperly wired or configured outlets, fixtures, and junctions is recommended as soon as possible, especially in apartment units and common areas accessible to tenants.
 - Inoperative outlet observed in unit 108 living room. Current was detected at the hot incoming wire (which was wired to the neutral, so the outlet appeared to have an open neutral).
- Corrosion was also observed on the wiring, as well as wall damage suggesting leakage from above had occurred at some time.

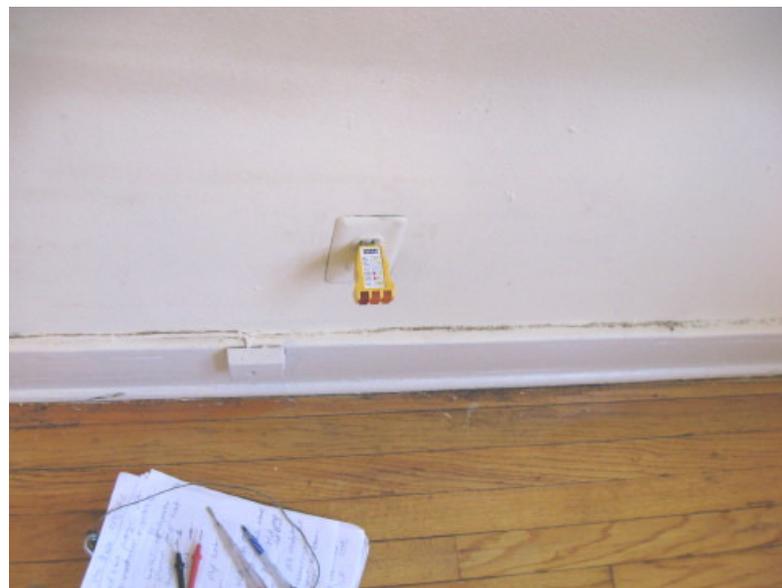
- Bedrooms: Inoperative outlet observed in unit 103 bedroom, possibly disconnected wiring.

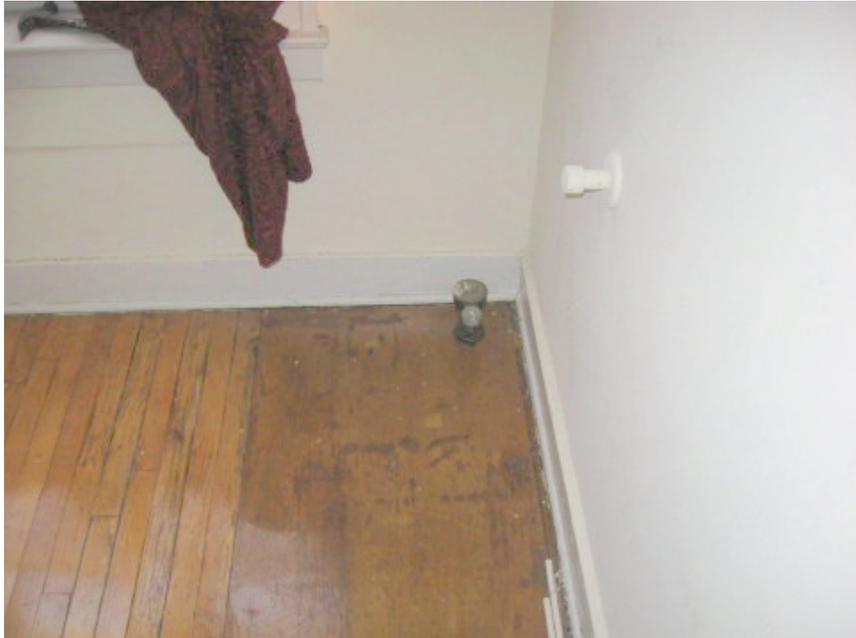
- Many rooms, especially bedrooms, did not have radiators present. The rooms did appear to be reasonably warm despite this and the cold weather.

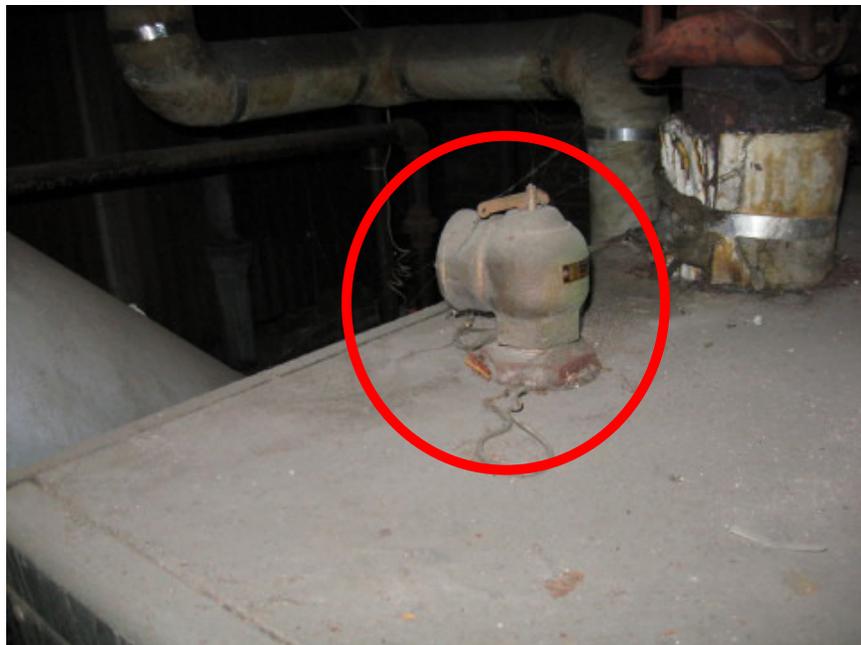
- Temperature/pressure release valve ("T/P valve") on the boiler had no drain line ("blow-out tube"). Such a tube is important to direct steam and hot water to the floor if the valve releases, thereby reducing potential hazards and/or damage.

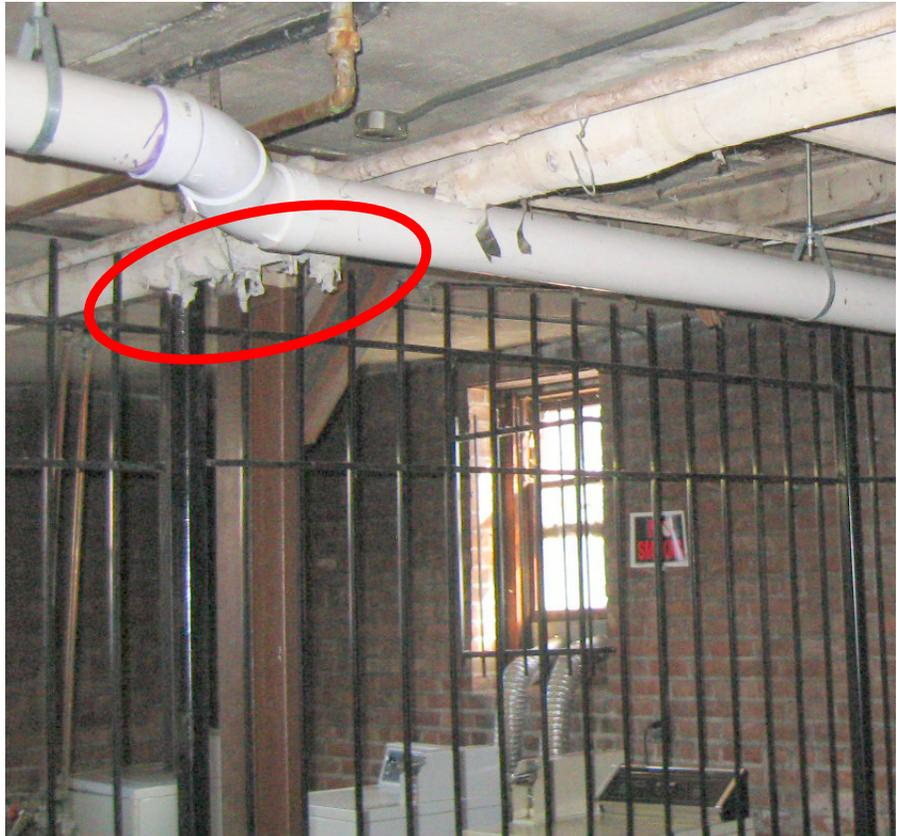
- The tenant in unit 102 reported no heat from the bathroom radiator. It appeared likely for there to be other ineffective radiators. Some had stuck or missing knobs.
- Basement: Some loose pipe insulation was observed. This may contain asbestos. Wrapping/encapsulation of all such insulation to contain possible asbestos dust is strongly recommended, especially in areas that are accessible to tenants, such as the laundry room (below).

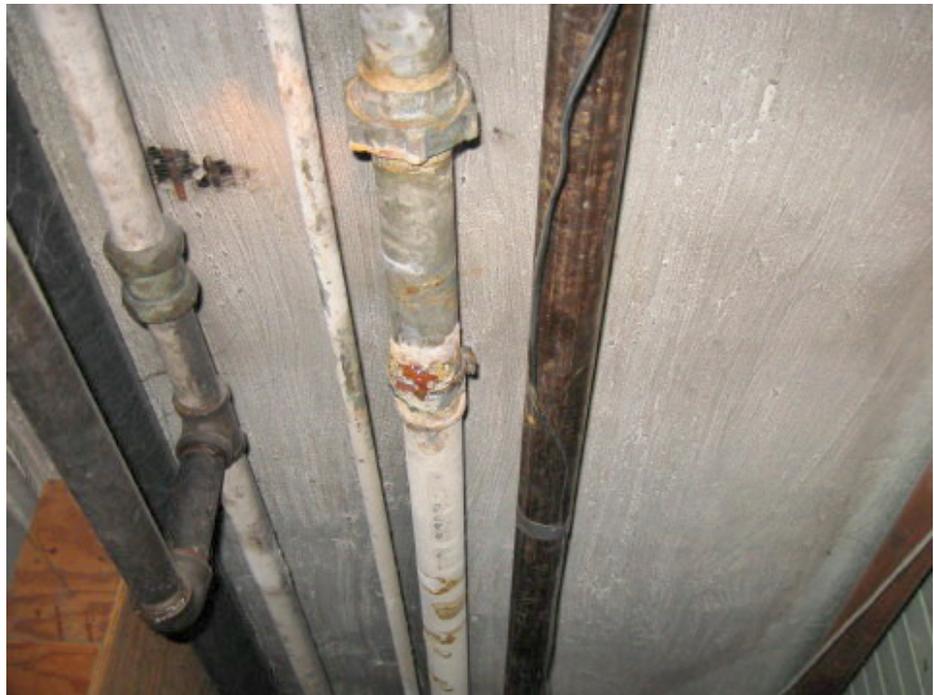
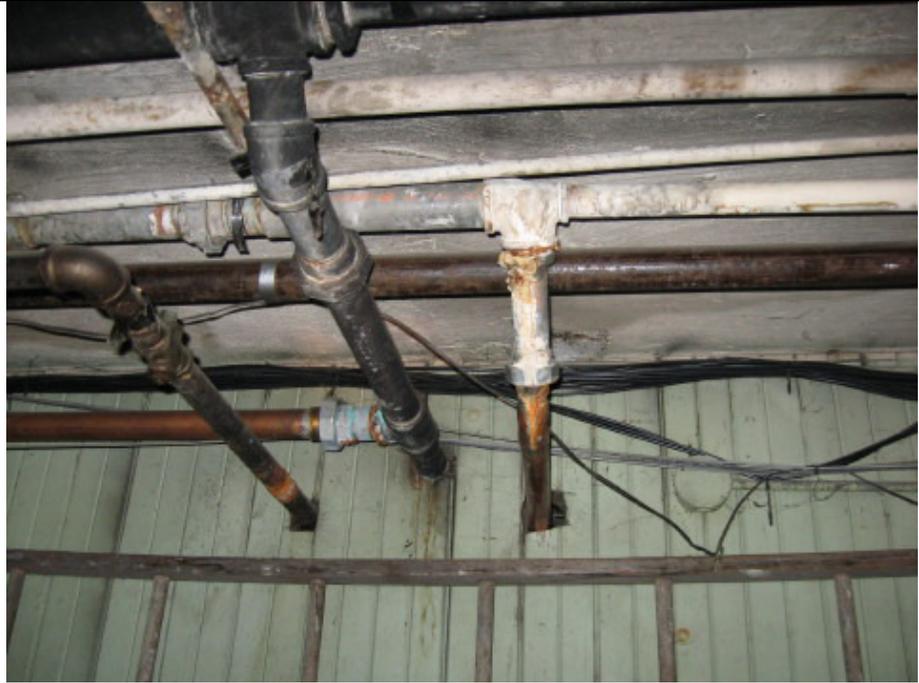
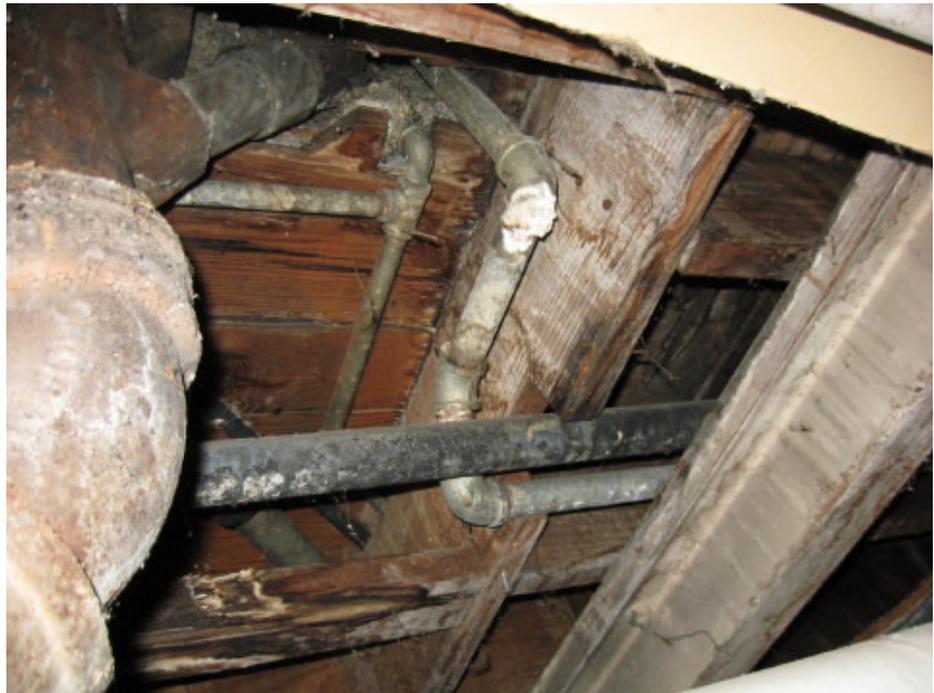
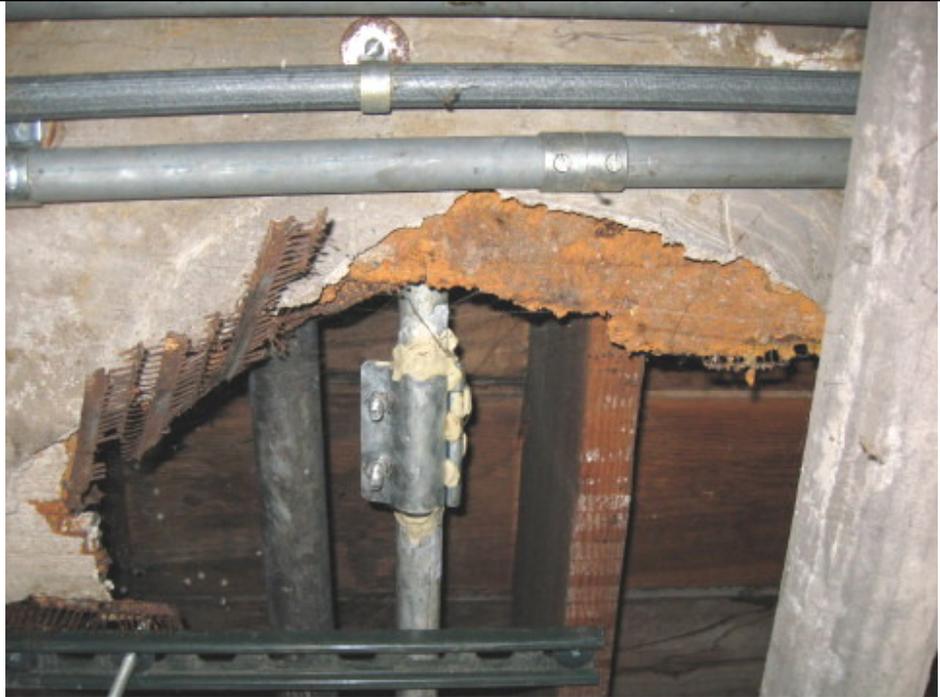
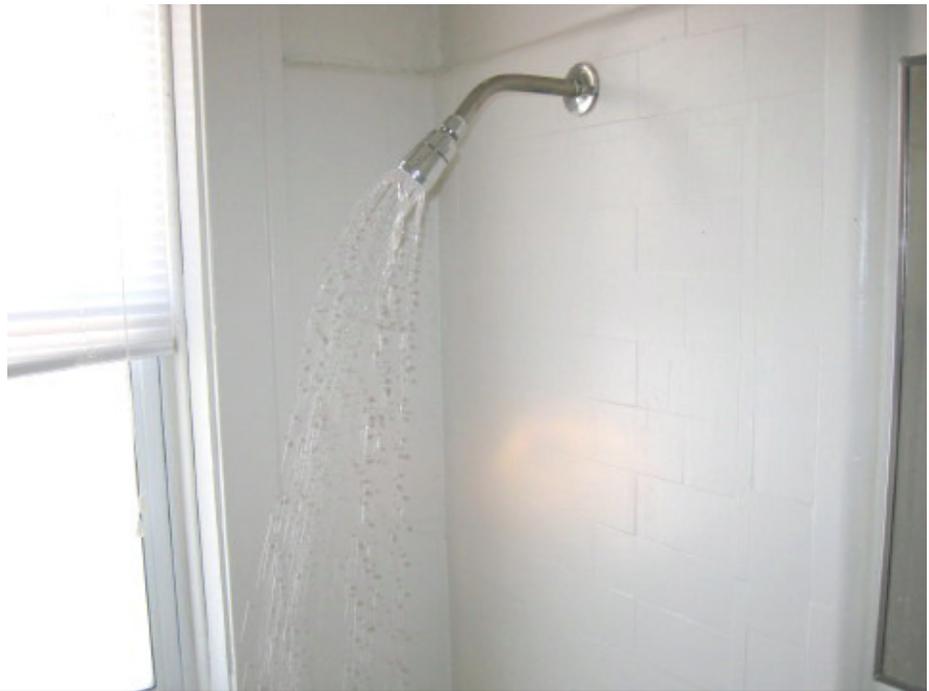
Many pipe clamps, pin-hole leaks, seriously corroded junctions and sections, and a few active leaks were observed.

These observations indicate significant deterioration of the piping, the pipes having been in service well past their useful life.

Replacement of all galvanized supply piping is recommended as soon as possible.

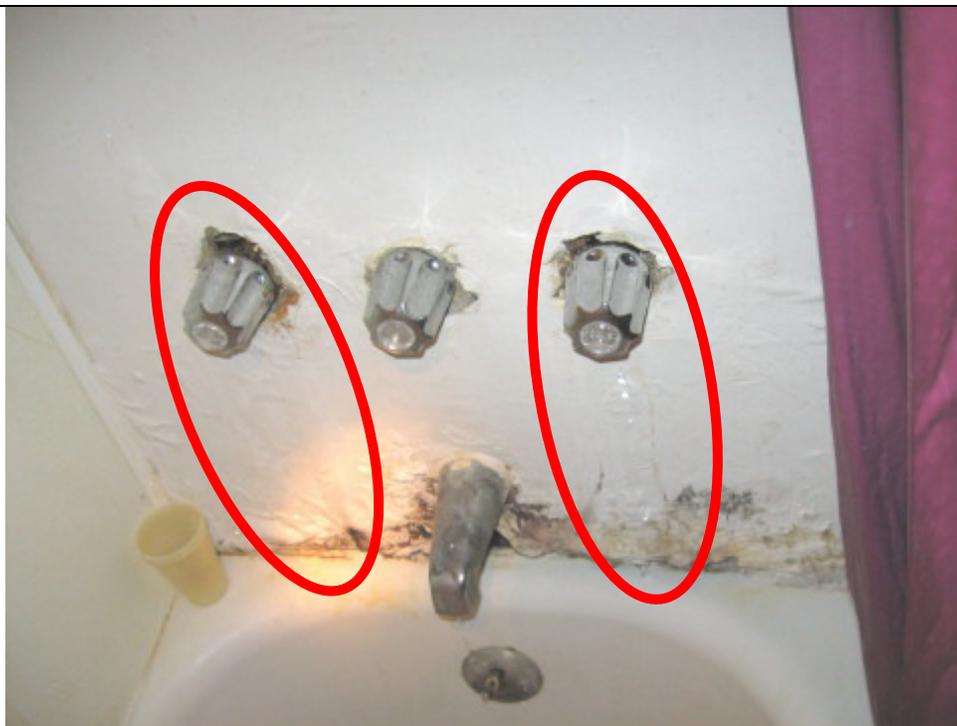
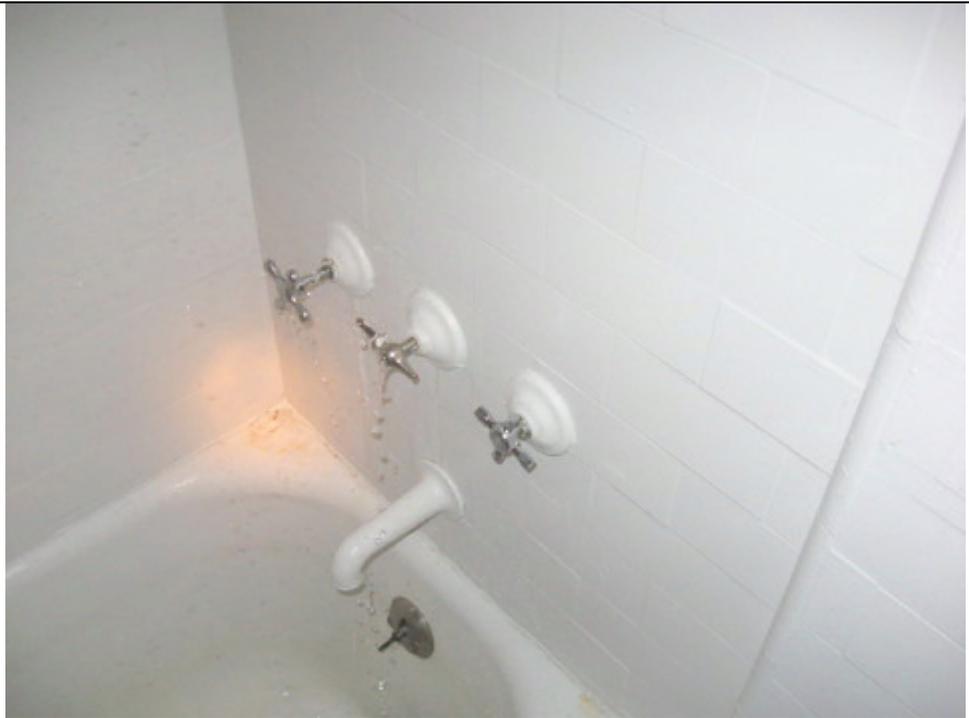
• Bathrooms: Stem leakage was observed from a large percentage -- possibly more than half -- of the tub faucets.
The degree of leakage varied, but in some cases it was considerable enough to cause damage to tub surrounds, walls, floors, and/or ceilings and walls in units below.
Some faucets and diverters may be able to be re-packed, some may need new stems, and a few may need to be replaced.
See following pictures.

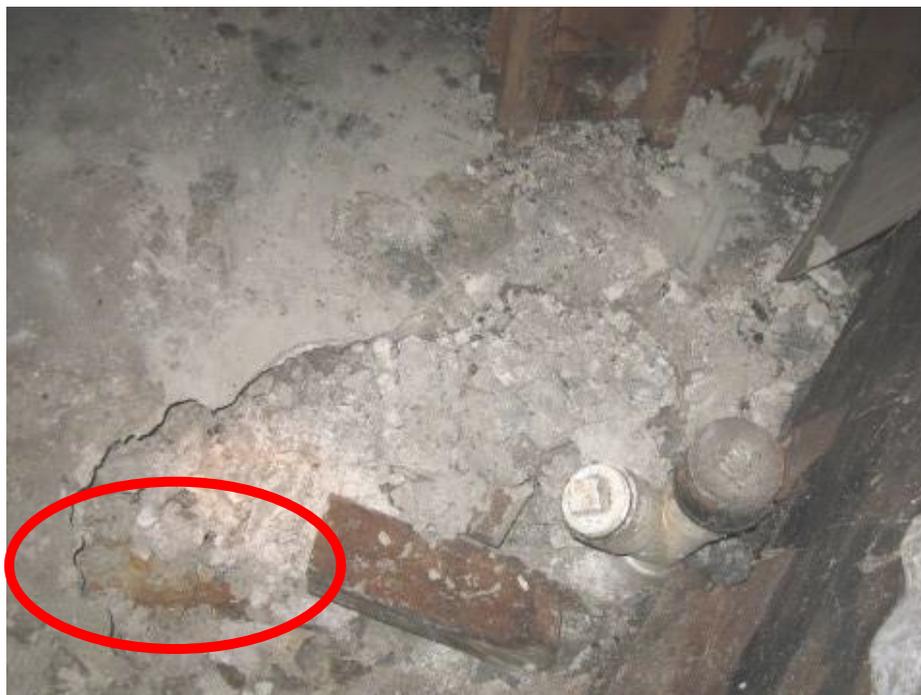
- Indications of significant deterioration observed in the drain line under the boiler room and former coal room under the NE portion of the basement.

Some sections of this pipe had been repaired with new PVC piping. It appeared likely the remainder of the line would need to be replaced in the near future. It may be best to do this when extensive supply line updates are done. There may be other underground drain lines that are also seriously deteriorated. Having a camera snake inspection of these done when other work is done may enable other deteriorated areas of the underground drain and sewer piping, if any, identified before significant problems develop.

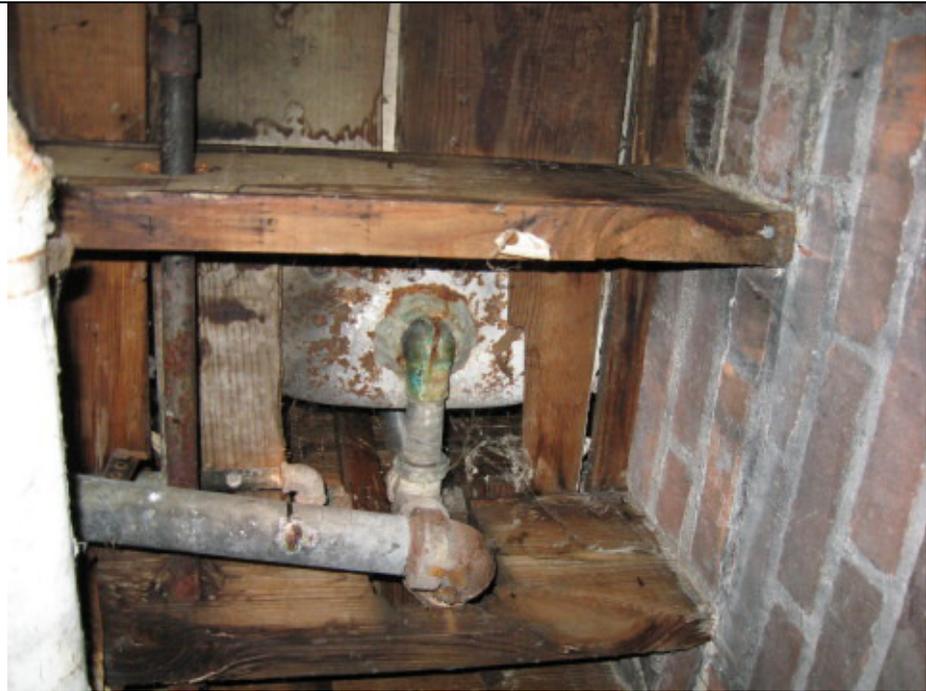
- Many old drain sections remained that showed indications of significant deterioration, mainly from tubs. Some may have minor leaks, as evident from ceiling damage, though no obvious major leaks were observed. Replacement of all seriously deteriorated sections and gaskets is recommended.
