Inspection Report (major defects)

**27735 Sample Lane,
Detroit, MI 48222**

Inspection Date: August 7, 2009

**Prepared By:
Evergreen Home Inspections
telephone: 313-320-6514
fax: 313-336-0026**

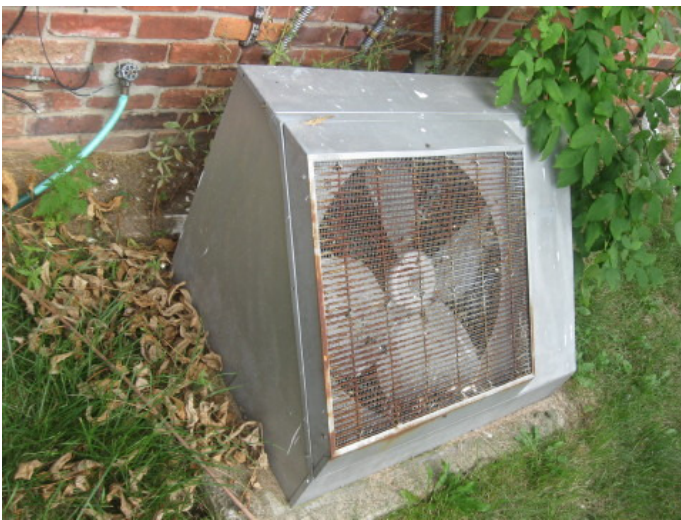
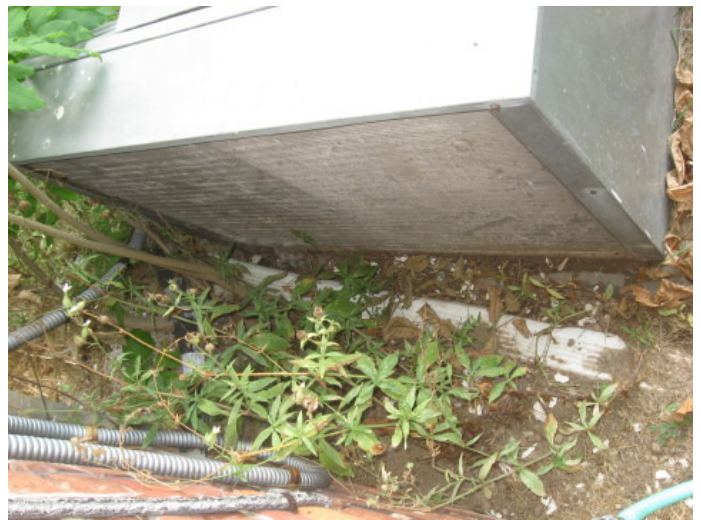
AC: very old, no cooling. The AC unit was very old, possibly the original unit installed when the house was built, and did not cool the air, though its fan appeared to operate well. The unit may just need a recharge, but it is possible that it may no longer be repairable, as it appeared to be well past the typical life expectancy of such a unit.

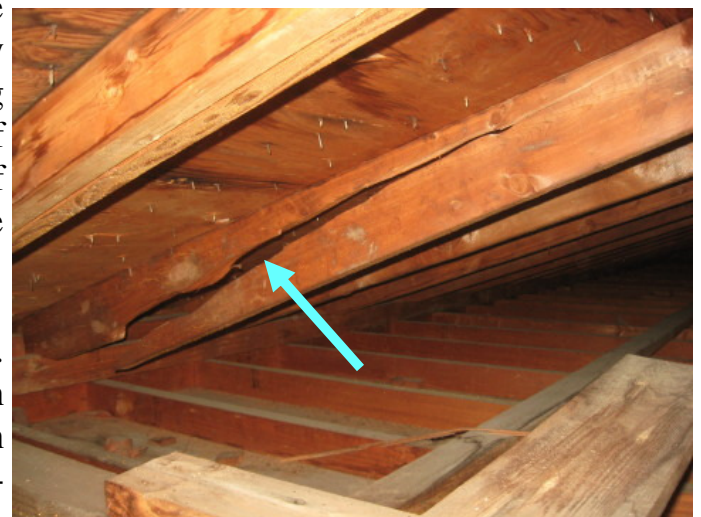
Attic: split rafter above front porch. One of the rafters above the front porch was badly split, to the point it appeared to be providing no significant structural support to the roof there. A large person who steps on the roof above the split rafter could fall through, as the roof had rather thin, weak sheathing.

Reinforcement of the rafter is recommended. This may be most easily done by taking down the ceiling of the porch below (roughly in front of the front door) to work on it from below, rather than squeezing through the very tight attic space to get at and support it.

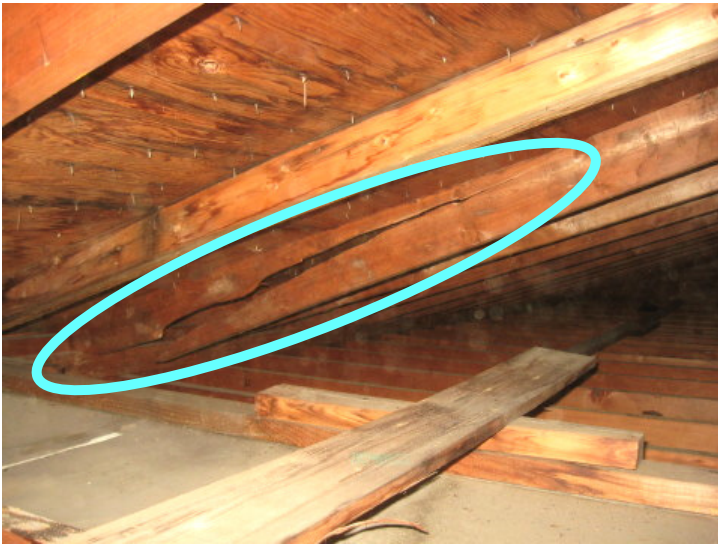
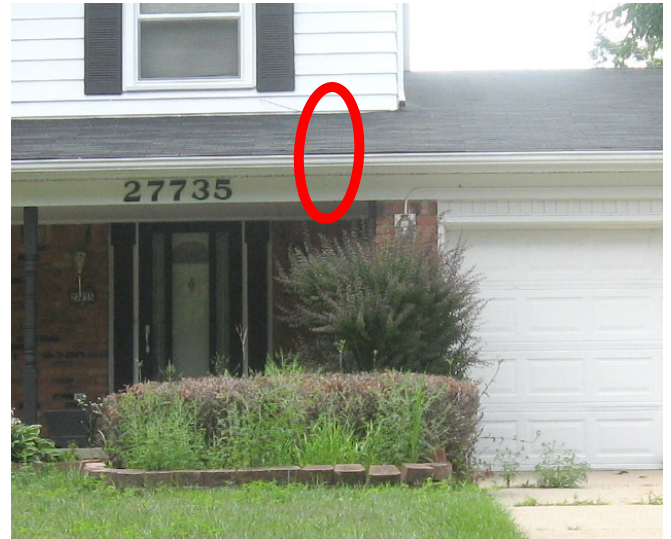
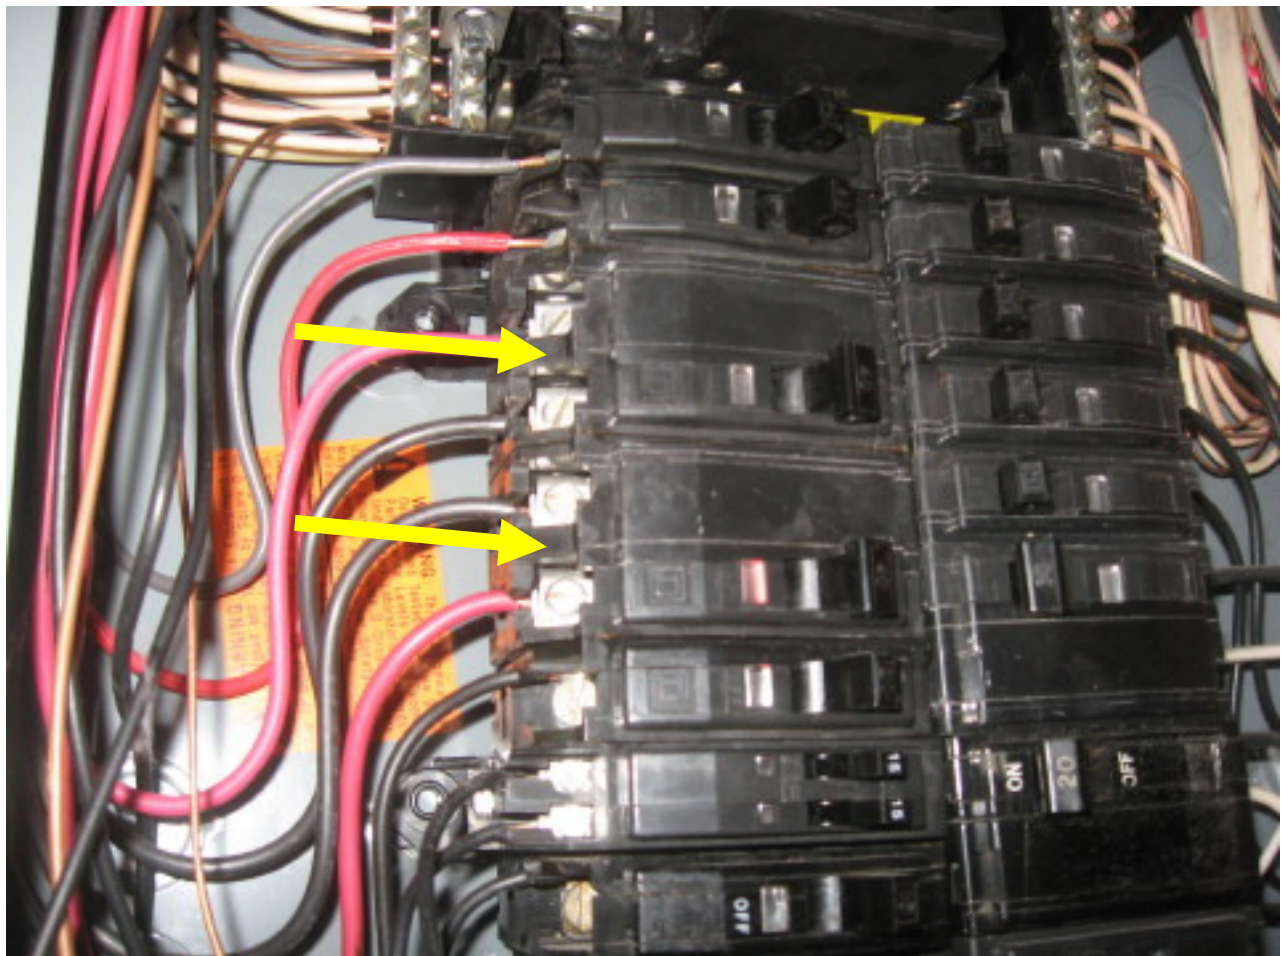
Electrical: improper circuit breakers. The 40A circuit breakers near the top left of the main panel (marked as being for the oven and cooktop) were improperly sized for the 10 gauge copper wiring on their circuits. This could be a fire hazard, as a circuit breaker rated too high for the wiring on its circuit might not trip before the wire overheats. These should be replaced with compatible dual circuit breakers rated no higher than 30A as soon as possible.

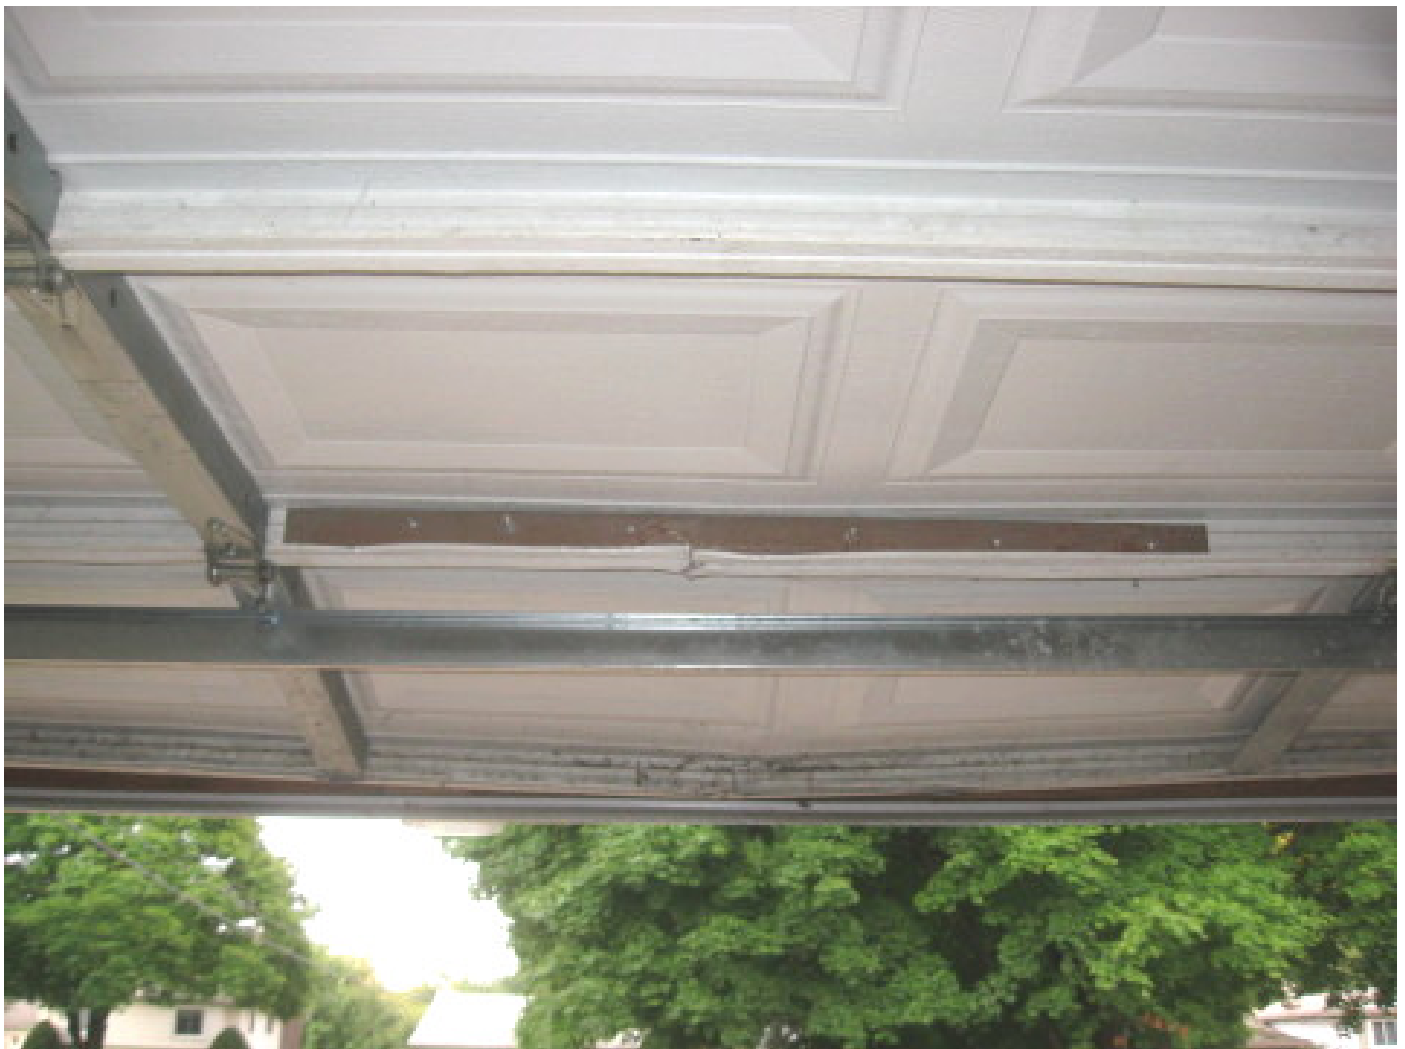
Garage door: damaged, opener not properly working. The garage door was damaged, somewhat bent and cracked near the bottom center. The automatic garage door opener did not work properly, though it did close the door once, responded to its auto-reverse sensors, and appeared to respond to its control button consistently.

The garage door did open and close manually without much difficulty.

It is possible the damage to the door caused it to be sufficiently out of alignment to jam enough to activate the door's pressure sensor. If so, reinforcement of the damaged area of the door to keep it straight and ensure smooth movement. If that does not enable the automatic opener to work the unit may need to have its setting adjusted or there may be a problem with its electronics, particularly the auto-reverse mechanism.
