Inspection Report (1 year home warranty)

42160 Sample Dr., Novi, MI 48375

Inspection Date: June 3, 2018

The property was inspected for defects due to premature failure and improper work for the Client's 2 year home warranty.

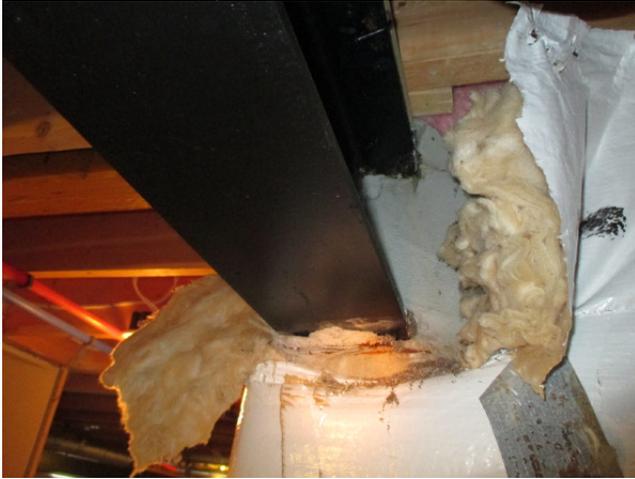
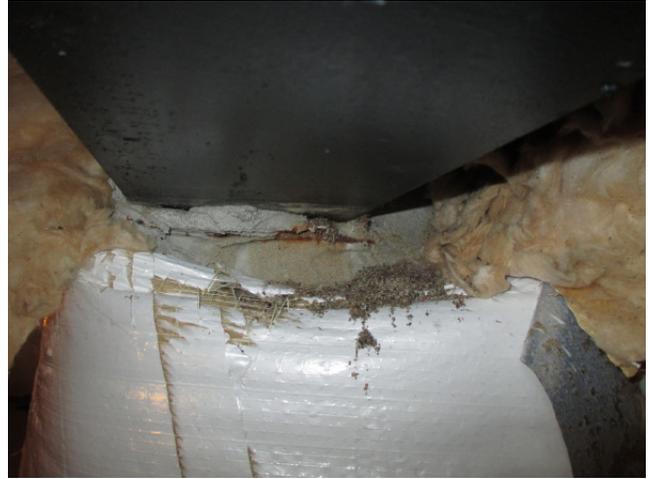
Leakage: basement ceiling. Indications of leakage and elevated moisture were observed in the basement ceiling area below the front door and nearby I-beam. Client/owner reported such leakage was most pronounced during rains with SE winds. These observations were consistent with leakage through the door threshold.

Area Client noticed leakage – note rust stain and sandy deposits consistent with insect activity

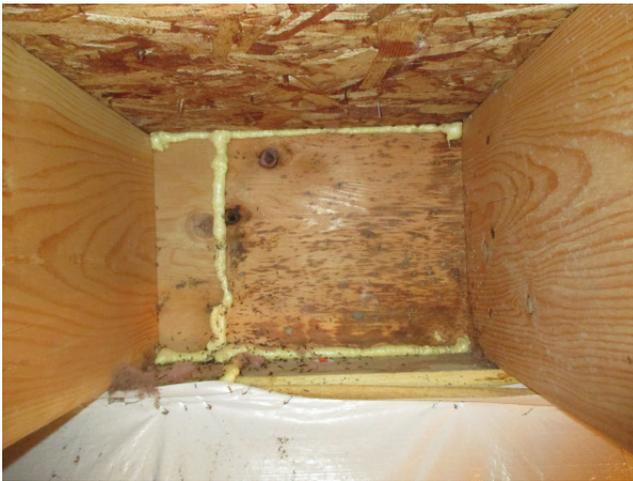
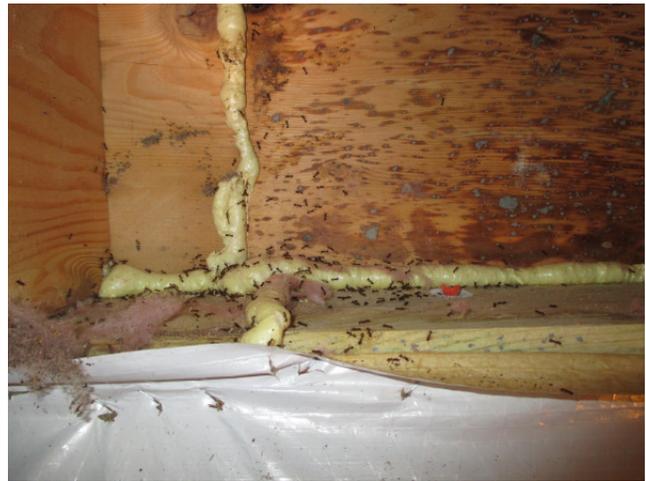
Wood below threshold – note stains, ant activity, and elevated moisture readings

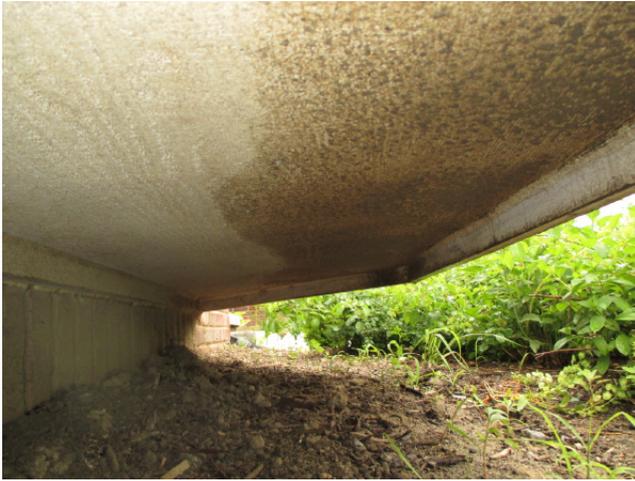
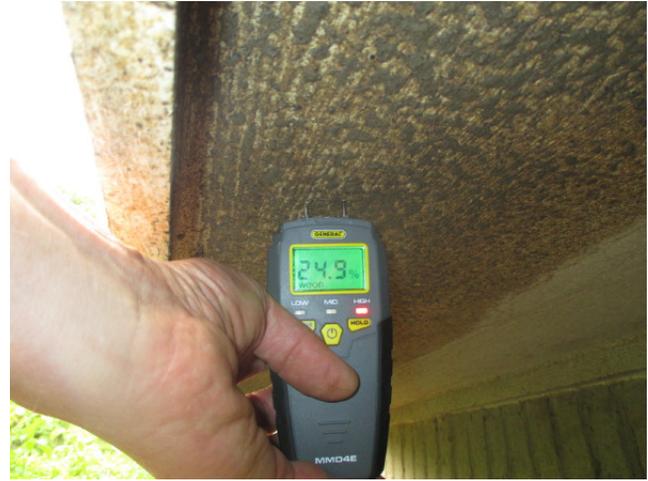
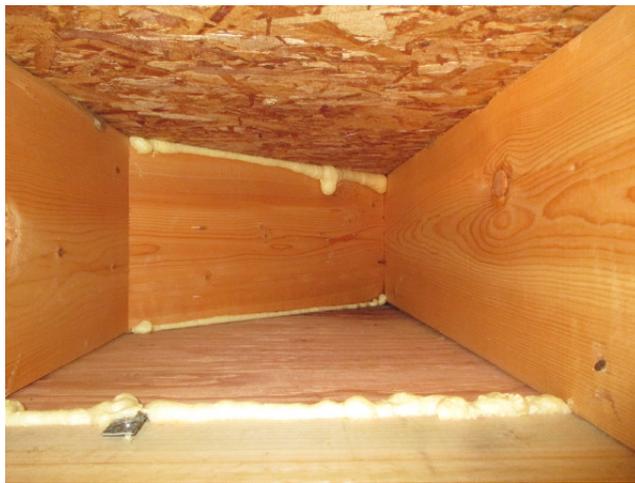
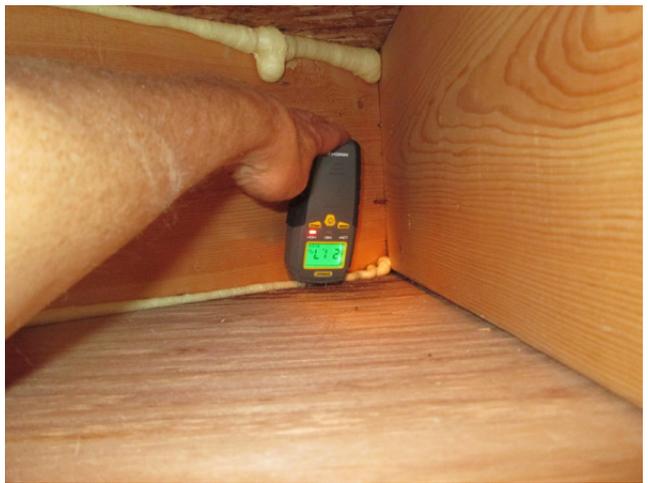
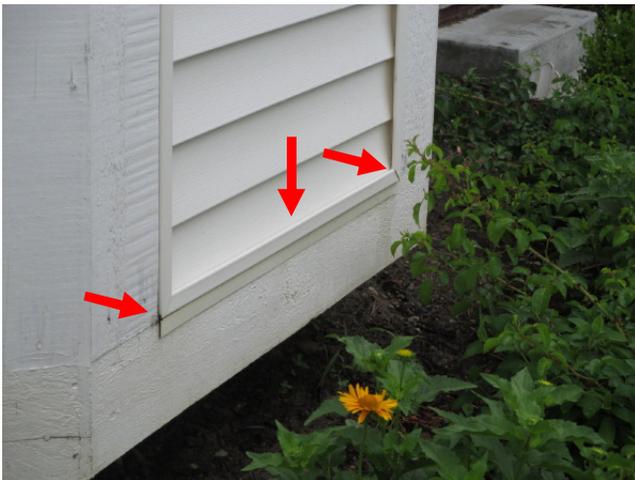
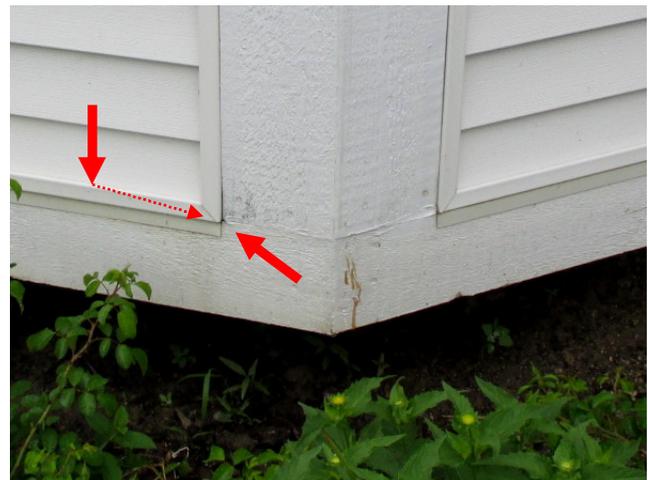
Leakage: bay window. Moisture was observed under the living room bay window. This was most likely due to poorly configured siding below windows, with a “J” channel above wooden trim, which tends to hold water from rain falling on it. A “Z” flashing was observed, which evidently did not fully shed water at the corners where said water evidently ran out.

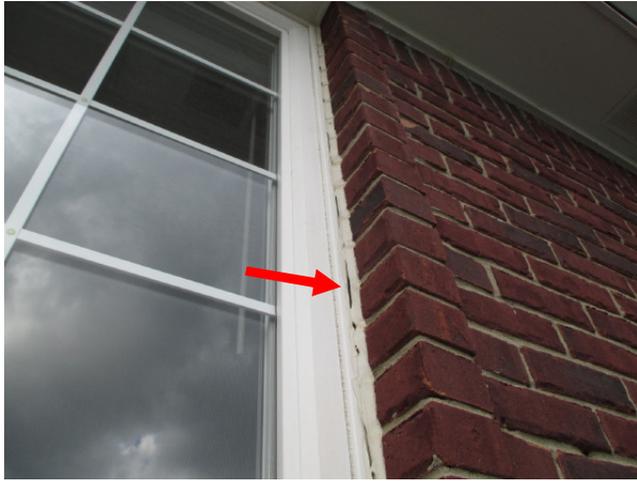
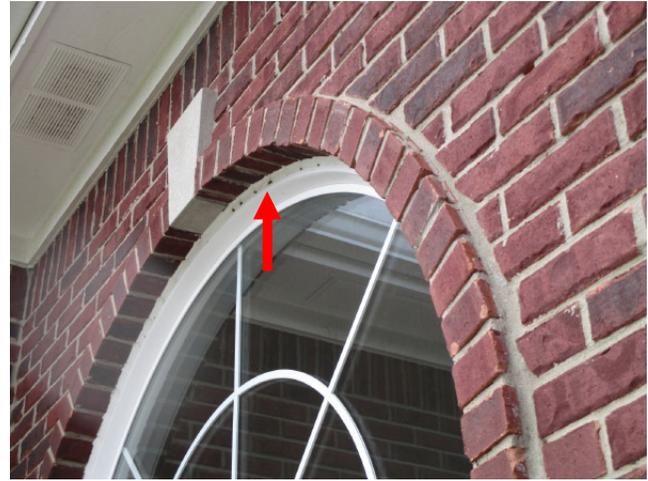
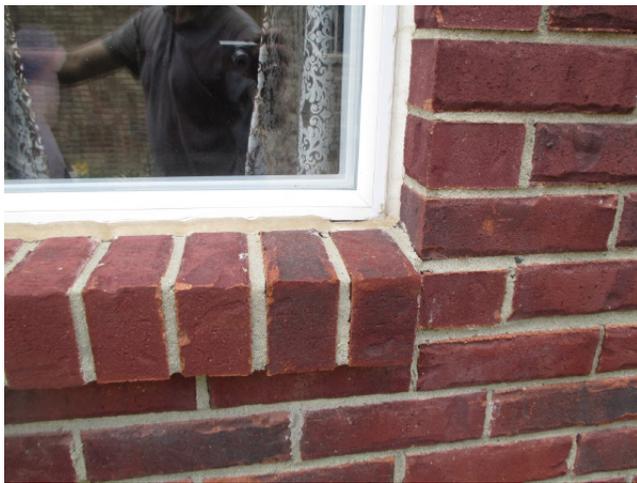
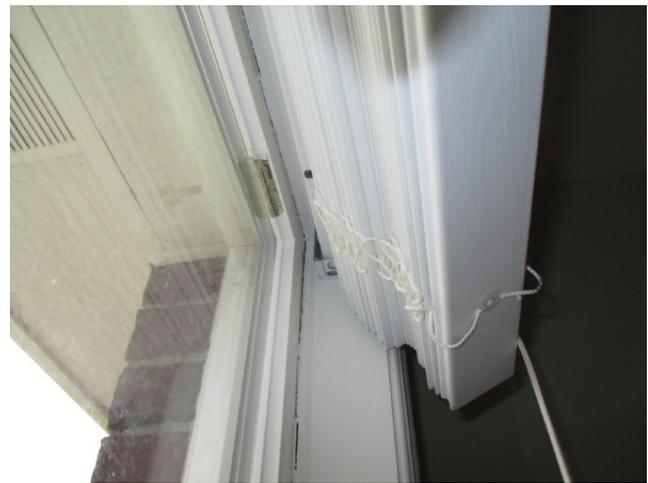
Gaps in window caulk. Noticeable gaps were observed in the caulk around the 2nd floor SE bedroom window and circular window above the front door, through which water may be able to enter and heat can pass.

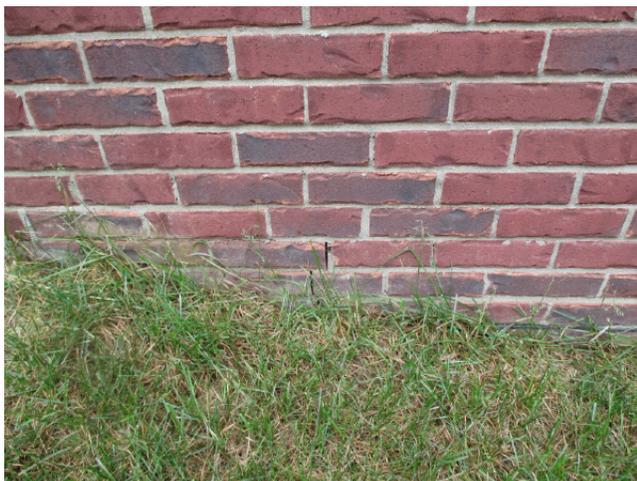
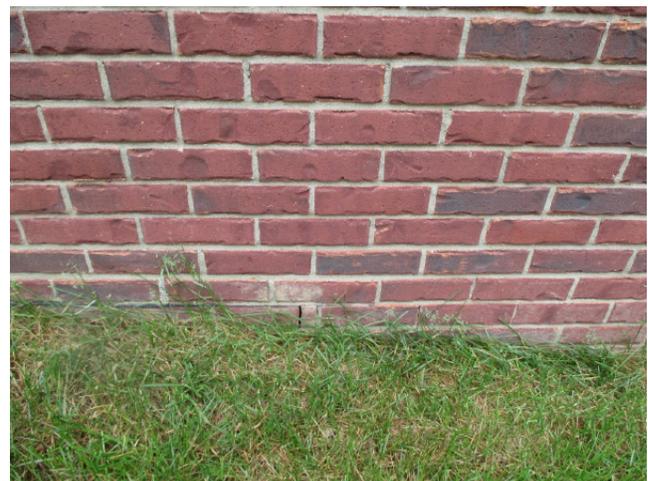
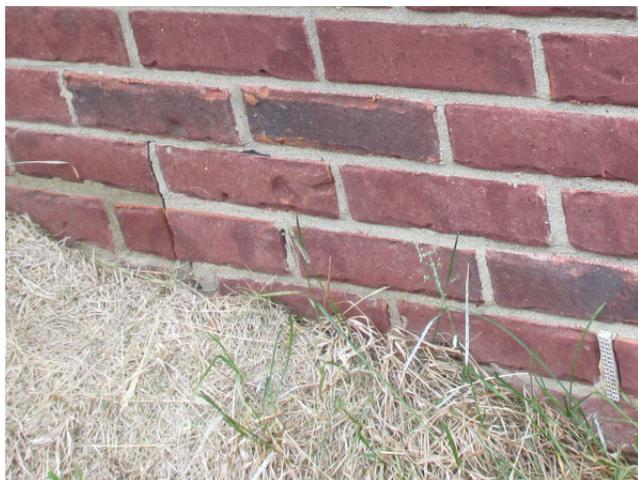
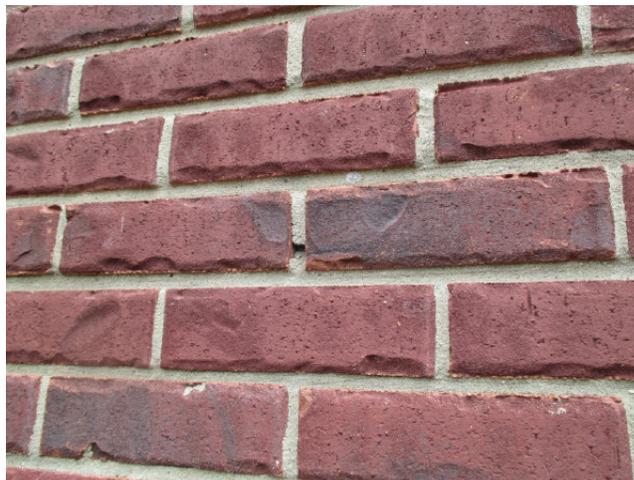
Masonry cracks and mortar gaps. Masonry was noticeably cracked near the ground near the N end of the E side, through which water could enter. Numerous gaps were observed in the exterior masonry all around the structure. No indications of leakage were observed, but the condition of underlying materials could not be determined.

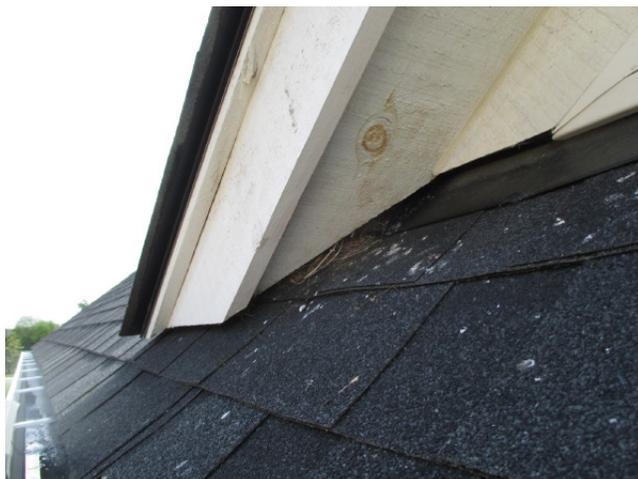
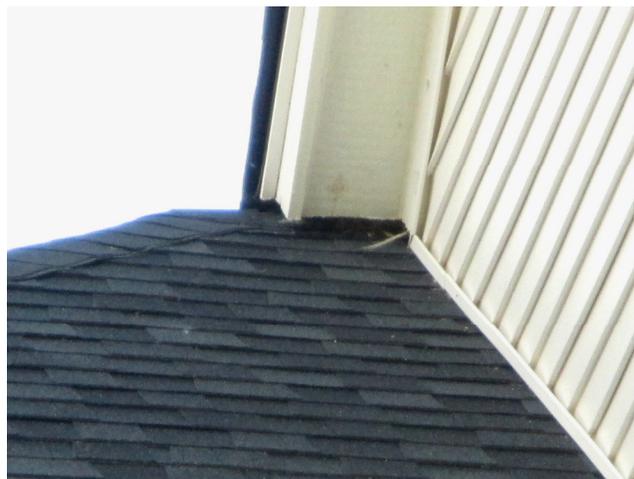
Gaps between soffit and roof; birds. Gaps were observed between the soffit and roof line, in which birds were evidently nesting. Such gaps could also enable vermin such as wasps and mice to enter the structure if there is passage into walls or attic spaces.

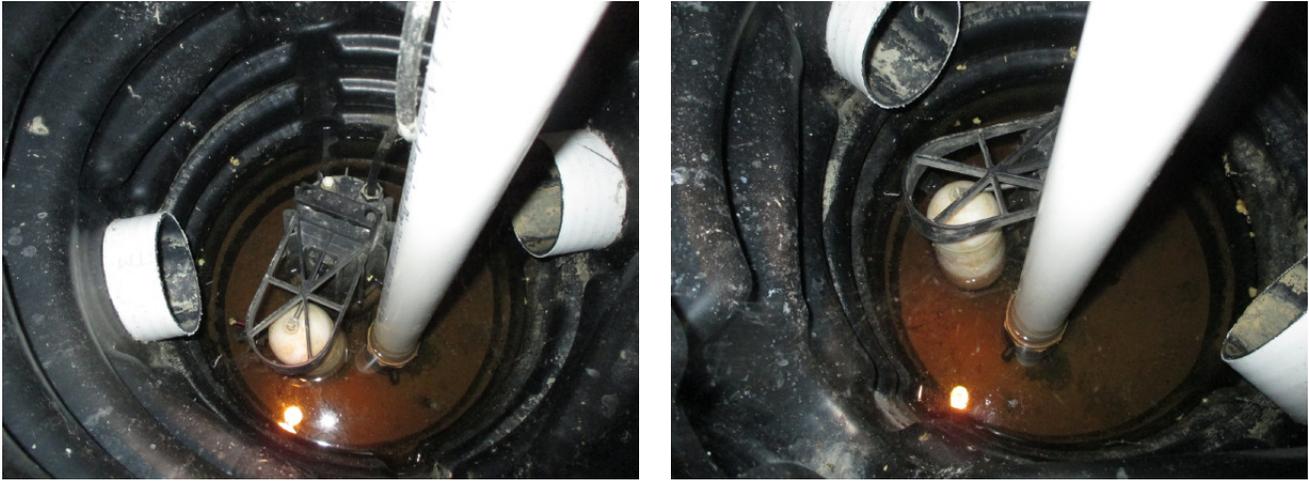
Sump pump. Sump pump did not operate when its float was initially lifted. The pump eventually ran after having sharply lifted the float several times, but would evidently not operate normally. Client said it had not been running lately, which was consistent with the initial observations. Float switch most likely needs to be replaced.

Note float fully up, water undisturbed (not running)

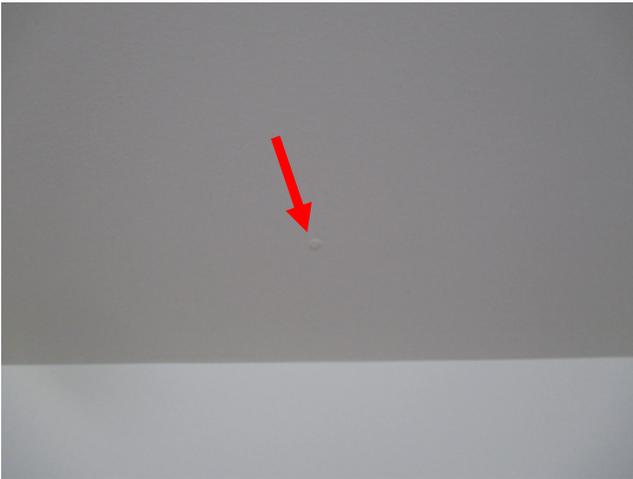
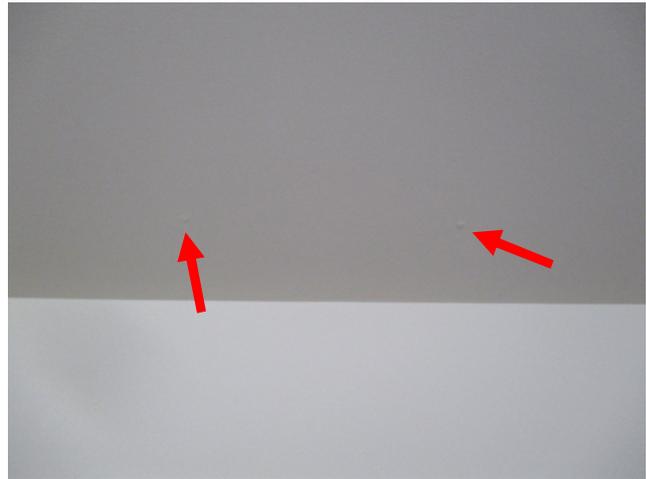
Ceilings: popping nails. A few popping nails were observed on the ceilings in the living room and dining room. Such issues tend to be difficult to see in pictures.

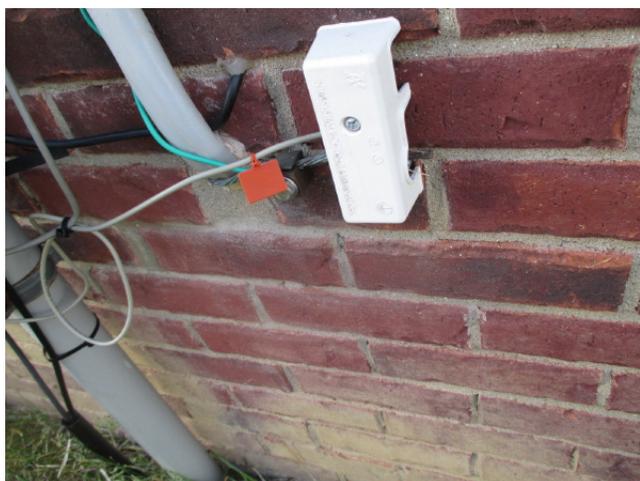
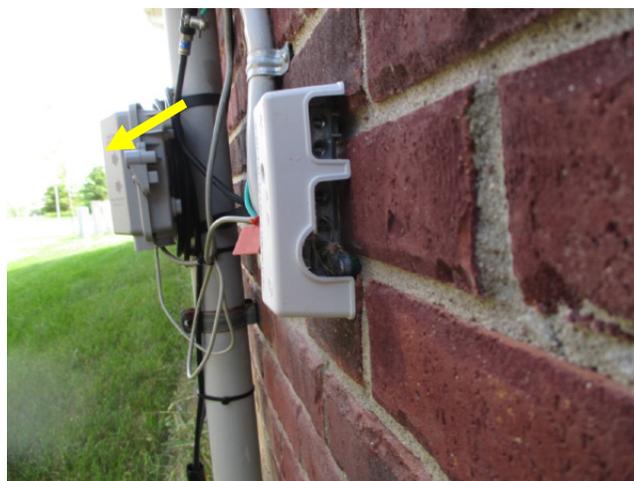
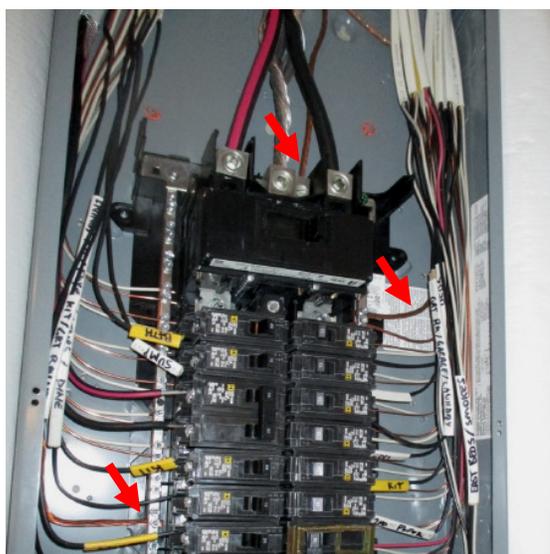
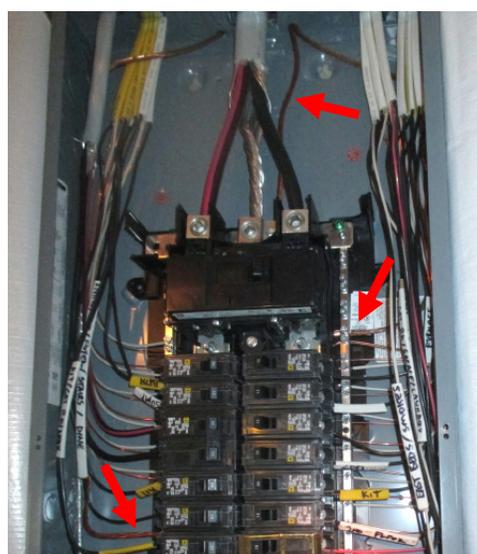
Electrical: grounding not visible. No visible electrical service grounding connection was observed. A 6 gauge stranded wire consistent with such a grounding wire was observed, which was cut off at a multi-connection terminal, which did not have any visible continuity to an external grounding rod or other obvious grounding connection.

The main water supply pipe was evidently plastic, and therefore unsuitable for electrical grounding. A connection to one or more rods embedded in the foundation could be present that was not visible. 3 wires consistent in appearance with grounding wires were observed in the main panel, so evidently the service was properly grounded.
