## **Evergreen Home Inspections**

# **PROPERTY INSPECTION REPORT**

Concerning: **45717 Sample Lane, Novi, MI 48088**

Inspection Date: **April 1, 2014**

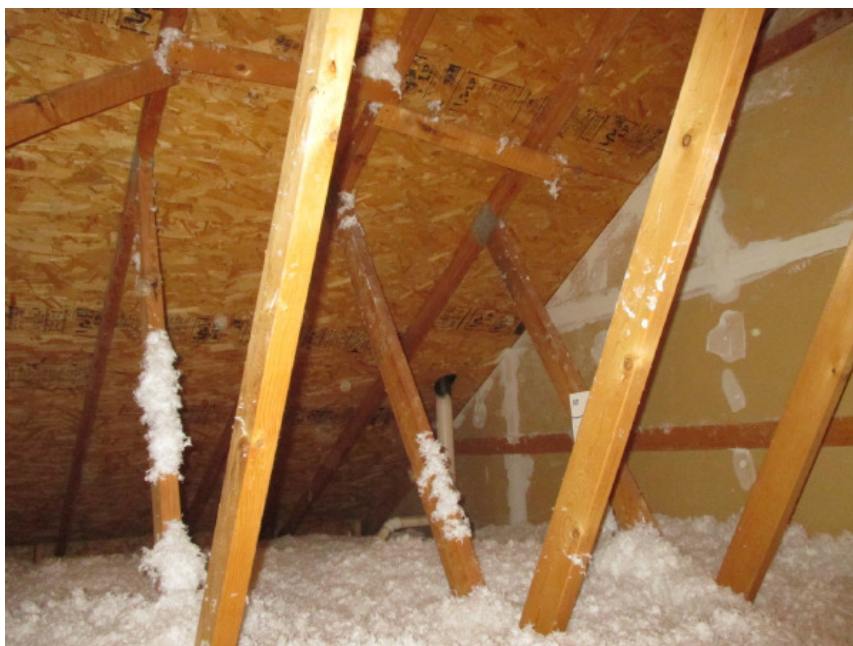
Attic framing and roof sheathing were observed to be sound, with no significant issues evident where visible, except as otherwise noted.

Ventilation appeared to be very good and properly configured, but was not measured, as such would be well beyond the scope of such an inspection.

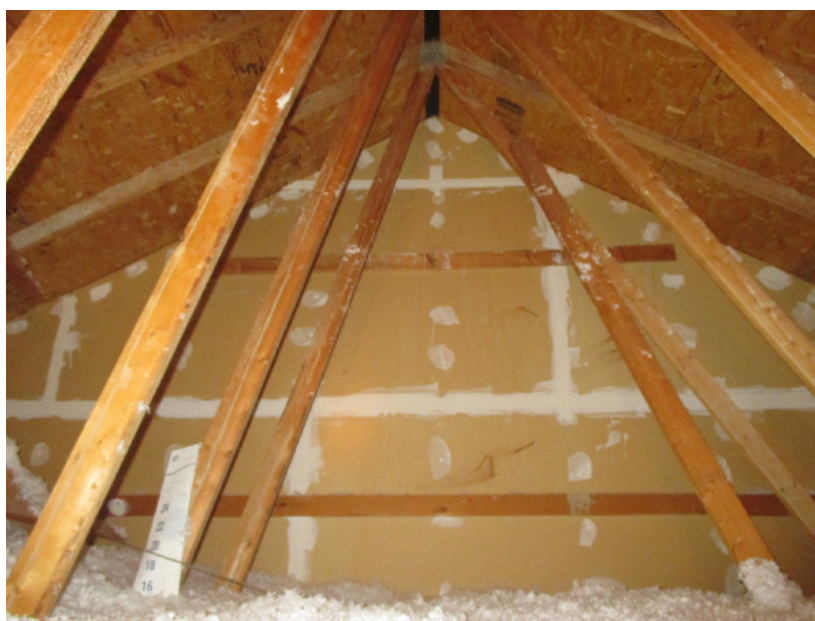
- Attic spaces between units may only be separated by drywall on top of framing, which could be easily cut to allow passage between the attic spaces of the units.

Locking latches on the access panel would be desirable as a precautionary measure.

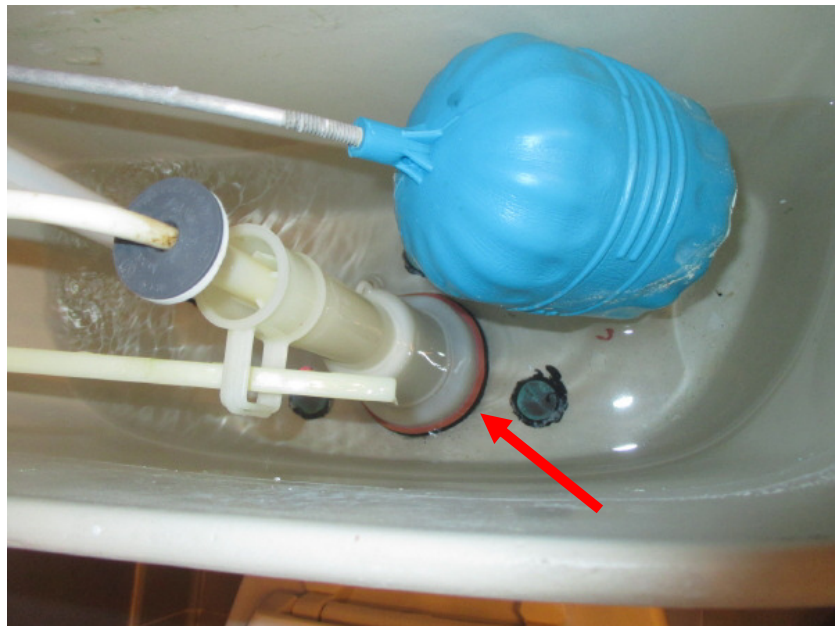
- Copper supply piping was observed to be generally in good condition to the extent it was visible. Water flow was good at all fixtures, with very little decrease in water pressure when multiple fixtures were run at the same time. Fixtures were observed to be functional and in good condition.
- Stopper gaskets cautionary note: Toilet stopper gaskets were of a type that is subject to premature deterioration, resulting in the toilet running constantly. These were in good condition and effective at the time of the inspection.

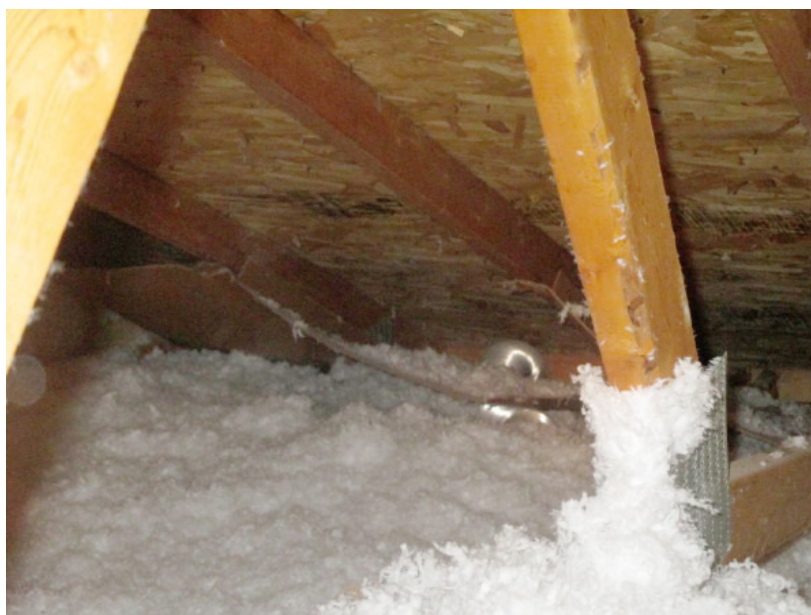
- Bathroom exhaust fans observed to be functional and in good condition, with ductwork and hoods for exterior discharge observed where visible.
