Evergreen Home Inspections

PROPERTY INSPECTION REPORT

Concerning: **888 Sample St., Detroit, MI 48222**

Date: **February 7, 2011**

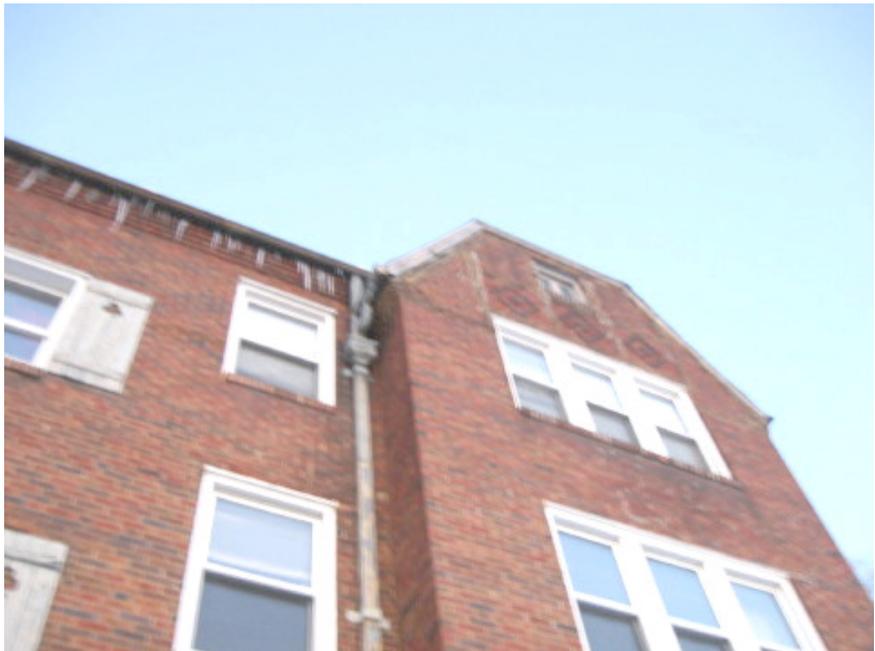
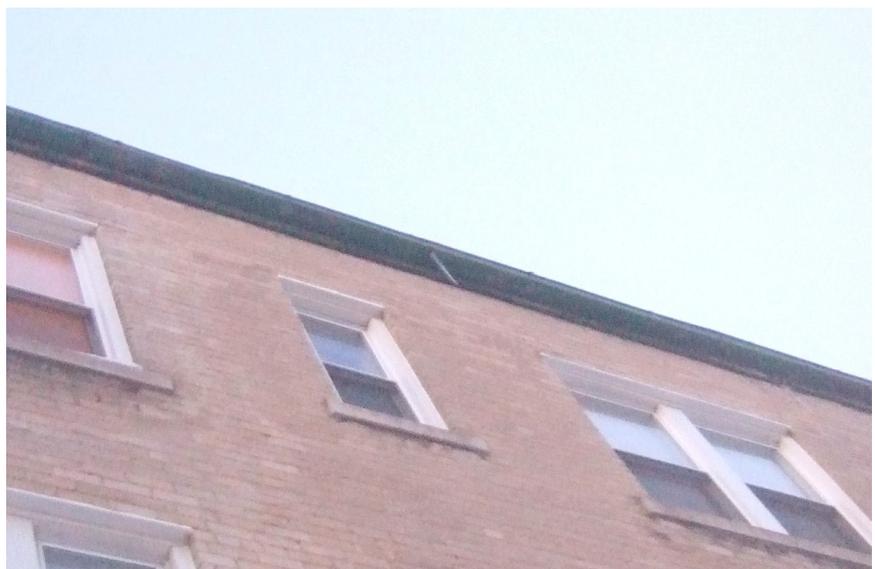
- Roof: When the low-pitched portion of the roof is next resurfaced, it may be advisable to use modern membrane roofing material, which is more easily replaced than a built-up roof.
 - Exterior: Leakage observed from gutter and downspout seams. Noticeable corrosion was observed on some lengths of the gutters.
- Considerable ice glazing was observed along much of the perimeter of the building, some of which may just have been a consequence of melting snow and ice, but some of which was evidently due to gutter/downspout leakage. All in all, the gutters and downspouts appeared mostly functional, but in need of updating.
