Inspection Report (1 year home warranty)

42160 Sample Dr., Novi, MI 48375

Inspection Date: June 3, 2018

The property was inspected for defects due to premature failure and improper work for the Client's 2 year home warranty.

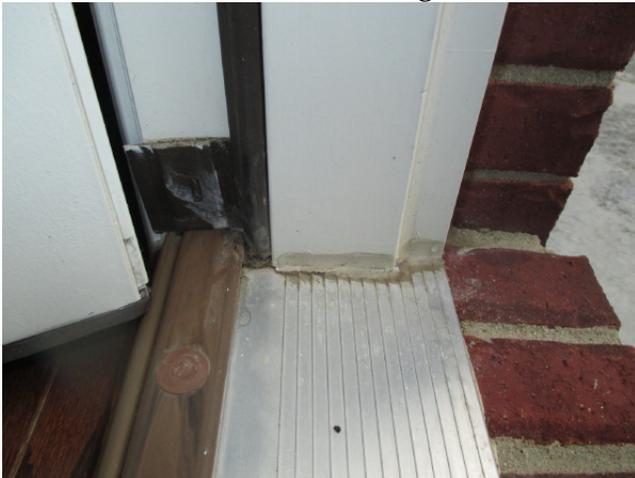
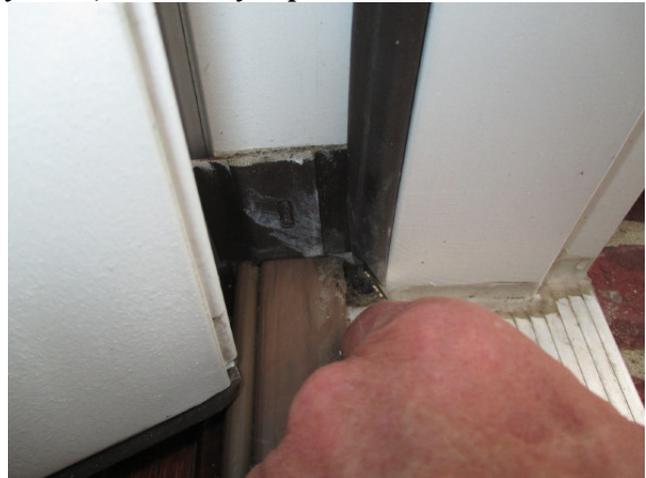
Leakage: basement ceiling. Indications of leakage and elevated moisture were observed in the basement ceiling area below the front door and nearby I-beam. Client/owner reported such leakage was most pronounced during rains with SE winds. These observations were consistent with leakage through the door threshold.

Door threshold through which water may enter, with sandy deposits like below
